**INCIDENT**

<b>Aircraft Type and Registration:</b>	Embraer EMB-145EP, G-RJXA
<b>No &amp; Type of Engines:</b>	2 Rolls-Royce AE 3007A turbofan engines
<b>Year of Manufacture:</b>	1999
<b>Date &amp; Time (UTC):</b>	10 May 2007 at 1215 hrs
<b>Location:</b>	In the climb, 20 nm south-west of Aberdeen Airport
<b>Type of Flight:</b>	Commercial Air Transport (Passenger)
<b>Persons on Board:</b>	Crew - 4                      Passengers - 16
<b>Injuries:</b>	Crew - None                      Passengers - None
<b>Nature of Damage:</b>	No 1 IC-600 computer unserviceable
<b>Commander's Licence:</b>	Airline Transport Pilot's Licence
<b>Commander's Age:</b>	36 years
<b>Commander's Flying Experience:</b>	5,000 hours (of which 3,000 were on type) Last 90 days - 112 hours Last 28 days - 39 hours
<b>Information Source:</b>	AAIB Field Investigation

**Synopsis**

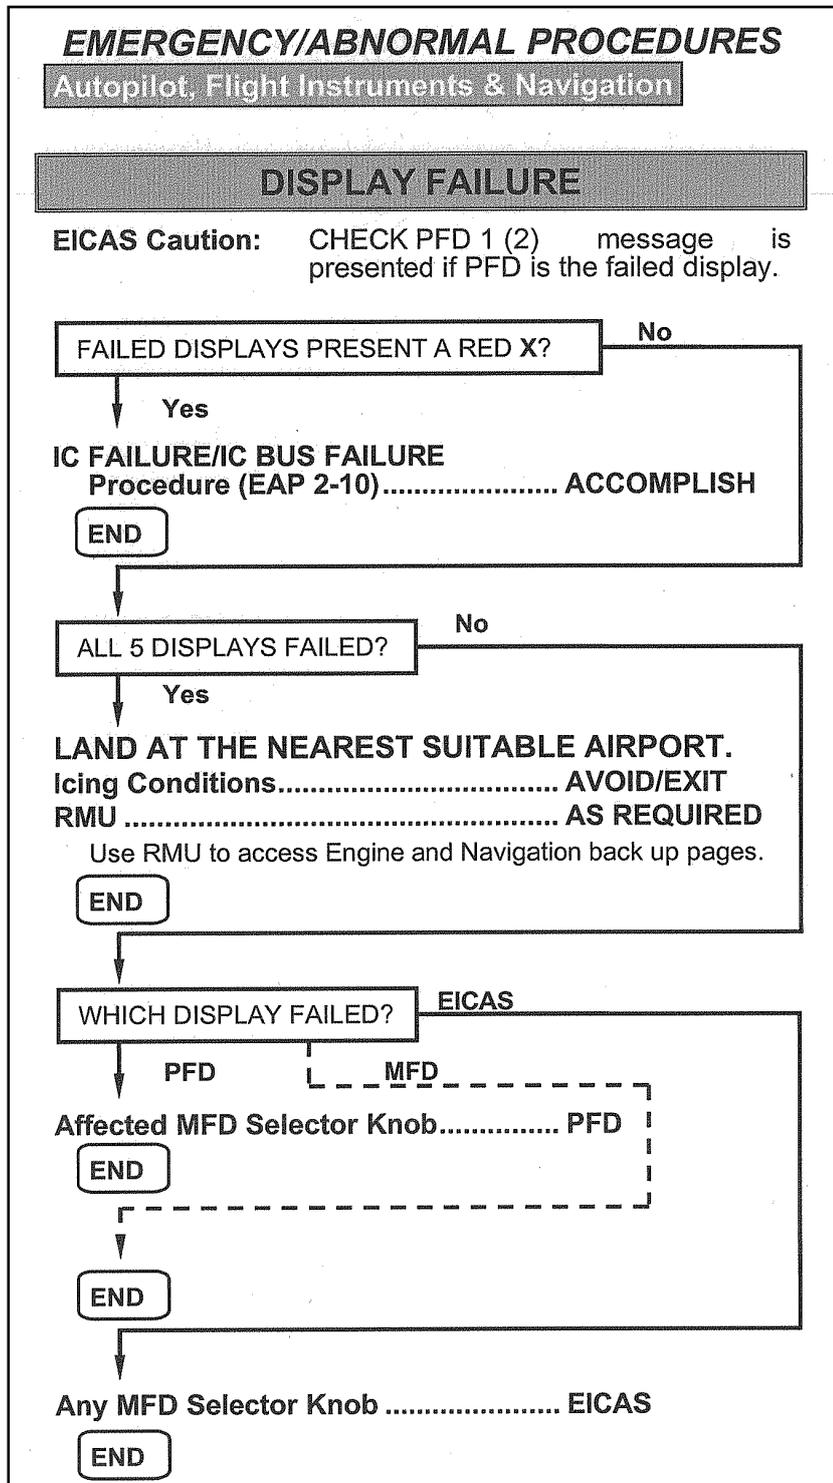
Figure 2

The following is the Display Failure checklist, for the symptoms the commander experienced (Figure 2):

There was no fault diagnosis of the commander's blank

screens. As a result the Display Failure/IC-600 failure checklist was not completed. Had the commander completed this checklist he would have had his PFD, MFD and EICAS restored to him. This would have made it much easier for him to monitor the co-pilot's flying. As they were in IMC, and he landed the aircraft using the standby instruments, this would have been prudent. The commander's request to the co-pilot to contact the cabin crew at 300 ft aal was inappropriate. As the commander landed the aircraft using the standby instruments, the co-pilot should have been closely monitoring the commander during the final stages of the approach.

The crew's actions should have been to don their oxygen masks, establish communications, complete the 'Air Conditioning Smoke' or 'Electrical System Fire Or Smoke' checklist, as they saw appropriate, then the 'Display Failure' checklist, followed by the 'Smoke Evacuation' checklist, if smoke was still present. Once

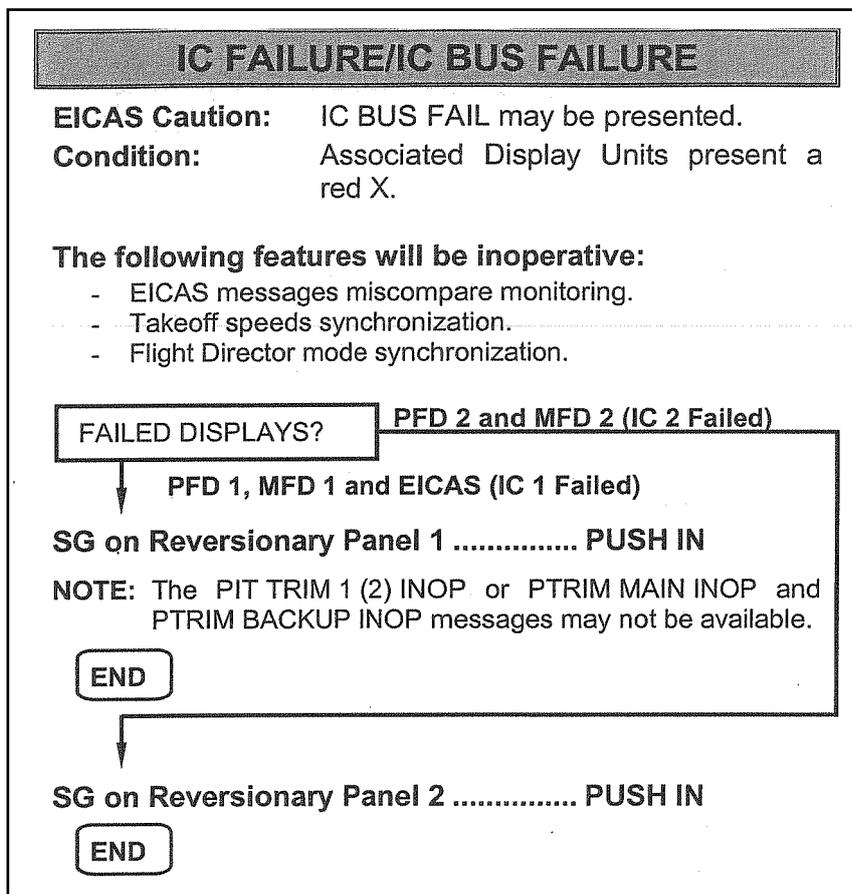
Figure 3

The following is the 'IC Failure' drill to which the 'Display Failure' checklist directs the crew (Figure 3):
