Aircraft Type and Registration:	1) Slingsby T50 Skylark 4, BGA identification number 1116
	2) Schempp-Hirth Ventus cT, BGA identification number 3259
No & Type of Engines:	1) None

Synopsis

VENTUS/SKYLARK COLLISION SCHEMATIC

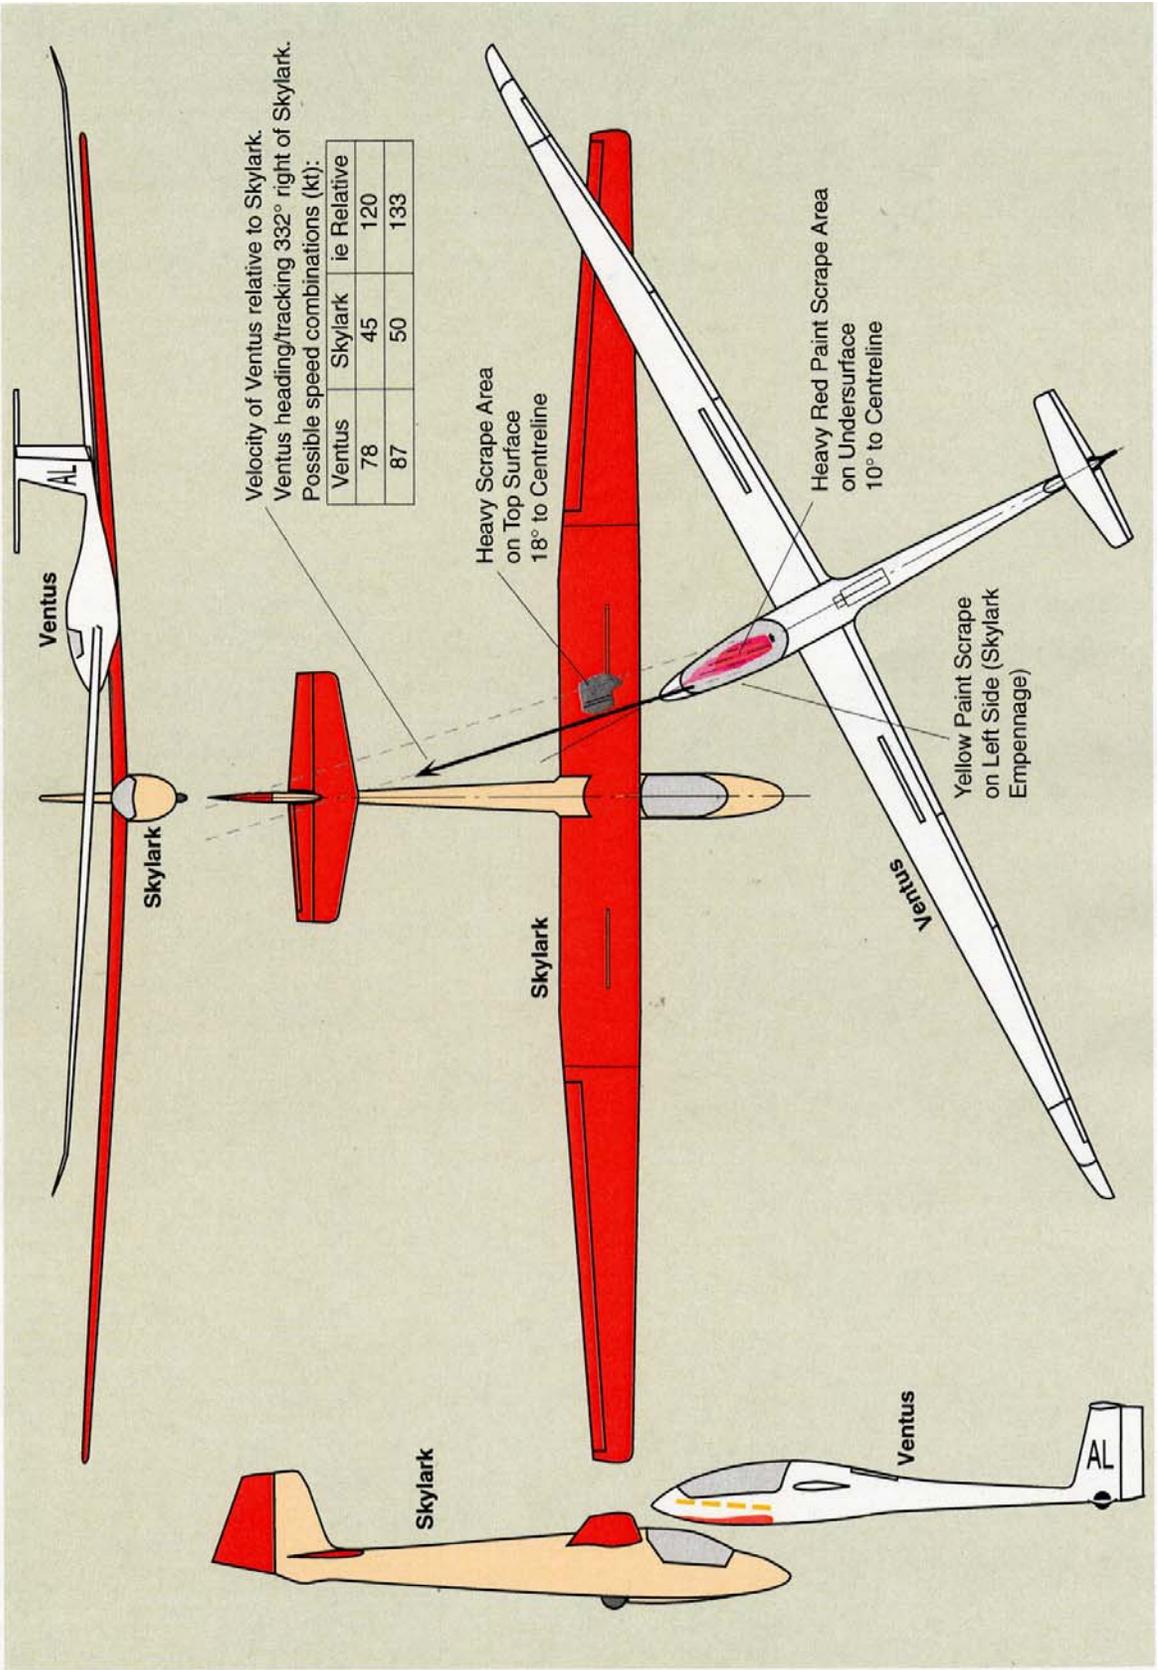
Figure 1

Detailed examination revealed multiple red paint deposits scraped onto the underside of the forward fuselage. The deposits were centred on the aircraft's centreline and extended over almost the whole length of the cockpit. They were angled 10° to the centreline, from right to left, forward to aft. There were also cream paint deposits scraped on the left side of the forward fuselage beneath the canopy coaming.

Scrape marks and heavy gouges that were not consistent with ground impact effects were present on the upper surface of the left wing, 4.9 feet outboard of the fuselage centreline. The markings passed across the top of the heavily-built wooden wing spar. They were angled 18° to the aircraft's centreline, from left to right, forward to aft. The spacing between two deep gouges matched that between two small steel brackets protruding from the underside of the Ventus beneath the aft part of the cockpit.

It was clear from the markings on the two gliders that the underside of the nose of the Ventus had made forcible contact with the top surface of the Skylark's left wing in the area of its robust spar. This was followed by collision between the forward fuselage of the Ventus and the empennage of the Skylark, as indicated by geometric considerations and by a number of items of evidence. These included wreckage distribution features, the cream paint scrape on the Ventus and the findings, when the Skylark empennage parts were laid out in order, of particularly severe damage to the inboard part of the left tailplane and of GRP fragments embedded in a control mechanism in the tailplane root.

The angles of the collision markings showed that the Ventus had been tracking 332° relative to the Skylark at the collision (ie 28° from head-on, Figure 1). The Ventus travelled around 400 metres north-north-east from the collision point but, as there was no definitive evidence as to its manoeuvres after the collision, neither the absolute heading nor track of either glider when they collided, nor their
