INCIDENT

| Aircraft Type and Registration: | Boeing 737-300, G-CELI | |
| Date & Time (UTC): | 19 October 2009 at 1316 hrs | |
| Location: | Manchester Airport | |

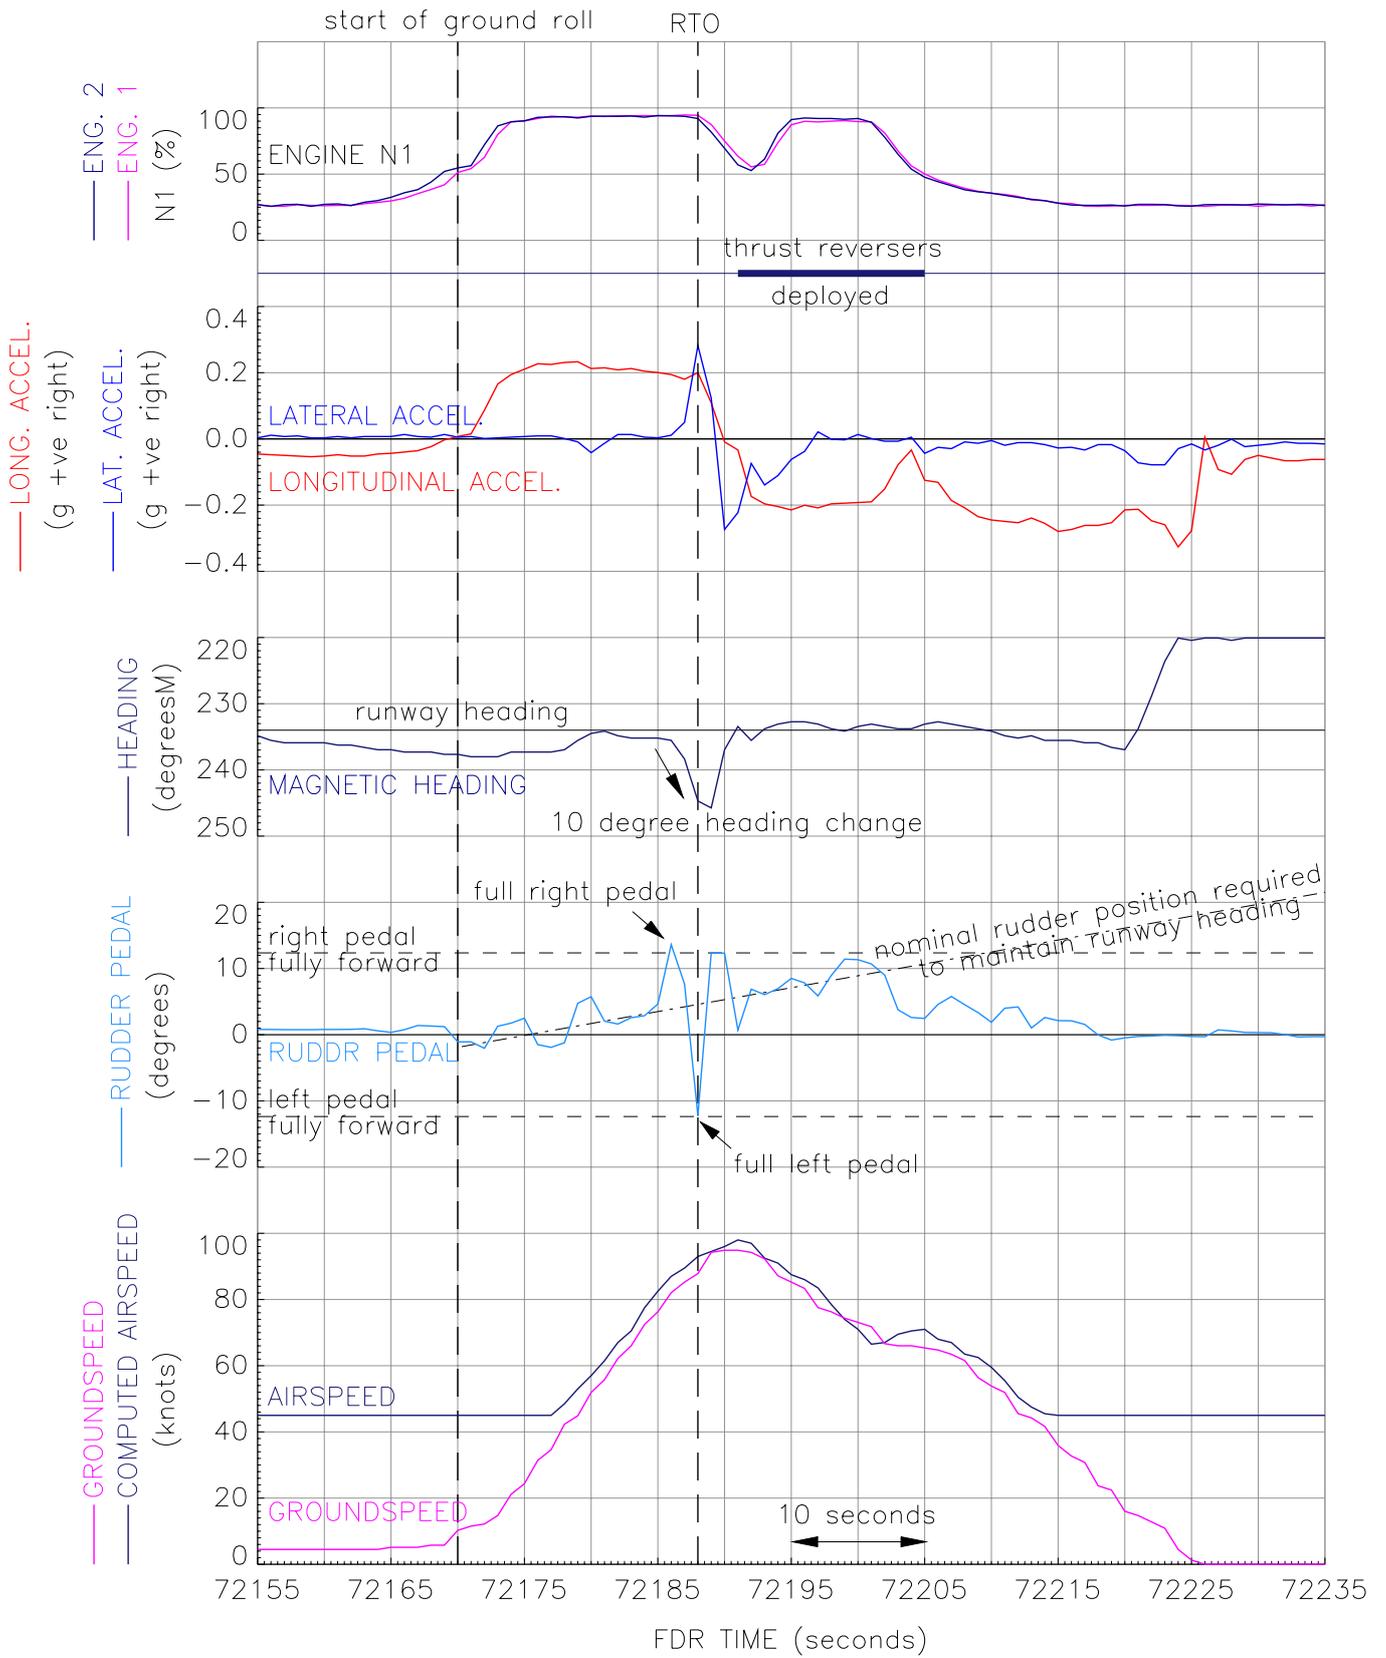
Figure 1
Salient FDR parameters for the incident to G-CELI

A time history of salient parameters from the FDR for the incident is shown at Figure 1. The aircraft was configured for a flaps 5 takeoff with the autothrottle engaged (not shown). As soon as the aircraft started to accelerate along the runway (at about 72170 seconds), increasing amounts of right rudder pedal were required to maintain the runway heading (evidenced by the zero lateral acceleration). At approximately 72185 seconds and 83 kt computed airspeed, the rudder pedal deflected further to the right, reaching full travel one second later. A maximum lateral acceleration to the right of 0.3 g was reached about two seconds later at which point the crew, aware of a problem, rejected the takeoff. A heading change of approximately 10° to the right was

also recorded at this time. Subsequently, a large left rudder pedal input to just under full travel was recorded followed by a maximum lateral acceleration to the left of 0.3 g and a return of the aircraft back to the runway heading. Again, increasing amounts of right rudder pedal were required to maintain runway heading during the deceleration.
