Map of route followed by G-BKFN

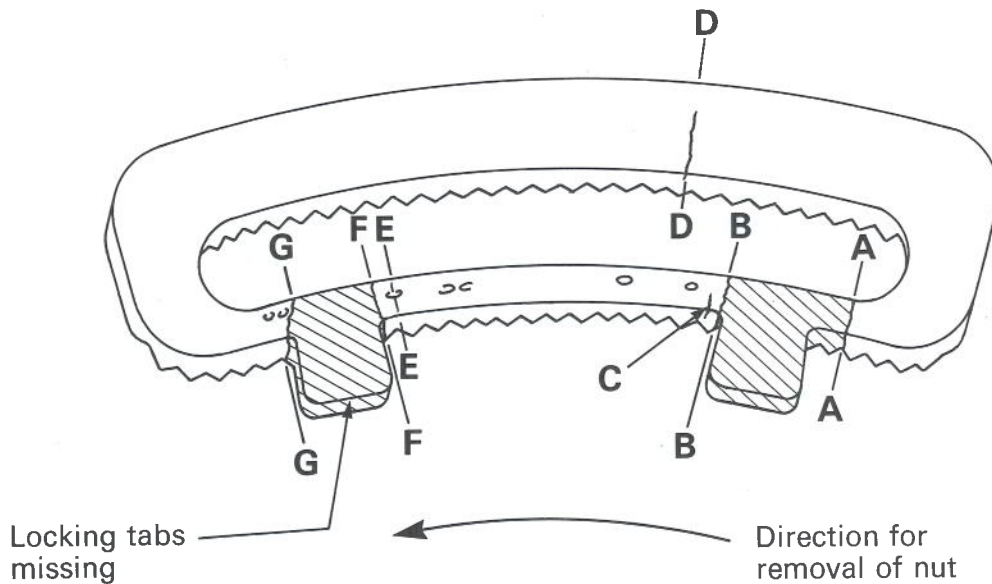
**VIEW OF BOTTOM SIDE OF LOWER LOCKING PLATE**  
(i.e. looking upward as installed on aircraft)

Fracture/Crack Location

Fracture	Serration No.	The upper locking plate engaged in serrations 14 through 24. The retention screws centered on serrations 16 and 22.
A - A	5	
B - B	10	
F - F	24	
G - G	27	
Crack		
C	11	
D - D	14	
E - E	24

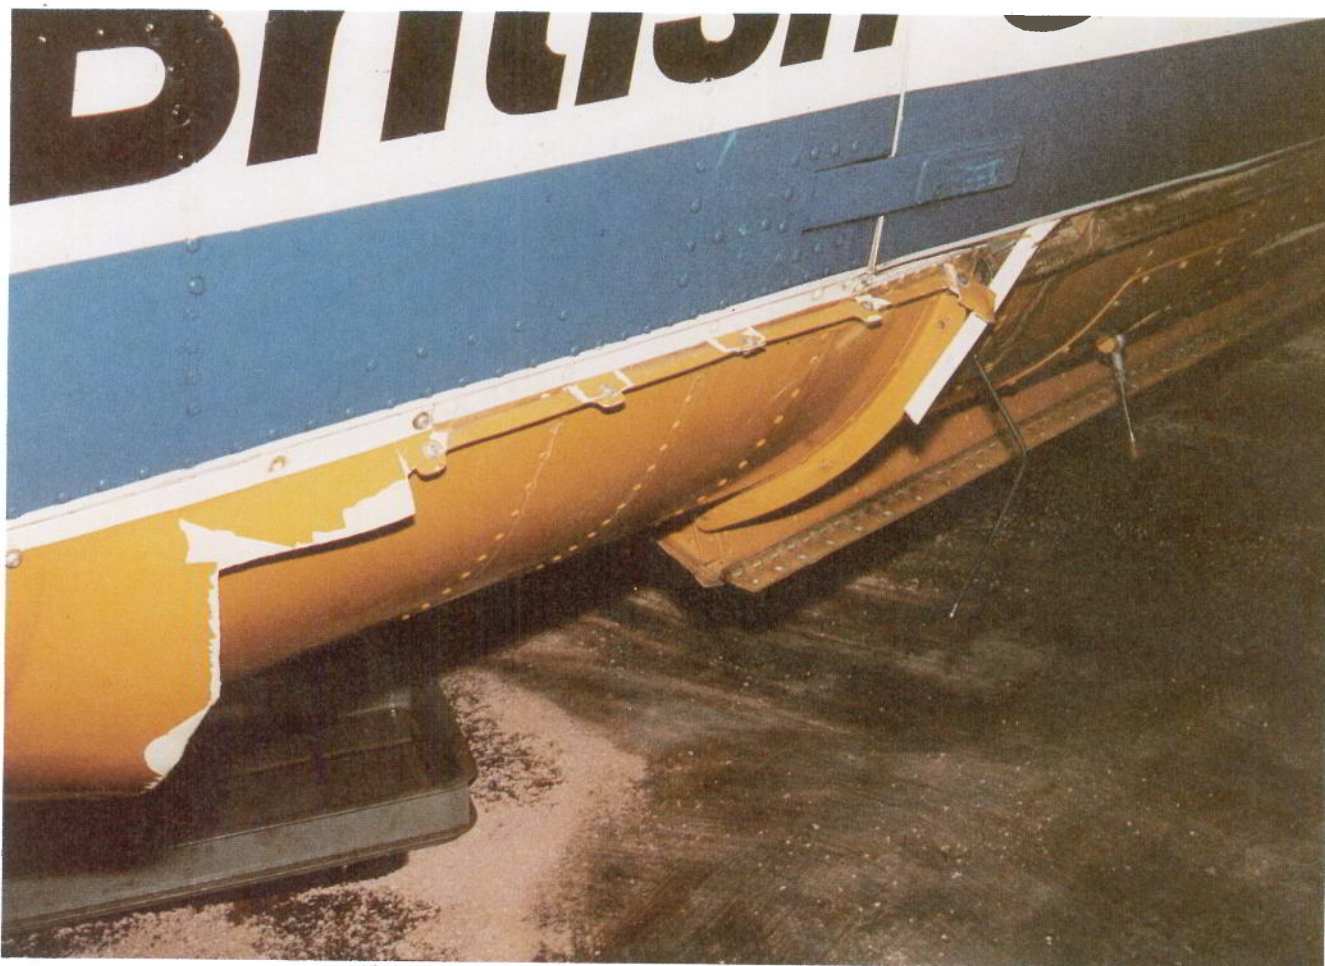
**VIEW OF REMAINS OF FORWARD FAIRING (FLOATS REMOVED)  
NOTE TABS ON ATTACHMENT BRACKET**
