ACCIDENT

Aircraft Type and Registration:	Gardan GY80-160 Horizon, G-ATGY	
No & Type of Engines:	1 Lycoming O-320-B3B piston engine	
Year of Manufacture:	1965	
Date & Time (UTC):	1 October 2011 at 1455 hrs	
Location:	Yeovilton Airfield, Somerset	
Type of Flight:	Private	
Persons on Board:	Crew - 1	Passengers - 2
Injuries:	Crew - None	Passengers - None
Nature of Damage:	Landing gear, propeller and engine shock-loaded	
Commander's Licence:	Airline Transport Pilot's Licence	
Commander's Age:	67 years	
Commander's Flying Experience:	14,328 hours (of which 14 were on type) Last 90 days - 98 hours Last 28 days - 25 hours	
Information Source:	Aircraft Accident Report Form submitted by the pilot and subsequent AAIB enquiries

Synopsis

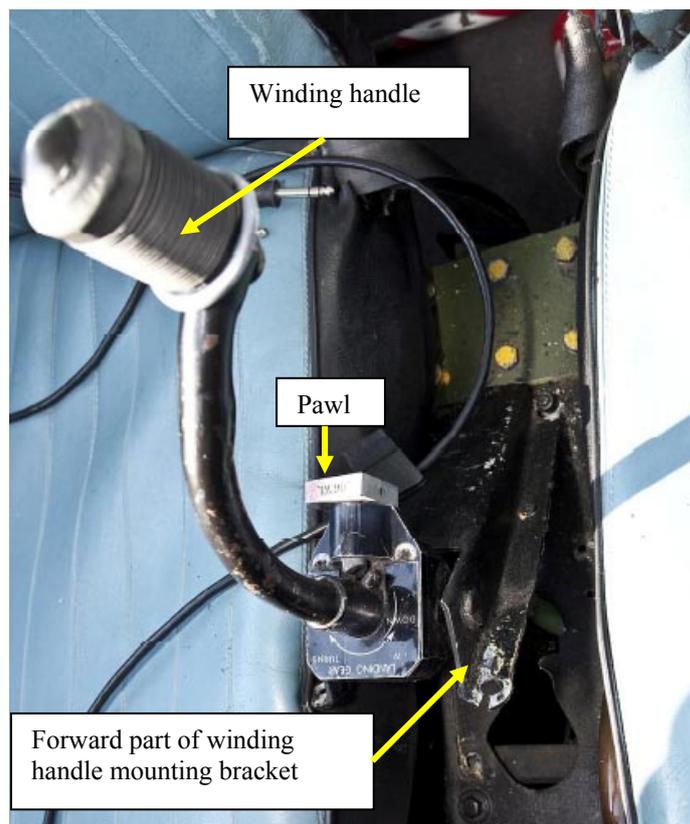
Figure 1

propeller blades struck the ground. The mainwheels then collapsed and the aircraft ran off the right side of the runway and came to a stop on the grass. The pilot later noticed that the forward part of the landing gear winding handle, located between the two front seats, had come away from the control pedestal. See Figure 1.

Landing gear winding handle

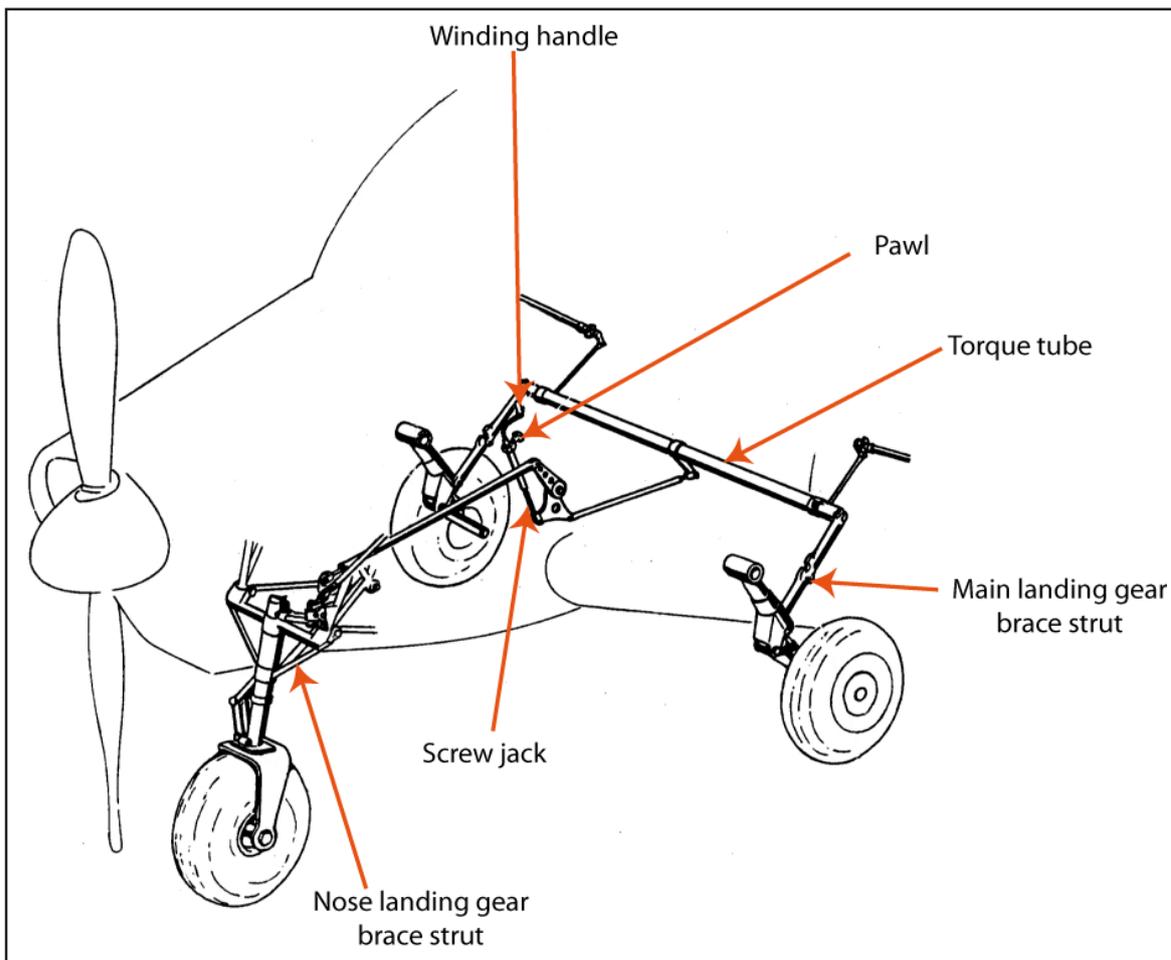
Figure 2

handle operates a screw jack which through a system of bell cranks, struts and a torque tube cause the landing gear to extend or retract. See Figure 2. Brace struts, located between the main legs and the torque tube, move over-centre (by 0.7 +/- 0.05 mm) as the gear is extended, locking the main legs in the down position. Similarly, a nose leg brace strut also moves over-centre (0.8 +/- 0.1 mm) to lock the nose leg in the down position. A pawl at the base of the winding handle engages a ratchet assembly which prevents the handle from moving in flight.

Landing gear operating mechanism

The landing gear position microswitches only give the relevant position of the screw jack and do not detect if the brace struts have moved into the over-centre position. The pilot reported that he had a 'green' gear indicating light and the nose landing gear retracted during the

ground roll shortly after the nosewheel made contact with the runway. This suggests that the nosewheel brace strut might not have been fully over-centred and, consequently, the nose landing gear would have started to collapse rearwards as the wheel was lowered onto the runway. As it collapsed, a force would have been transmitted through the control linkages sufficient to detach the forward part of the winding handle securing bracket away from the pedestal. At the same time, the main landing gear torque tube would have rotated, causing the main landing gear brace strut to move out of the over-centre position and thereby allowing the main landing gear to retract under the weight of the aircraft.
