### **Detailed examination of the left engine accessory gears**

## **Analysis of the rupture of the idler pin support**

## **Investigations into torsional viscous damper's and accessory gears**

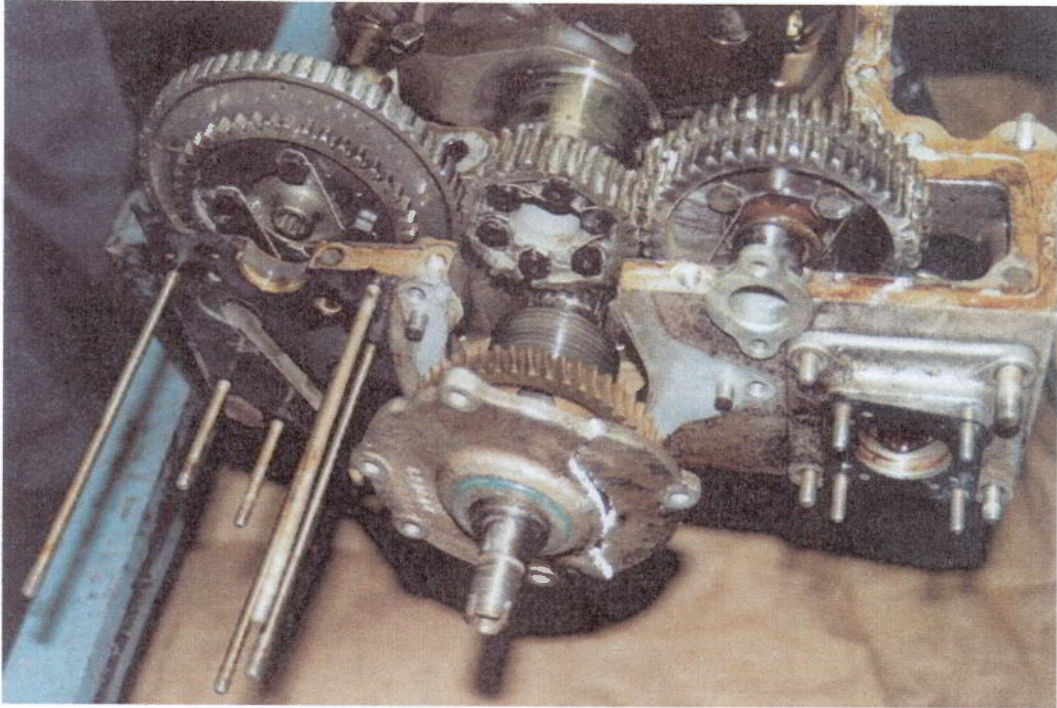
**PHOTOGRAPH OF DAMAGED ACCESSORY GEARS - LEFT ENGINE**

The starter gear (Part number 653712C) had been stripped of all its teeth and only four survived in recognisable state in the debris recovered from the sump. The one tooth of the starter gear, which was considered to be the first to fail, contained multiple fatigue sites. No material or manufacturing defects were identified and it appeared, therefore, that fatigue had developed due to high cyclic loading conditions. The gear tooth flanks showed evidence of heavy wear, being indented, polished and pitted and this, also, was an indication that the gear had been subjected to damaging loads. This wear was distinct from the coarse damage seen on the flanks of the other teeth and was taken to represent the condition of the gear before its break-up had begun and was therefore the result of a longer term wear process.

The crankshaft gear (Part Number 653580C) had lost 17 of its 30 teeth. All the tooth fractures were in overload. The 13 still in place showed bruising and impact damage from running out of mesh with the starter gear, the camshaft gear and the idler gear. Damage from the starter gear could be distinguished because its teeth were broader than those of the other two gears. The gear teeth flanks (both sides) also showed evidence of longer term wear. The teeth which had detached from the crankshaft gear and were found in the sump showed less damage from their contacts with the other gears but all showed heavy wear.

All the teeth on the camshaft gear had been removed and only the smeared roots of the teeth remained. No camshaft gear teeth were identified in the sump debris.

The idler gear was less damaged than the other gears described above. The crowns of the teeth were damaged but the teeth were not wiped out down to the roots as on the camshaft gear. One tooth had broken off at the root in overload and was recovered from the sump. One flank was highly polished, slightly dished at mid height (just perceptible) and there were two pits near one end. These features were indicative of wear rather than traumatic damage. On its crown and other flank the tooth showed evidence of having been sheared out by crown to crown impact with another gear tooth. The tooth's crown was almost undamaged but near its trailing edge (relative to direction of travel) material has been sheared downwards along a straight spanwise line. One half of the tooth was sheared downwards against the other, splitting the tooth from crown to root. This had forced the other half of the tooth backwards against direction of rotation shearing it off at the root. The two halves of the tooth appeared to be welded together along the

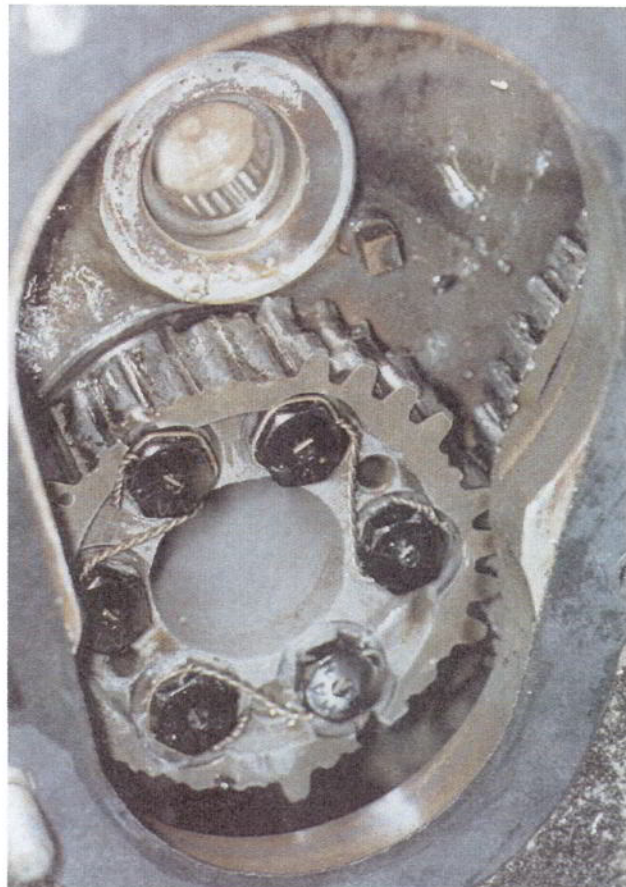
**CLOSE-UP OF CRANKSHAFT GEAR - LEFT ENGINE**

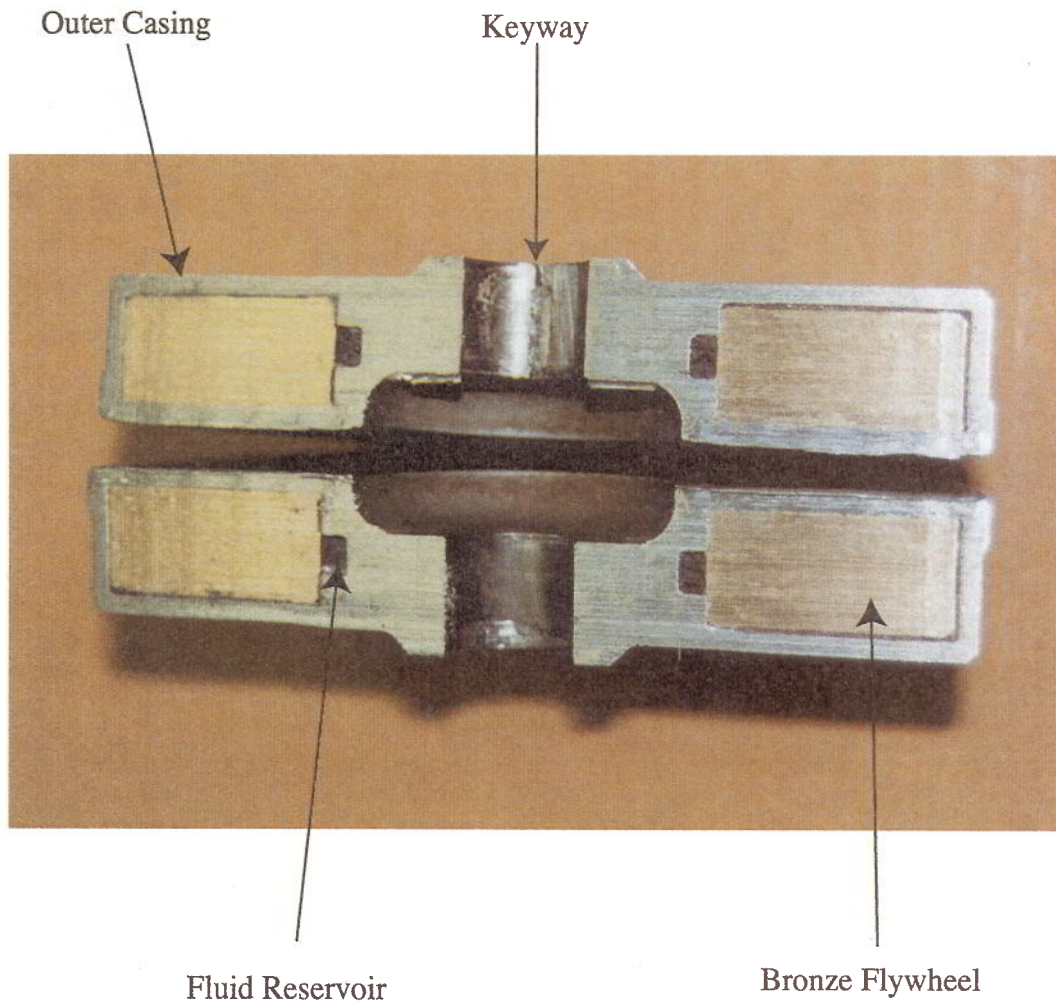
**TORSIONAL VISCOUS DAMPER FROM LEFT ENGINE AS SECTIONED**

All the fluids showed signs of decreased viscosity with use. The indications were strongest in damper Nos. 1269, 1239 and 733 which had the highest metal particulate contamination. (There was some evidence that No. 250 contained a higher viscosity fraction.) The damper fluid from G-ILGW, while showing a lesser indication of any decrease in viscosity was in the highest category of metal congestion.

All 31 dampers were examined in the areas involved in their attachment to, and their security on, the starter shaft. Most showed no damage to the keyway and only light fretting in the bore with slight smearing of the pressure faces loaded by the securing nut. However, the three dampers which were associated with the most heavily damaged gears (i.e. loss of teeth) contained wear and damage to the keyway and other surfaces which were similar to, though less severe than, the effects seen on the damper from the left engine of G-ILGW.
