ACCIDENT

Aircraft Type and Registration:	Robinson R22 Beta, G-RIDL	
No & Type of Engines:	1 Lycoming O-360-J2A piston engine	
Year of Manufacture:	2001	
Date & Time (UTC):	15 November 2009 at 1530 hrs	
Location:	Pinfold Farm, Macclesfield, Cheshire	
Type of Flight:	Private	
Persons on Board:	Crew - 1	Passengers - None
Injuries:	Crew - 1 (Fatal)	Passengers - N/A
Nature of Damage:	Aircraft destroyed	
Commander's Licence:	Private Pilot's Licence	
Commander's Age:	69 years	
Commander's Flying Experience:	476 hours (of which 130 were on type) Last 90 days - 0 hours Last 28 days - 0 hours	
Information Source:	AAIB Field Investigation

Synopsis

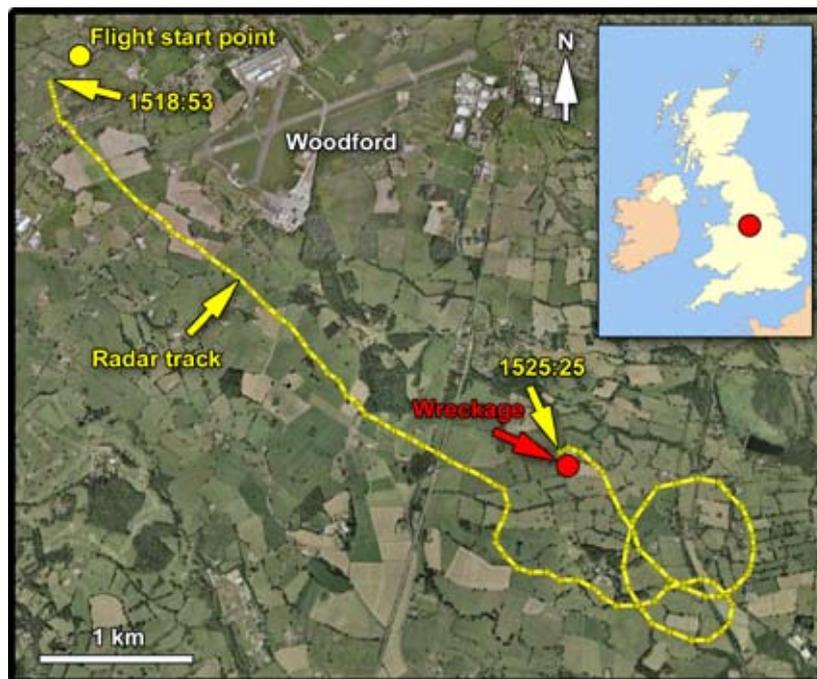
Figure 1

The flight path of the helicopter was, however, captured by Manchester Airport’s radar (Figure 1). The helicopter’s transponder was not set to report its altitude, so only its ground track could be assessed.

G-RIDL radar track

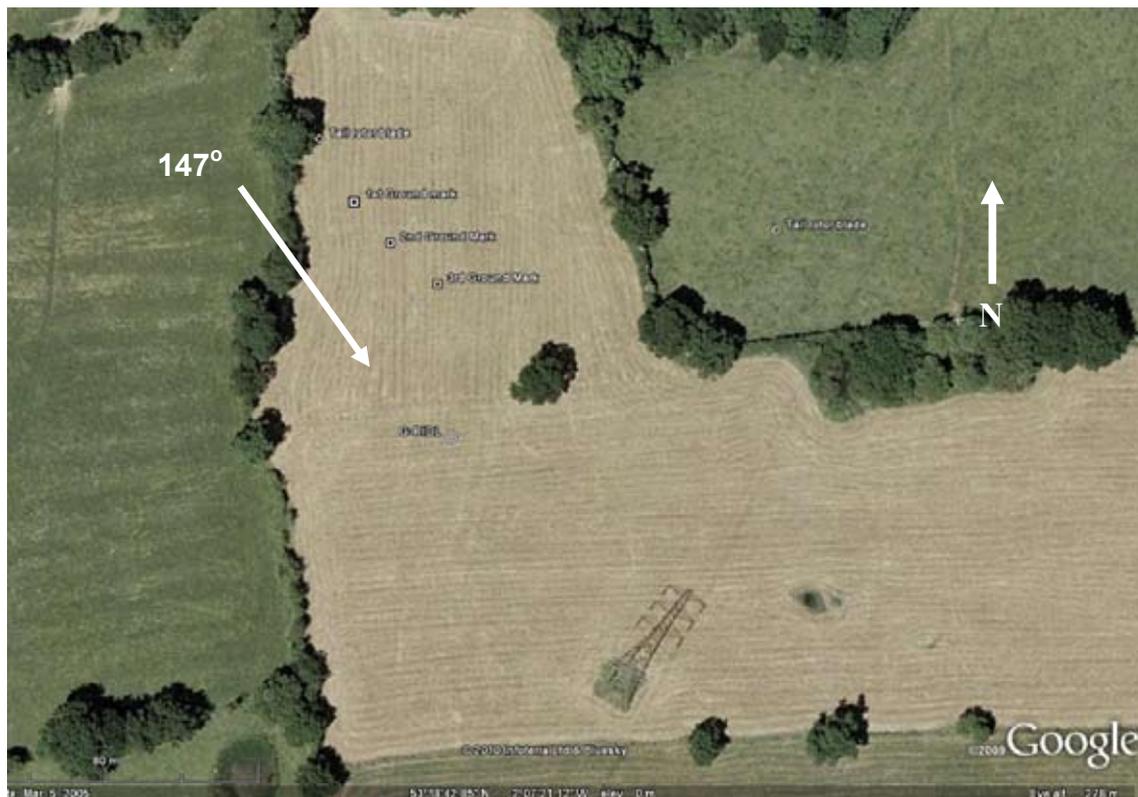
Figure 2
Accident site

The helicopter struck the ground approximately 50 metres from the north-west corner of a field near the top of an elevated area of ground (Figure 2). The first ground mark consisted of a shallow scrape together with two associated angled slash marks, consistent with the helicopter's tail rotor blades striking the ground whilst rotating. A second ground mark was found three metres beyond the first and contained a portion of the tail rotor gearbox mounting bracket. These markings showed that the helicopter was on a heading of approximately 147°(M) when it first struck the ground. The tail rotor gearbox, including the roots of both tail rotor blades, and the tail assembly of the helicopter had detached and were found close to the second ground mark. The tail rotor blades had failed at approximately 25% of their span; one detached blade section was found 20 metres beyond the first ground mark and the second

was recovered from an adjacent field, 115 metres to the left of the first ground mark.

A third ground mark was identified 15 metres beyond the second, which was consistent with the right skid striking the ground. The final ground mark was produced when one of the main rotor blades struck the ground. This had resulted in the fuselage of the helicopter rotating 180° around the rotor head and landing heavily on its right side. The helicopter came to rest in a low-lying, waterlogged area of the field, 53 metres beyond the point of first ground contact. There was no evidence that the helicopter had made contact with any of the trees surrounding the field, or the overhead electricity cables which crossed the field.

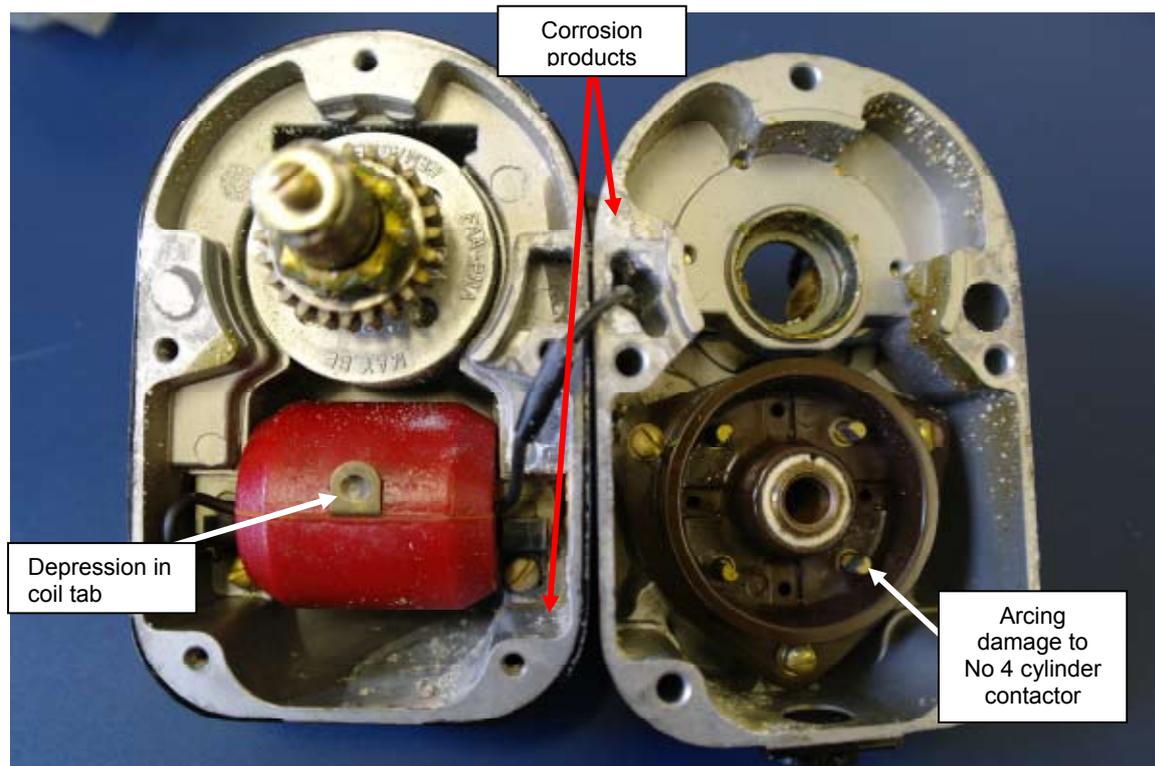
Figure 3

A bench test of both magnetos confirmed that sufficient energy was being produced to generate a spark across a representative air gap. On disassembling the magnetos, no defects were observed in the right magneto; however, when the left magneto was opened, clear evidence of water ingress was found. Examination of the mating faces of the magneto case halves failed to identify the location of water ingress. Removal of the distributor gear revealed evidence of arcing damage to the number four cylinder contactor and the presence of a layer of oxide on the contactor. The copper outlet tab on the magneto coil was coated in a layer of oxide and a depression had formed in the middle of the tab (Figure 3).

Measurement confirmed that the depression had been formed as a result of a loss of material from the tab. The carbon brush in the distributor gear was measured and found to be 10.7 mm long (the minimum permitted length is 9.53 mm), but the surface of the brush that touched the magneto coil tab was pockmarked as if material had been plucked from its surface. The formation of oxide on the conducting surfaces would have resulted in an increase in the electrical resistance and also accelerated the rate of wear of the components. The damage to the number four cylinder contactor confirmed that arcing had occurred between the

Left magneto showing corrosion and contactor damage

distributor gear and the contactor. Such arcing would have the effect of delaying the generation of a spark from the number four cylinder spark plug connected to the left magneto. This delay would change the speed of combustion within the cylinder resulting in burning fuel passing out of the exhaust valve and an engine misfire.

Tests identified that the engine was capable of generating its maximum rated power despite the number four cylinder misfiring intermittently at high power settings. The misfire, caused by the defect within the left magneto, could have resulted in an increase in engine vibration and noise. The presence of moisture in the magneto would have accelerated the formation of oxides on the electrical contacts within the magneto, resulting in a deterioration in its performance. Whilst the method of moisture ingress could not be identified, the exposure of the helicopter to the elements, whilst parked outside, may have been a contributory factor.
