**ACCIDENT**

<b>Aircraft Type and Registration:</b>	Jabiru J430, G-RCST, amateur-built	
<b>No &amp; Type of Engines:</b>	1 Jabiru Aircraft PTY 3300A piston engine	
<b>Year of Manufacture:</b>	2006	
<b>Date &amp; Time (UTC):</b>	5 June 2011 at 1704 hrs	
<b>Location:</b>	Gloucester Lodge Farm, Northumberland	
<b>Type of Flight:</b>	Private	
<b>Persons on Board:</b>	Crew - 1	Passengers - None
<b>Injuries:</b>	Crew - None	Passengers - N/A
<b>Nature of Damage:</b>	Damage to engine, nose landing gear, firewall	
<b>Commander's Licence:</b>	Private Pilot's Licence	
<b>Commander's Age:</b>	53 years	
<b>Commander's Flying Experience:</b>	885 hours (of which 495 were on type) Last 90 days - 26 hours Last 28 days - 13 hours	
<b>Information Source:</b>	Aircraft Accident Report Form submitted by the pilot and additional AAIB investigation

**Synopsis**

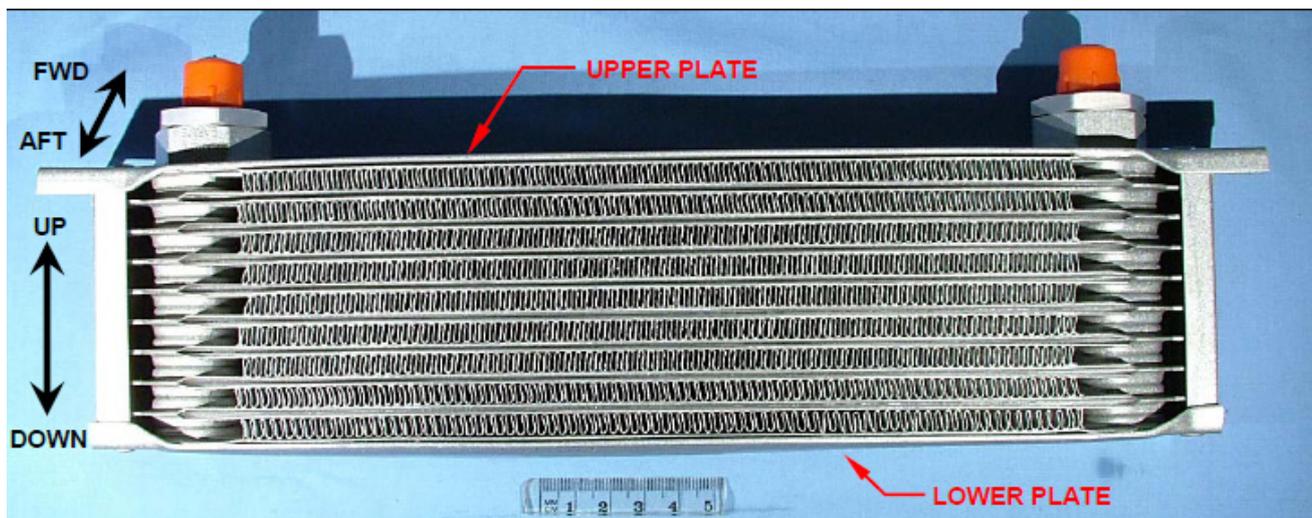
Figure 1

Upon investigation, it was immediately apparent that a large quantity of oil had been lost via a split along a seam at the rear of the engine oil cooler. In fact this was a new component that had only just been fitted following a ‘weep’ that had been discovered in the previously fitted unit. Some of the oil had dropped onto the exhaust system, thus generating the smoke that had entered the cockpit.

The owner/pilot noted that the lower plate of the oil cooler had developed a “bulge” since being fitted to the aircraft and the leak appeared to be associated with this.

View of the incident oil cooler, as received

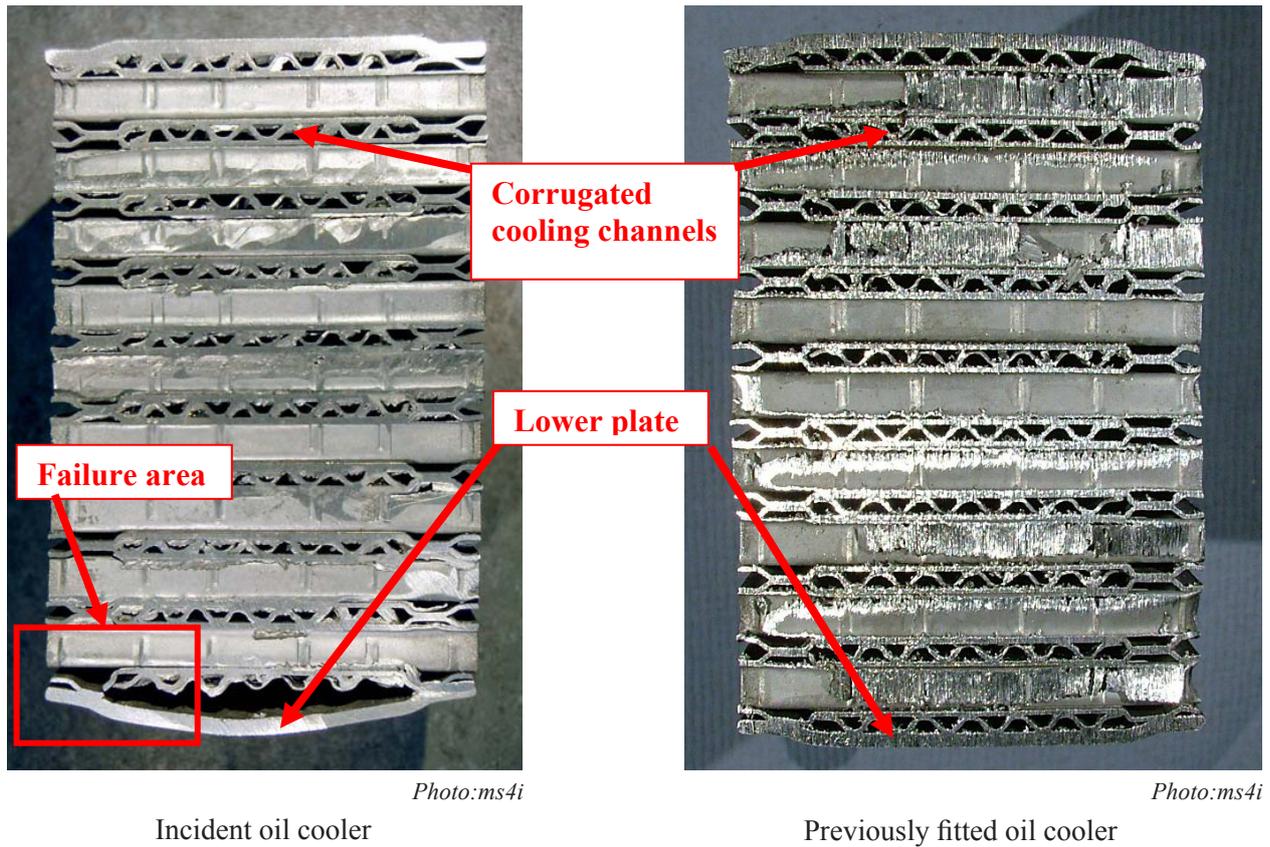
**Figure 2**

Oil coolers after being sectioned. Bulge in lower plate of incident unit is clearly visible

It was therefore concluded that the oil cooler failed as a result of the corrugated channels not being joined to the lower plate. This was in turn due to the omission of solder that should have been applied during the manufacturing process.

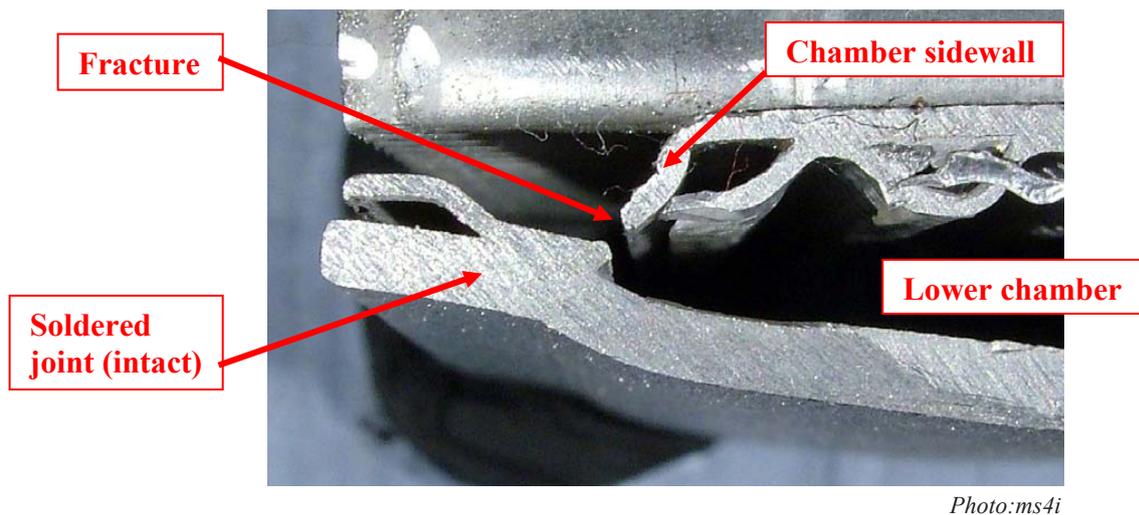
**Figure 3**

Enlarged view of area of failure

Examination of the fracture surface indicated that the failure was consistent with overload; there was no evidence of slow crack growth mechanisms, such as fatigue.

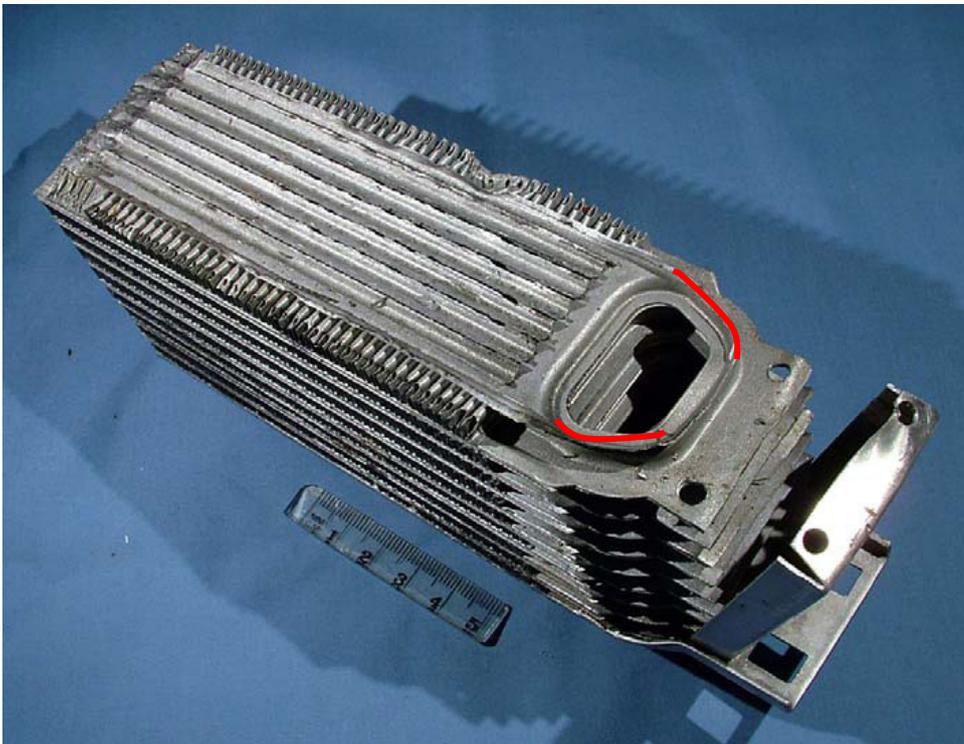
**Figure 4**

As part of the investigation, the lower plate of one half of the previously fitted oil cooler was deliberately torn from the matrix. In contrast to the incident unit, the corrugated cooling channels were found to be securely joined to the lower plate such that the removal process caused the channel material to fail (Figures 4 and 5).

The ‘weep’ in the previously fitted cooler, which had achieved 94 hours since fitment, was also investigated, and it was found that two fatigue cracks had developed in the corners of the lower plate sidewall. The remaining half of the lower plate was deliberately torn off in order to expose and examine these features, which are indicated in Figure 4 (note: a conventional leak test could not be conducted due to the cooler having already been sectioned).

View of underside of previously fitted oil cooler, with lower plate torn off. Remains of channels can be seen; fatigue crack regions are highlighted

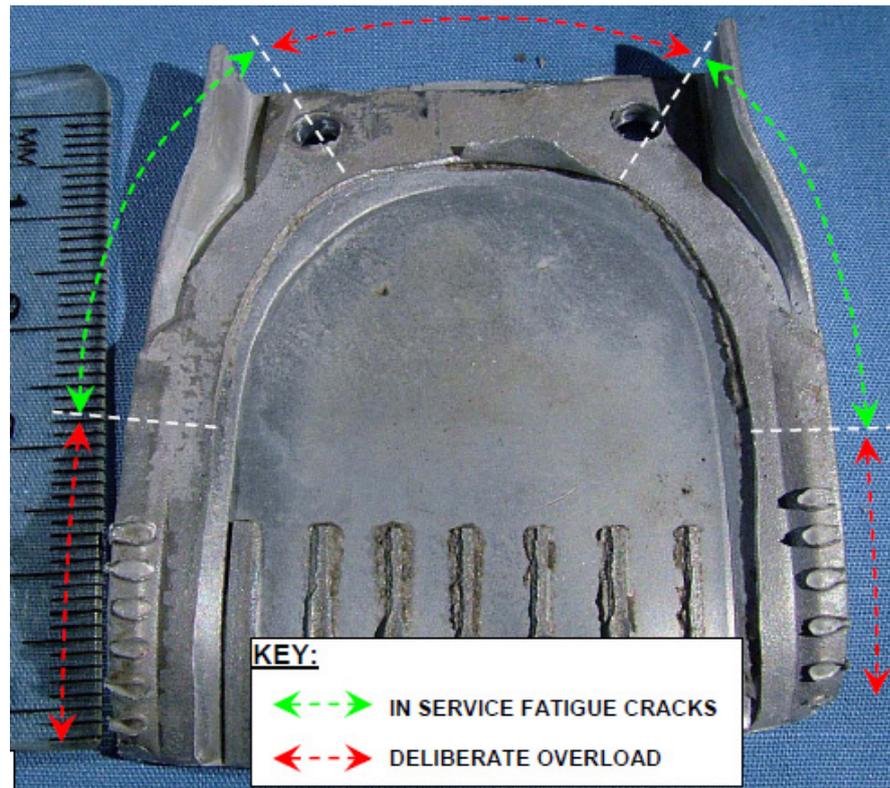
**Figure 5**

Both the fatigue cracks were approximately 25 mm in length and had penetrated through the full thickness of the chamber sidewall. These are shown on a photograph of the lower plate at Figure 5. The fatigue cracks were visually distinguishable from the deliberate

View of lower plate after removal, with areas of pre-existing fatigue indicated. Note remains of oil channels, which had been attached to those seen in Figure 4

overloading of the sidewall, since they were darker in appearance, due to oxidation and staining during stable crack growth. The nature of the fracture surface indicated that the fatigue crack had initiated from multiple sites on the internal surface of the chamber sidewall. It was not possible to establish a figure for the amount of time taken for the crack to progress from initiation to failure.
