ACCIDENT

Aircraft Type and Registration:	Extra EA 300, G-SIII	
No & Type of Engines:	1 Lycoming AEIO-540-L1B5 piston engine	
Year of Manufacture:	1994	
Date & Time (UTC):	7 April 2010 at 1825 hrs	
Location:	White Waltham Airfield, Berkshire	
Type of Flight:	Private	
Persons on Board:	Crew - 1	Passengers - 1
Injuries:	Crew - None	Passengers - None
Nature of Damage:	Right landing gear, propeller blades and right aileron damaged	
Commander's Licence:	Commercial Pilot's Licence	
Commander's Age:	56 years	
Commander's Flying Experience:	1,983 hours (of which 327 were on type) Last 90 days - 36 hours Last 28 days - 13 hours	
Information Source:	Aircraft Accident Report Form submitted by the pilot and AAIB enquiries

Synopsis

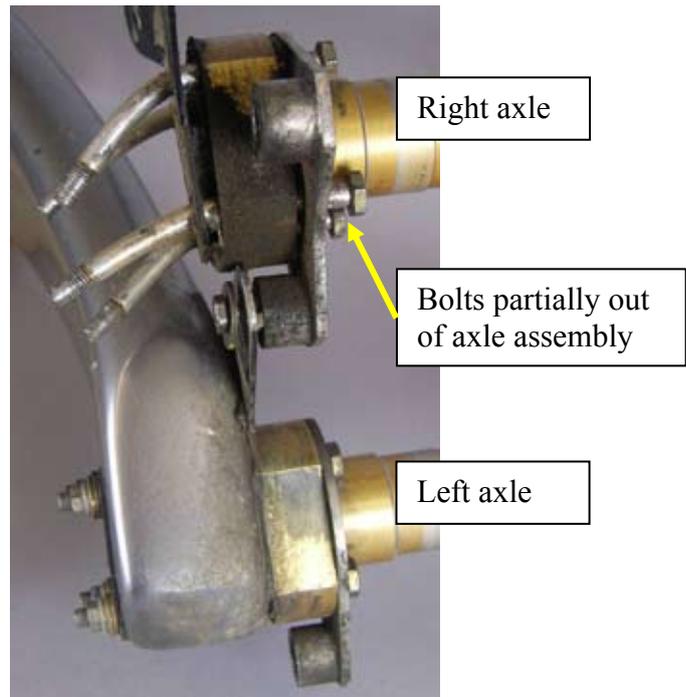
Following the accident, the four bolts, which had secured the right axle to the landing gear, were found to be bent and the threads were severely damaged; the nuts were not recovered. The bend in the bolts was consistent with a side load having been applied to the outside of the bottom of the tyre after the bolts had withdrawn out of the axle by around 10 mm to 15 mm. Figure 1 shows the damaged bolts on the right axle next

Right and left axles and securing bolts

to the left axle, which is still attached to the landing gear.

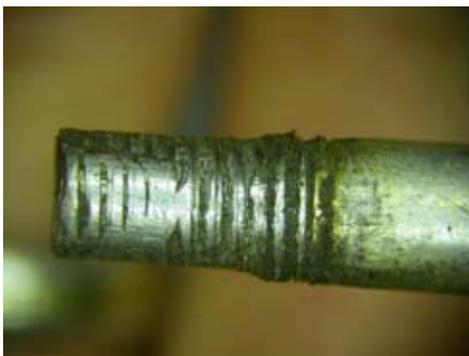
Figure 2

The threads on all four securing bolts, Figure 2, were extensively damaged and scored as a result of having been pulled through the locating holes in the landing gear leg; this action had destroyed any evidence that might have indicated the nature of any pre-detachment thread failures. However, examination by scanning electron microscopy (SEM) did reveal that the damage to the threads on the bolts was consistent with overload failure in a ductile manner. This damage may have been as a result of the nut having been pulled from the bolt. There was no evidence that any of the nuts had unwound prior to the failure of the threads.

Damaged threads on bolt from right axle

The four fasteners securing the right axle to the landing gear had failed as a result of the nuts having been pulled off the bolts. However, because of the damage to the threads on the bolts, it was not possible to establish the reason why they failed. There was also no evidence that any of the nuts had unwound prior to the failure of the threads. The bolts on the left axle were identical to those used on the right axle and both sets of bolts were fitted to the aircraft at the same time. The torque on all four bolts on the left axle was found to be close to the industry guidelines, and the manufacturer's recommendation². There is no evidence that the torque on the bolts on the right axle was incorrect.

It is recommended that Extra Aircraft Company advise owners, and include an instruction in the maintenance manual, that new nuts and bolts are to be used when the wheel axles are replaced or refitted.

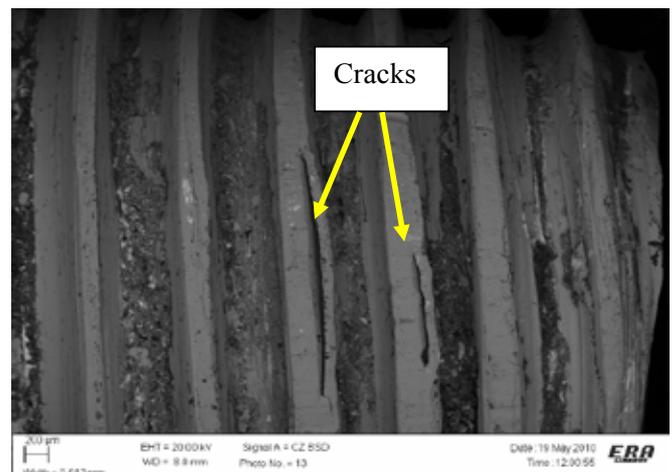
Figure 3

On each bolt, two washers were fitted between the head of the nut and the backing plate. The torque loading applied to the nuts was assessed as being between 7 Nm and 10 Nm. It was noted that the action of withdrawing the bolts from the axle and landing gear damaged the threads on two of the four bolts. This damage was difficult to detect visually without the use of optical viewing equipment.

One of the bolts was examined by SEM, which revealed cracking and damage to the threads, Figure 3.

SEM image showing cracks in thread

It was noted, from the SEM examination of one of the bolts from the left axle, that there were cracks in a number of threads. It was also noted that the threads can be damaged when the bolts are withdrawn from the landing gear. Had the threads of the attaching bolts on the right axle been cracked, or damaged when the landing gear and existing bolts were refitted 65 flying hours prior to the accident, then it is possible that they might have subsequently failed as a result of normal landing loads. While the manufacturer uses new bolts and nuts each time the axles are fitted to the aircraft, there is no such instruction in the aircraft maintenance manuals. Therefore the following Safety Recommendation is made to the aircraft manufacturer:
