ACCIDENT

Aircraft Type and Registration:	Piper PA-38-112, G-BNVD	
No & Type of Engines:	1 Lycoming O-235-L2C piston engine	
Year of Manufacture:	1978	
Date & Time (UTC):	9 December 2006 at 1110 hrs	
Location:	Durham Tees Valley Airport	
Type of Flight:	Training	
Persons on Board:	Crew - 2	Passengers - None
Injuries:	Crew - None	Passengers - N/A
Nature of Damage:	Left wing and main landing gear damaged beyond repair	
Commander's Licence:	Airline Transport Pilot's Licence	
Commander's Age:	63 years	
Commander's Flying Experience:	22,300 hours (of which 140 were on type) Last 90 days - 110 hours Last 28 days - 25 hours	
Information Source:	AAIB Field Investigation

Synopsis

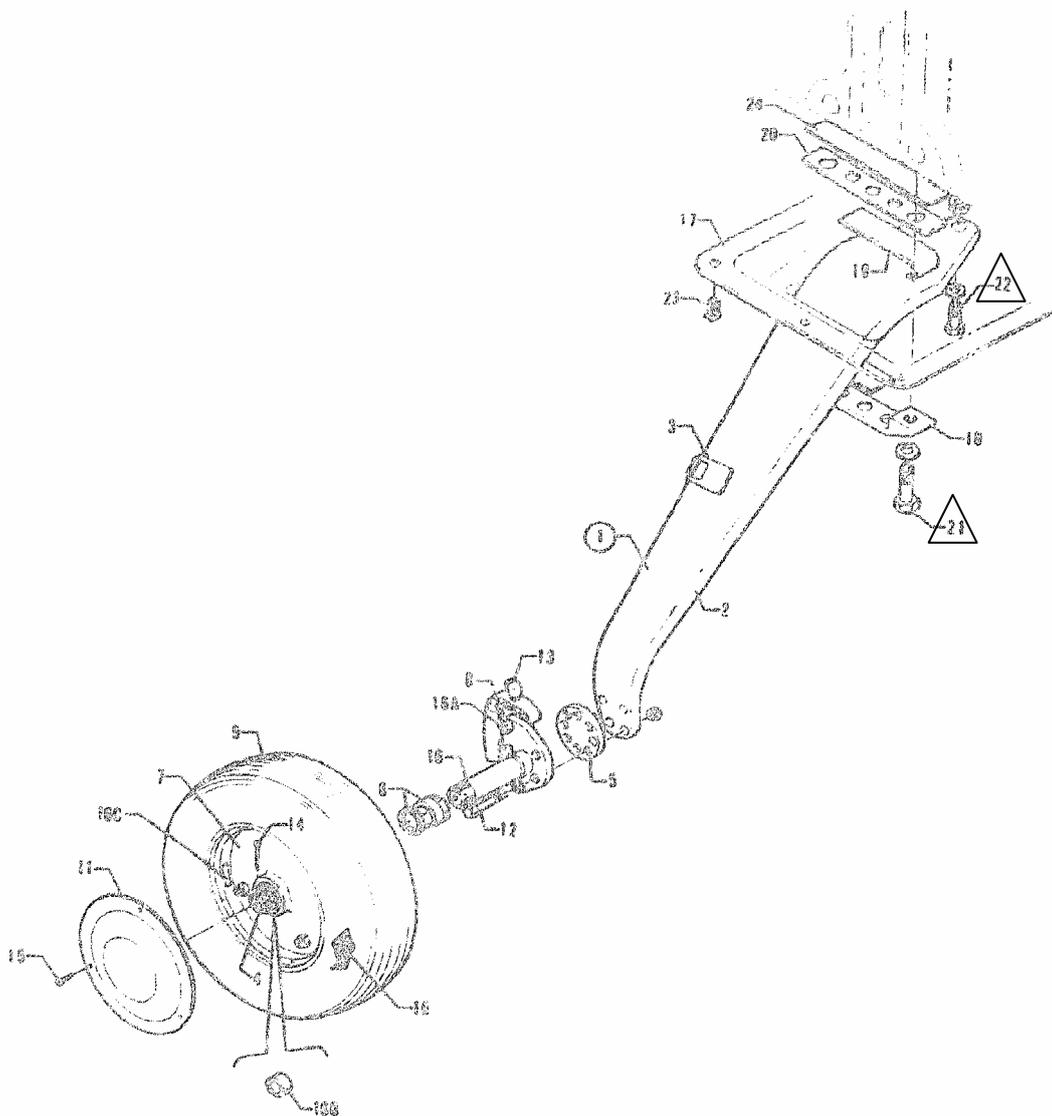
Figure 1

Examination of the detached left main landing gear indicated that one of the three bolts (Figure 1, item 22), part number 401 511, that attach the landing gear to the aircraft, was missing. The other two bolts (Figure 1, items 21), part number 401 462, were attached to the landing gear with locking wire and exhibited very good

Main Landing Gear

evidence of having been pulled out of their barrel nuts as the landing gear was in the process of detaching from the aircraft. A search of the runway touchdown area located the missing bolt, which, upon examination, showed that it had unscrewed and dropped out of the barrel nut located in the wing. There was no wire locking or lock washer and none were specified in the aircraft's Maintenance Manual.

It is recommended that the Federal Aviation Administration require that Piper Aircraft introduce a form of locking on the main landing gear attachment bolt, part number 401 511, fitted to PA-38 series aircraft.
