ACCIDENT

Aircraft Type and Registration:	Rotorway Executive 162F, G-FLIT	
No & Type of Engines:	1 Rotorway RI 162F piston engine	
Year of Manufacture:	1998 (Serial no: 6324)	
Date & Time (UTC):	26 August 2012 at 1315 hrs	
Location:	Near Haslemere, Surrey	
Type of Flight:	Private	
Persons on Board:	Crew - 1	Passengers - None
Injuries:	Crew - None	Passengers - N/A
Nature of Damage:	Damage to tail rotor blade tips	
Commander's Licence:	Private Pilot's Licence	
Commander's Age:	72 years	
Commander's Flying Experience:	536 hours (of which 365 were on type) Last 90 days - 4 hours Last 28 days - 1 hour	
Information Source:	Aircraft Accident Report Form submitted by the pilot

Synopsis

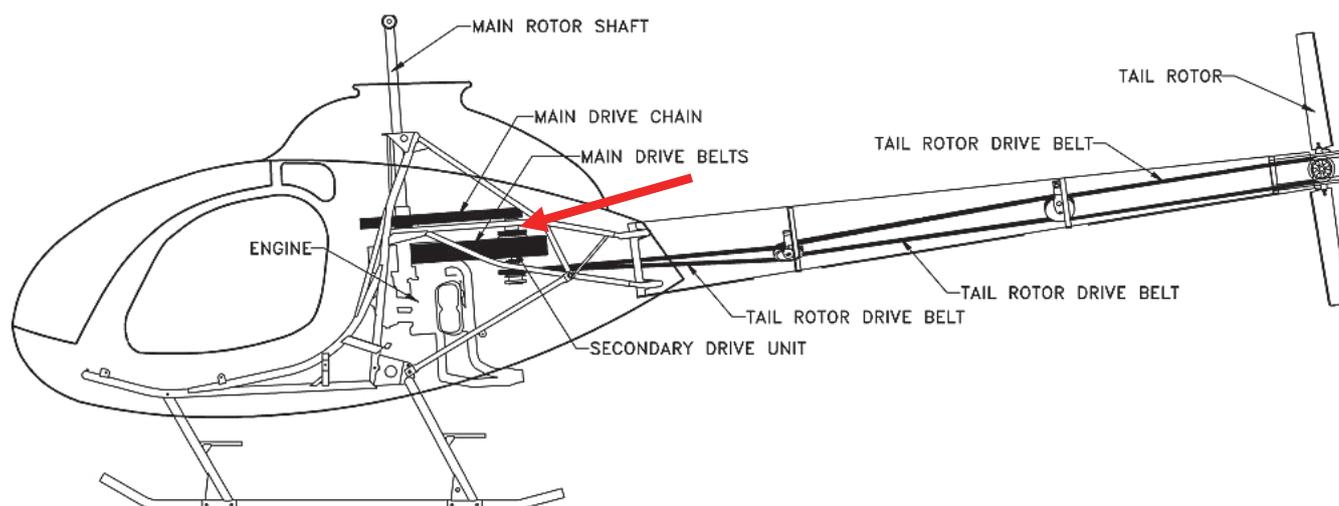
Figure 1

It subsequently became apparent that there had been a failure of the secondary driveshaft, such that the engine was no longer driving the main rotor. The drive-train components of the helicopter are illustrated in Figure 1.

Main components of the drive-train, position of shaft failure arrowed

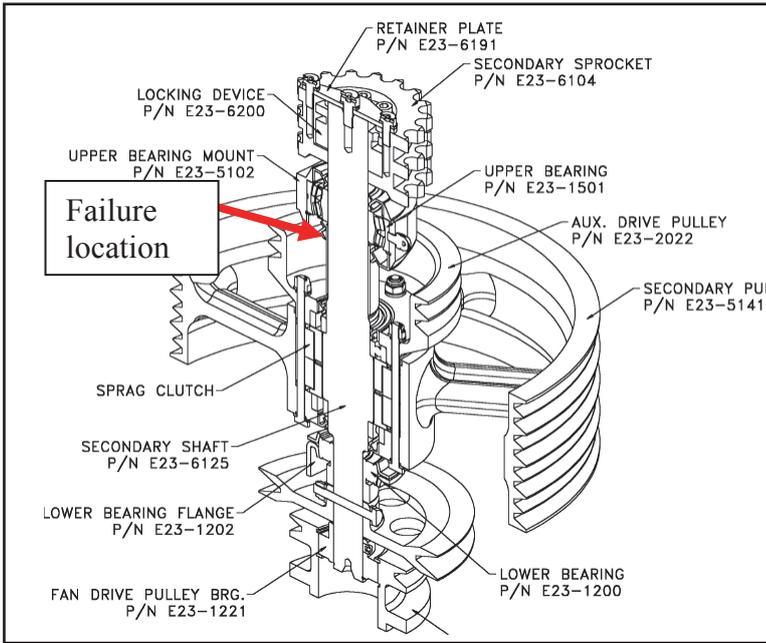
Figures 2 and 3 show a diagram of the secondary shaft assembly, together with a photograph of the failure. It can be seen that the failure occurred adjacent to the lower edge of the inner race of the upper bearing. The components were returned to the manufacturer in the USA, where the shaft, which is solid, was subjected to a metallurgical analysis. Figure 4 shows the two shaft halves following removal.

Figure 2
Diagram of shaft assembly

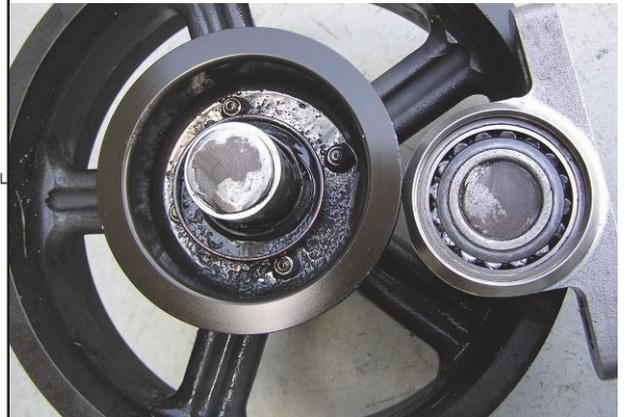
Figure 3
Pulley and bearing, showing both fracture faces of the failed shaft

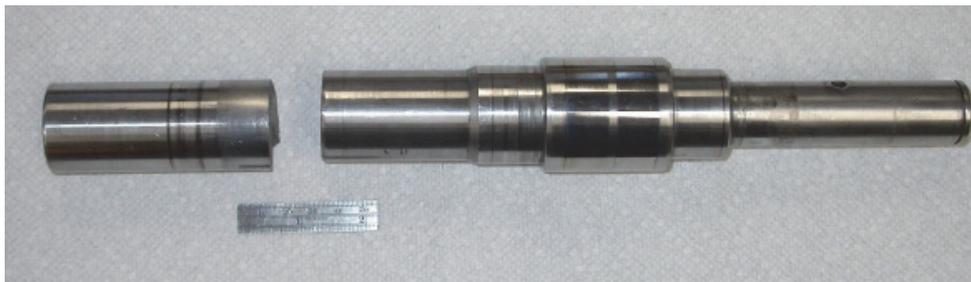
Figure 4
The two pieces of the shaft after removal from the aircraft

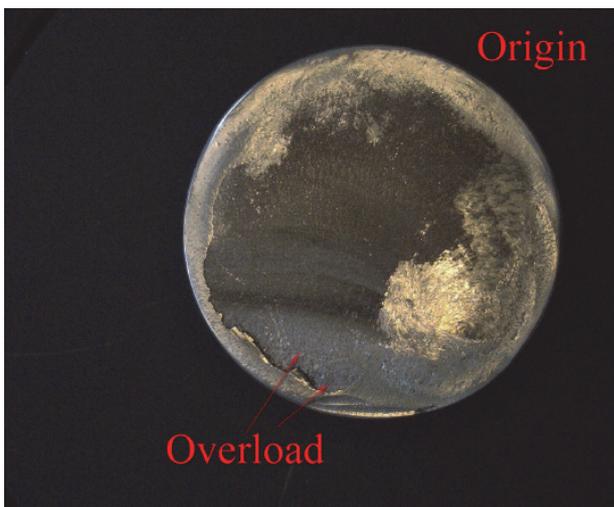
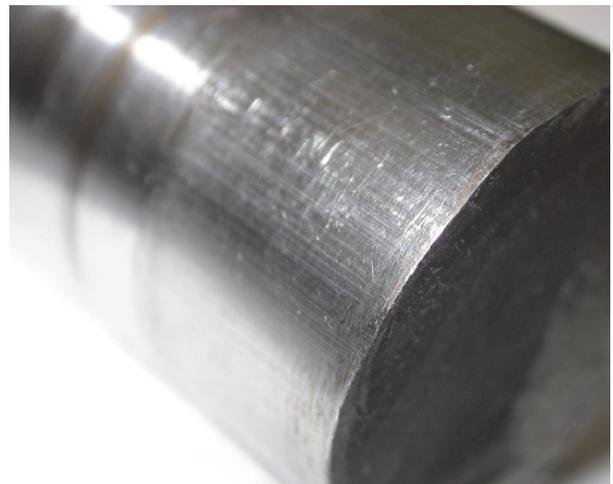
The examination indicated that the fracture occurred as a result of rotational bending fatigue, with area of the fracture origin and the final overload failure indicated in Figure 5. The surface of the shaft adjacent to the fracture showed evidence of mechanical wear in comparison to the surface finish elsewhere on the shaft; a photograph of this is also shown in Figure 5. It can be seen that the region was coincident with the location of the upper bearing, with the fracture occurring close to one end of it. The longitudinal scores were on top of the circumferential wear and are likely to have occurred during bearing removal.

Figure 5
Photographs of the fracture face and smeared surface close to the fracture origin

The metallurgical report indicated that the area of wear was consistent with a fretting process which, in the region of the fracture origin, was associated with missing flakes of metal. The report additionally indicated that this may have induced a fatigue crack. No material defects were observed either in the origin or in the microstructure.
