No: 9/91

Ref: EW/C91/3/1

Aircraft Type and Registration: Air Command 532 Elite, G-BPFW

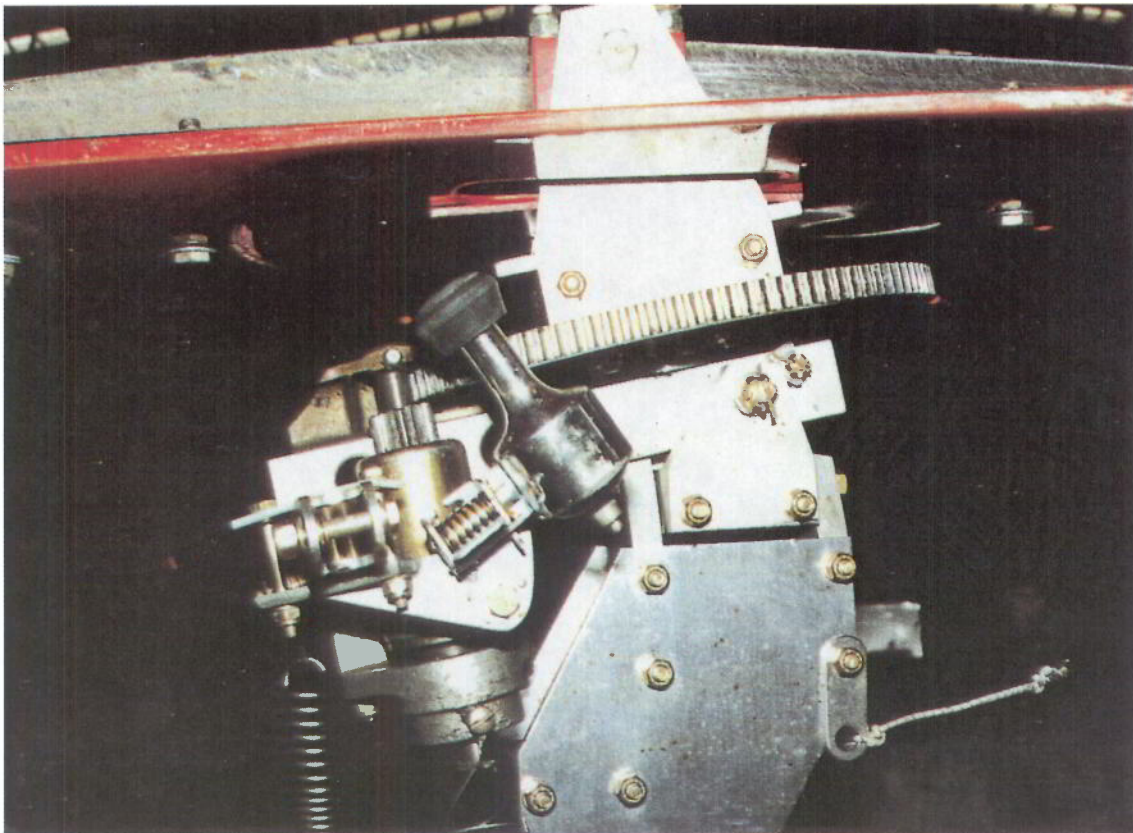
The wreckage was recovered to the AAIB at Farnborough, where a detailed examination revealed no evidence of structural failure of either the airframe or rotor. There had been no pre-impact disconnection of the flying controls. Examination of the rotor head showed that the rotor retaining bolt had been loose. The gyrocopter was equipped with a pre-rotator, the purpose of which was to spin up the rotor prior to take-off by means of a flexible drive shaft driven by the engine and engaged by operating a caliper on the control column. When the drive shaft rotated, a Bendix drive pinion was thrown into engagement with a ring gear attached to the rotor head. Figure 1 shows the head with the drive pinion in the disengaged position. The engaged position is illustrated at Figure 2, where it can be seen that there are a number of witness marks on the drive unit bell housing which have been caused by the lower corners of the ring gear teeth. It was found that the rotor head, which includes the ring gear, could move relative to the torque tube on which the drive unit was mounted. The degree of movement was such that with the drive pinion in the disengaged position, the ring gear was capable of partially meshing with the pinion; this caused the latter to be driven up into full gear engagement, where, with the head tilted to the rearwards limit of its free play, the ring gear teeth could contact the bell housing. The owner had exacerbated the problem by machining away 0.060 inch from the

attachment casting in order to increase the amount of drive spindle engagement within its upper bearing. This had positioned the drive unit closer to the ring gear.

FIGURE 1 Rotor head showing prerotator ring gear with drive pinion disengaged

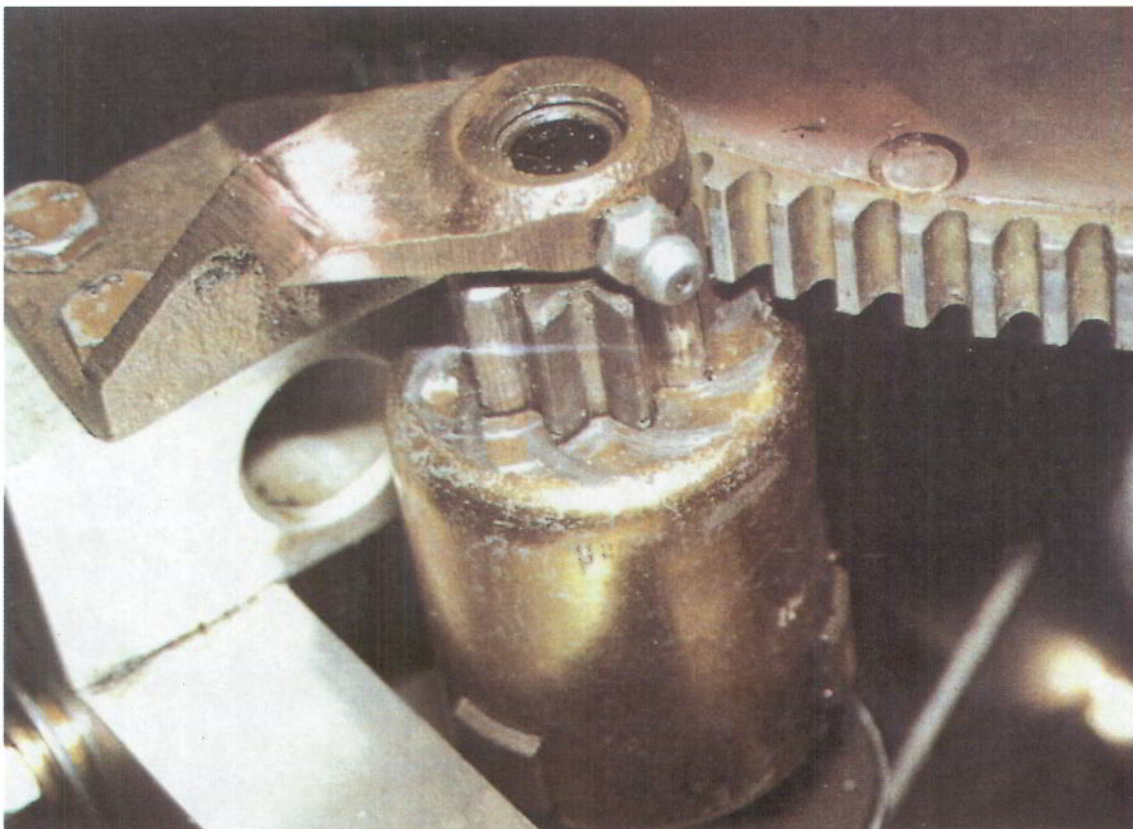
Initial examination suggested that the teeth marks on the bell housing had been present before the accident. Further evidence of a loose head bolt was provided by circular fretting marks on the soft alloy washer located immediately beneath the head bolt. (See the diagram at Figure 3). This could only have occurred due to relative rotation between the bolt and the washer. Supporting evidence was provided by the cadmium plating on the bolt shank and on the associated AN 960-816 washer having been worn away. The washer was found to have a Vickers Hardness value of 112. This low figure suggested the possibility of the washer material undergoing plastic flow as a result of flight loads, with a consequent loss of assembly torque. The dust cover, which had a hexagonal cut-out matching the shape of the bolt head, was shown in the aircraft build manual as being threaded on the bolt shank in the same way as a washer. It was designed to be pushed over the bolt head after assembly. Damage to the edges of the cut-out indicated that it may have become trapped under the bolt head and this could have occurred as a result of being threaded onto the bolt shank during assembly. An inspector associated with the Popular Flying Association stated that another gyrocopter had been submitted to him for inspection with the head so assembled. The dust cover had extruded itself out from beneath the bolt head during transportation, leading to loss of assembly torque on the head bolt.

FIGURE 2 Drive pinion in engaged position; note gear teeth marks on bell housing

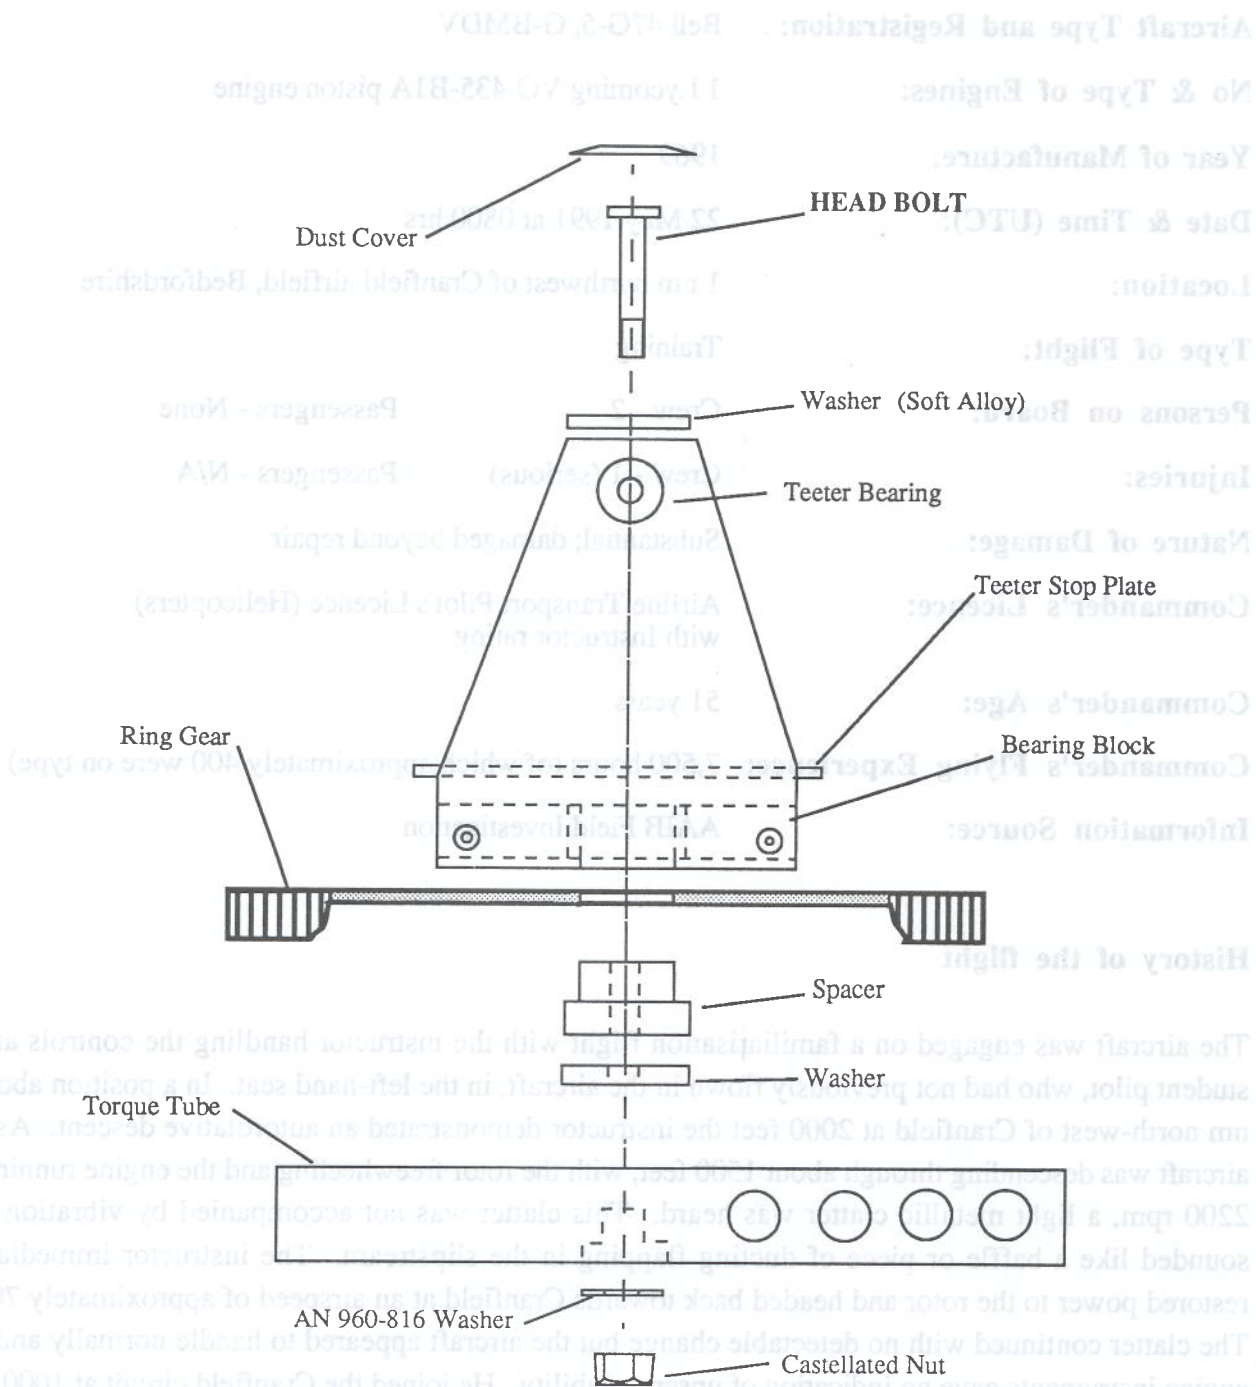
The loose bolt had allowed the rotor head to move about 3° from the position set by the flying controls, which are attached, by means of a cross tube, to the torque tube shown in Figure 3. It was not possible to assess the exact amount of free play that existed before the accident due to the additional distortion of the soft alloy washer that had occurred at impact.

FIGURE 3 ROTOR HEAD SCHEMATIC

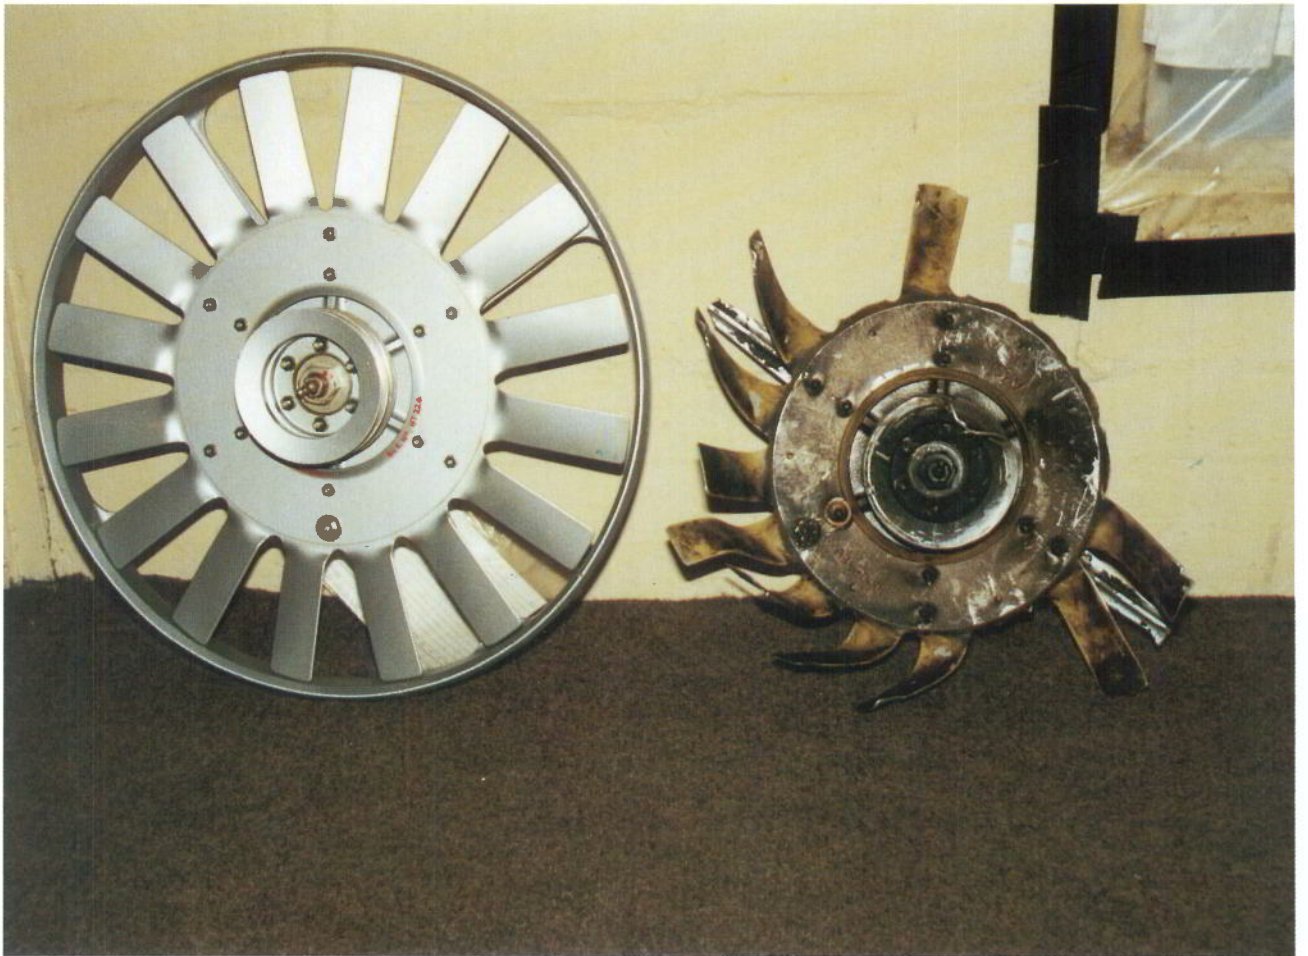
FIG 1 Fan assembly as removed from G-BMDV plus an intact unit

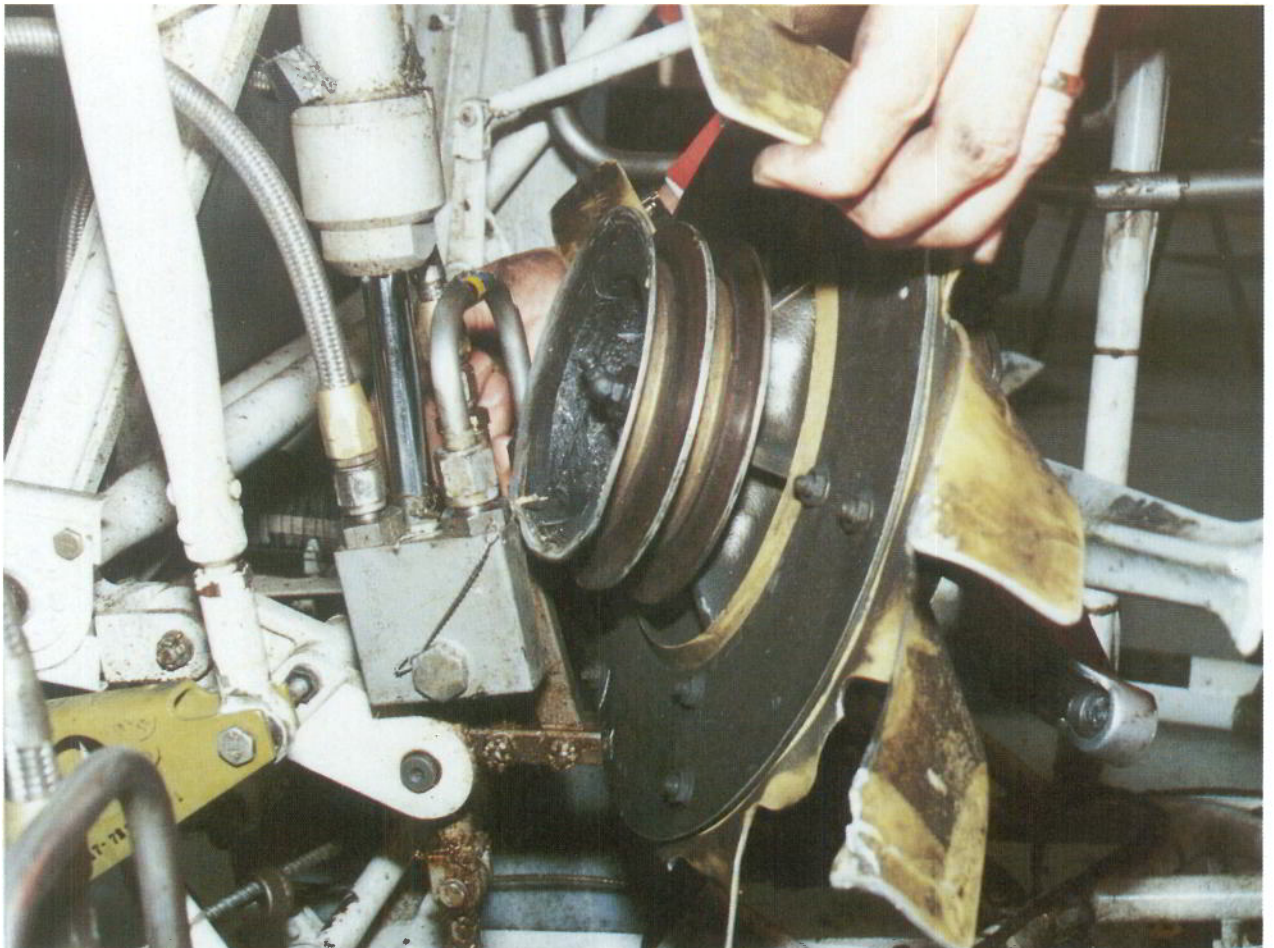
FIG 2 Estimated position at which fan assembly jammed servo
