SERIOUS INCIDENT

Aircraft Type and Registration:	AgustaWestland AW139, G-CHCV
No & Type of Engines:	2 Pratt & Whitney Canada PT6C-67C turboshaft engines
Year of Manufacture:	2007
Date & Time (UTC):	23 December 2008 at 1405 hrs
Location:	The North Sea, 65 nm north-east of North Denes Heliport
Type of Flight:	Commercial Air Transport (Passenger)
Persons on Board:	Crew - 2 Passengers - 8
Injuries:	Crew - None Passengers - None
Nature of Damage:	None
Commander's Licence:	Airline Transport Pilots Licence (Helicopters)
Commander's Age:	45 years
Commander's Flying Experience:	7,311 hours (of which 833 hours were on type) Last 90 days - 113 hours Last 28 days - 43 hours
Information Source:	AAIB Field Investigation

Synopsis

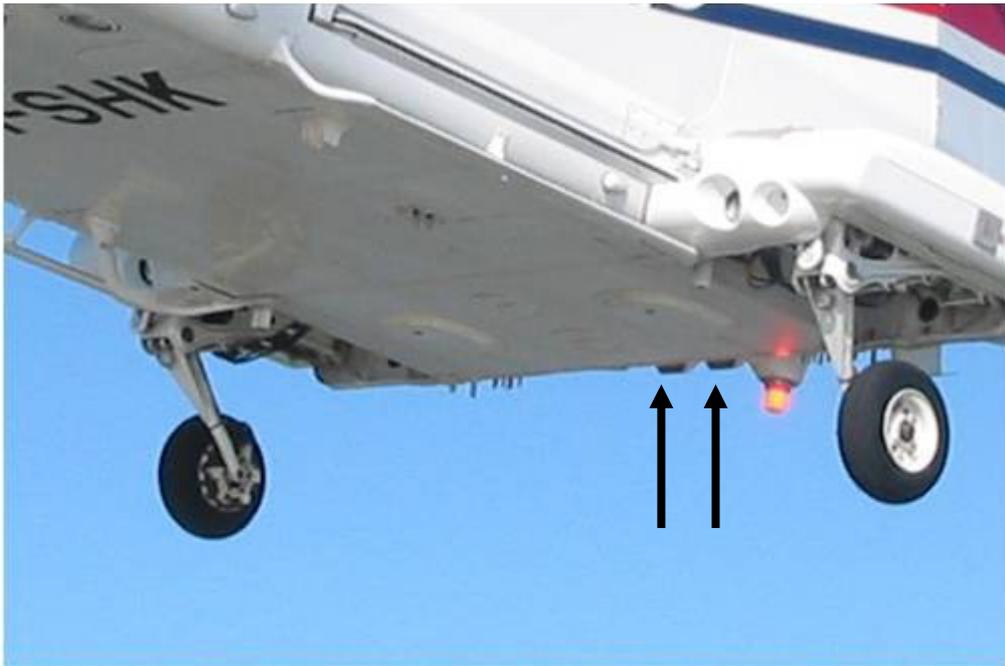
AW139 MAU Cooling Duct Intake Scoops

In order to meet the MAU installation requirements for the short nose aircraft, the helicopter manufacturer provided ducting that directed cooling air from two scoops on the underside of the rear fuselage. The ducts were asymmetrically disposed, such that the outlet of one of them was immediately underneath the MAU 2 cabinet. No outside air is used for cooling in the long nose MAU installation.

The investigation additionally found that CIO and power supply modules had been affected by corrosion, although there had been no resulting incidents. All the affected modules were located in MAU 2, with their location close to a cabinet vent which was, in turn, near to the cooling duct outlet.

In April 2009 AgustaWestland issued a Service Bulletin, Bollettino Tecnico BT AW139-166, which applied to short nose configuration helicopters. The purpose of the BT was twofold. Firstly, the power supply, CIO and CSIO modules of *both* MAUs were to be inspected for evidence of corrosion. The BT contained guidance material on accept/reject criteria, in order to assist in this process. Secondly, the cooling air duct was modified so that the outlet was moved away from the lower surface of the MAU 2 cabinet.

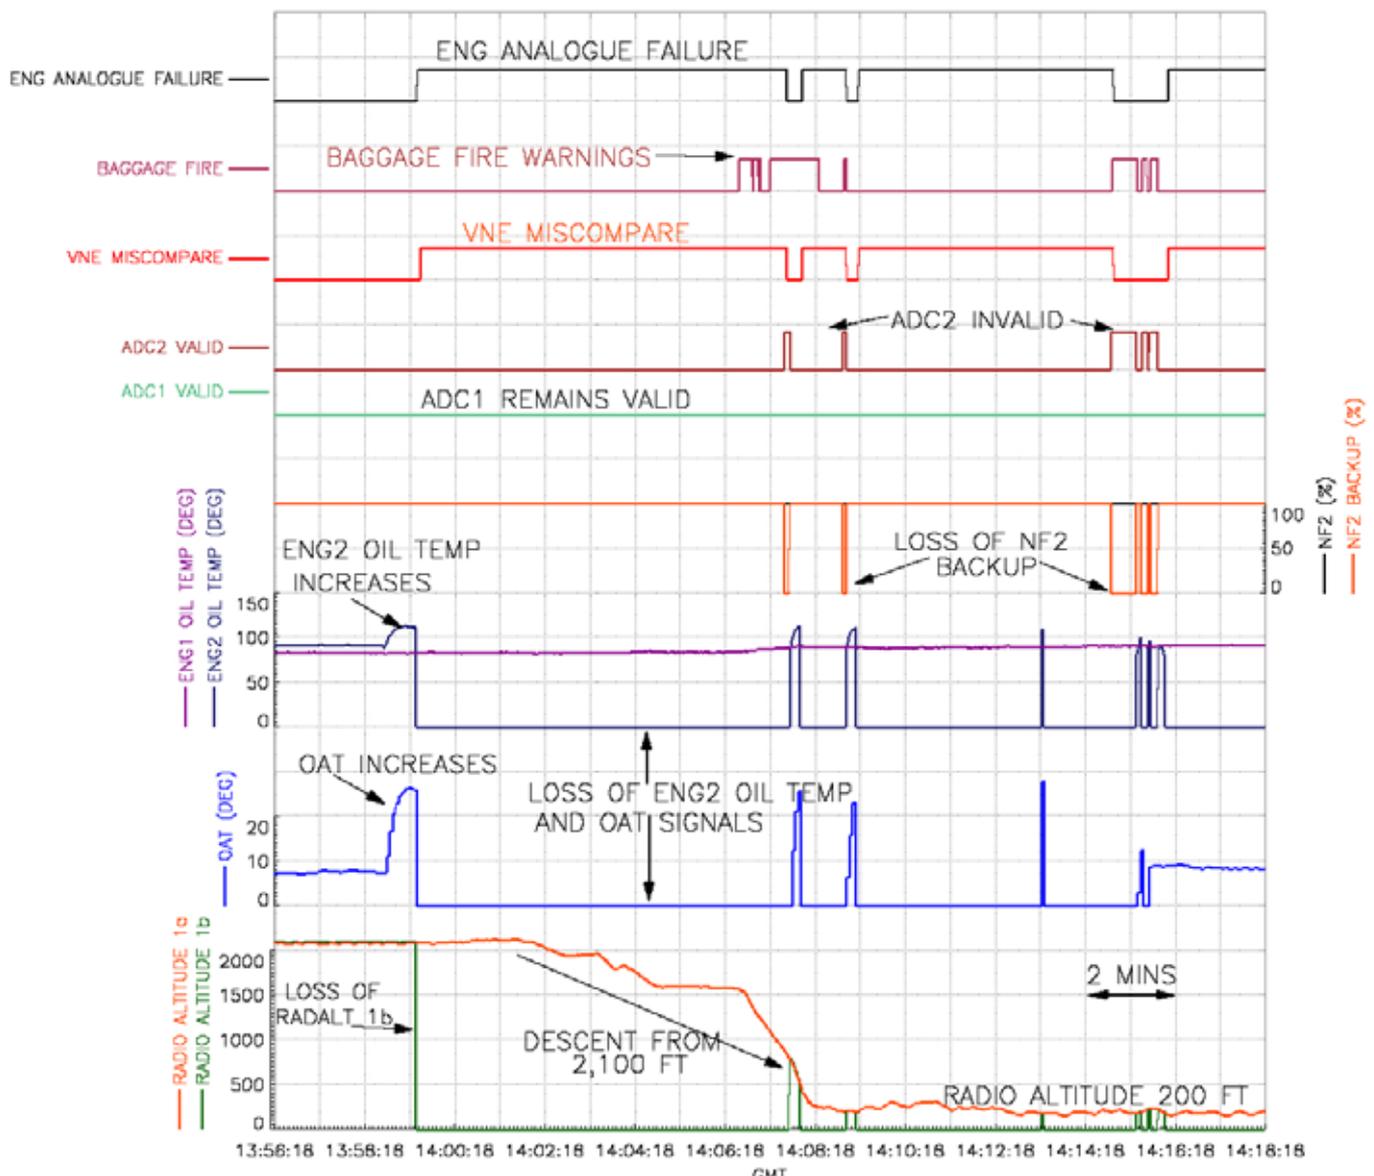
G-CHCV MPFR recorded parameters

in cruise at a radio height of 2,100 ft, on a magnetic heading of 022°M and an indicated airspeed (IAS) of 145 kt. At 1358:48 hrs, the outside air temperature (OAT) parameter began increasing from 7°C and, over a 30-second period, reached 26°C, before failing (characterised by a drop to 0°C (see Figure 4). No 2 engine oil temperature, the tail rotor gearbox (TGB) and intermediate gearbox (IGB) oil temperatures and No 2 hydraulic system temperature also exhibited this characteristic rise, followed by failure. For clarity, Figure 4 only shows the OAT and No 2 engine oil temperature.

At the same time as the loss of these temperature parameters, data was lost from one of the two radio altimeters, No 2 engine ITT and, 20 seconds later, the No 2 engine power index. The loss of No 2 ITT caused the ENG ANALOGUE FAILURE warning and, five seconds later, the VNE MISCOMPARE warning was recorded.

data shows loss of further engine analogue parameters and the failure of No 2 ADC (Air Data Computer No 2). This loss of data appeared to be reversible, with some data apparently recovering but then failing again (Figure 4).

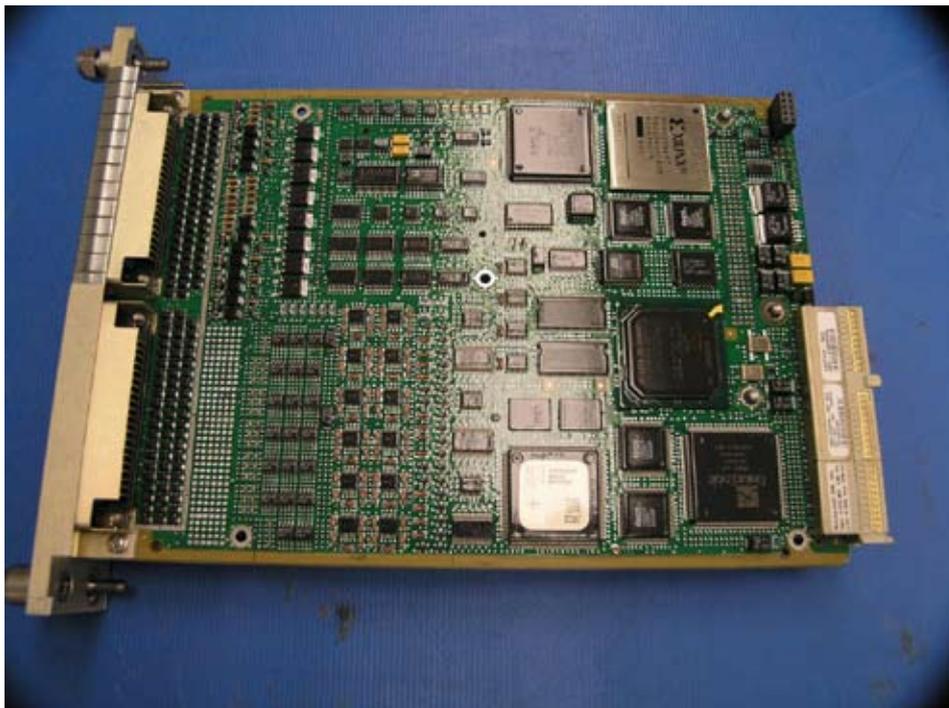
Figure 5a
A CSIO2 module

The power supply module was found to be clean and functioned correctly on test. Similarly, no problems were found with the NIC/PROC module. However, inspection of the CSIO2 card revealed that it was contaminated with dirt and debris. In addition there was evidence of corrosion with what appeared to be copper oxide on the pins of some of the circuit card components. Figures 5a and 5b show photographs of the module and an example of the corrosion, the latter being from one of the Australian incident helicopters. It was then decided to conduct a series of tests on this module on Honeywell's MAU system test bench.

The presence of contamination and corrosion on the CSIO2 card strongly suggested that moisture had been present on the board during service and, thus, may have been responsible for the incident to G-CHCV, although no indications of water were apparent on the MAU modules after the event. However, during the investigations of the Australian incidents, water was found to be present in and around the MAU cabinets. Accordingly, it was decided to examine the behaviour of the CSIO2 card under damp conditions by subjecting it to a water spray during operation.

The incidents involving G-CHCV and other helicopters occurred as a result of corrosion on the CSIO2 module installed in MAU 2. The corrosion had affected numerous pins on the components of the circuit board assemblies, which shorted out when they became conductive under the action of moisture, which in turn resulted in corrupted data being processed. In the case of G-CHCV, the resultant cascade of spurious warnings caused confusion on the flight deck as, in addition to the loss of ADS related information, the crew had difficulty in assessing the operational state of other aircraft systems. The BAG FIRE warning had a particular significance, as it raised the possibility of having to ditch, with the attendant risks to the aircraft and its occupants. Had the aircraft been equipped with the onboard video package, as installed in the SAR variant, the airframe mounted cameras could have been used to inspect for evidence of fire. Other incidents involved uncommanded descents, following disengagement of the autopilot and the potential risk to the aircraft with a busy, possibly distracted crew dealing with other CAS warnings. In all cases, upon reset on ground, the system recovered and the faults could not be reproduced during on-aircraft troubleshooting.

It is recommended that the European Aviation Safety Agency mandate the embodiment of the AgustaWestland Bollettino Tecnico BT AW139-166 on all short nose versions of the AgustaWestland AW139.

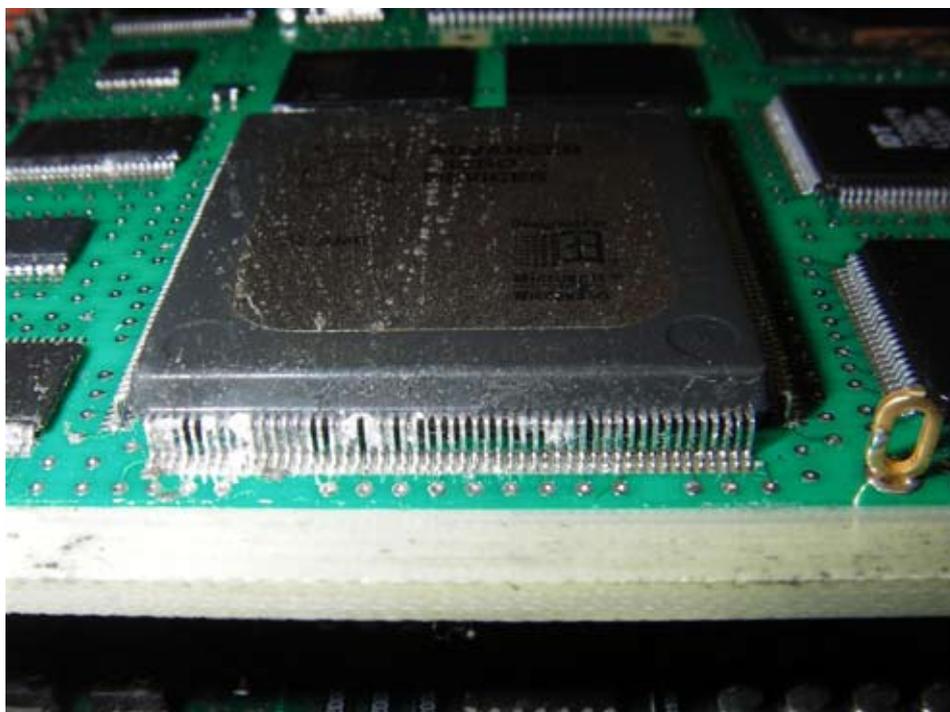
Figure 5b
Example of corrosion on another CSIO2 processor
