SERIOUS INCIDENT

Aircraft Type and Registration:	Britten-Norman BN2A Mk III-2 Trislander, G-RLON	
No & Type of Engines:	3 Lycoming O-540-E4C5 piston engines	
Year of Manufacture:	1975 (Serial no: 1008)	
Date & Time (UTC):	11 October 2013 at 1645 hrs	
Location:	En route Jersey to Guernsey	
Type of Flight:	Commercial Air Transport (Passenger)	
Persons on Board:	Crew - 1	Passengers - 15
Injuries:	Crew - None	Passengers - None
Nature of Damage:	Cowling partially unsecured, minor damage to cowling and propeller blades	
Commander's Licence:	Airline Transport Pilot's Licence	
Commander's Age:	54 years	
Commander's Flying Experience:	14,584 hours (of which 1,008 were on type) Last 90 days - 179 hours Last 28 days - 41 hours	
Information Source:	Aircraft Accident Report Form submitted by the pilot

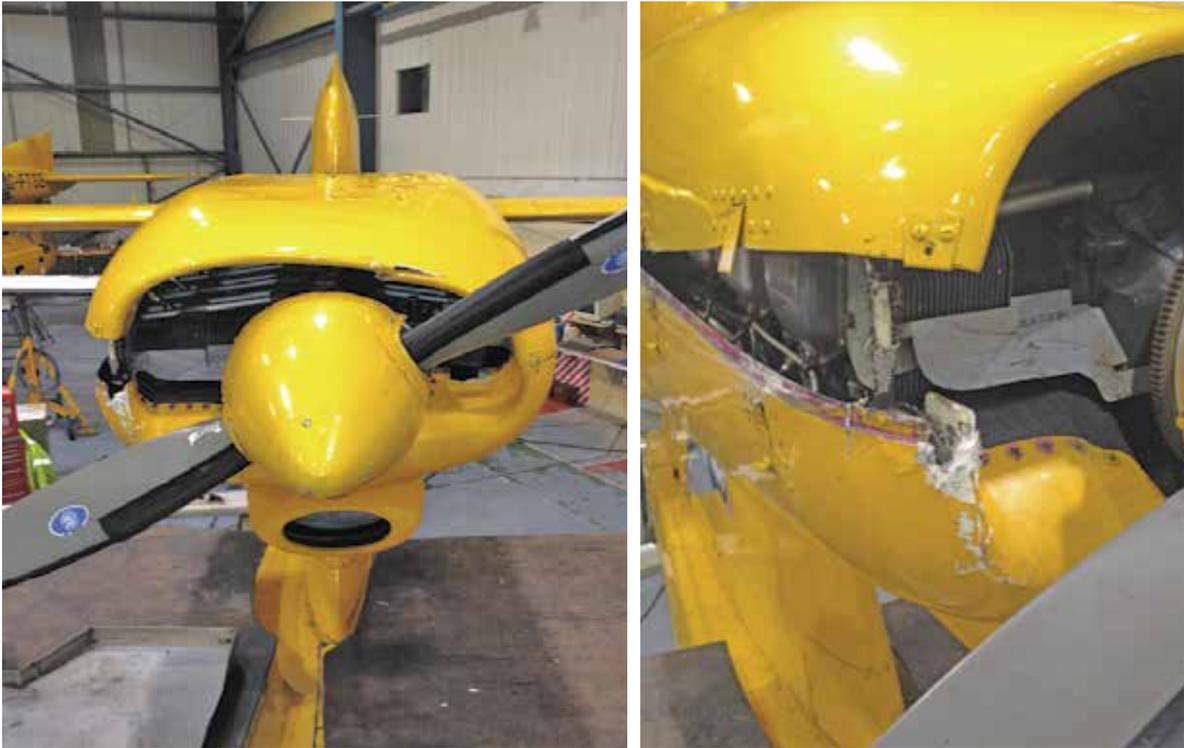
It can be seen that the cowling is made up of upper and lower fibreglass 'clamshells'. It was apparent that the front right hand fitting on the lower section had pulled out of the fibreglass and was missing. The resultant loss of structural rigidity would have allowed movement to occur in the upper cowling, which probably accounted for two clips, securing the upper

and lower sections together, having become undone on the right-hand side. The degree of movement was such that the upper cowling had made light contact with the propeller blades, leaving rub marks on them that subsequently required repair.

The organisation conducting the repairs to the aircraft commented that it was not unusual for cracks to appear in the cowlings of aircraft of this age, although this was the first that had resulted in the loss of one of the front fastener fittings. In the absence of the fitting it was not possible to establish the mechanism that led to the failure. A fleet check was not considered necessary, as engine cowling security is covered by the Daily Inspection.

The operator stated that the details of this event will be added to their continuation training syllabus.
