**ACCIDENT**

<b>Aircraft Type and Registration:</b>	Cessna T210N, XB-LLD	
<b>No &amp; Type of Engines:</b>	One Teledyne Continental TSIO-520-R piston engine	
<b>Year of Manufacture:</b>	1981 (Serial no: 210-64265)	
<b>Date &amp; Time (UTC):</b>	14 November 2011 at about 04:00 hrs	
<b>Location:</b>	9 miles north-east of Gerrard Smith International Airport, Cayman Brac, Cayman Islands	
<b>Type of Flight:</b>	Unknown	
<b>Persons on Board:</b>	Crew - 2	Passengers - None
<b>Injuries:</b>	Crew - 2 (Fatal)	Passengers - N/A
<b>Nature of Damage:</b>	Aircraft destroyed	
<b>Commander's Licence:</b>	Commercial Pilot's Licence	
<b>Commander's Age:</b>	N/K	
<b>Commander's Flying Experience:</b>	N/K	
<b>Information Source:</b>	AAIB Field Investigation

**Synopsis**

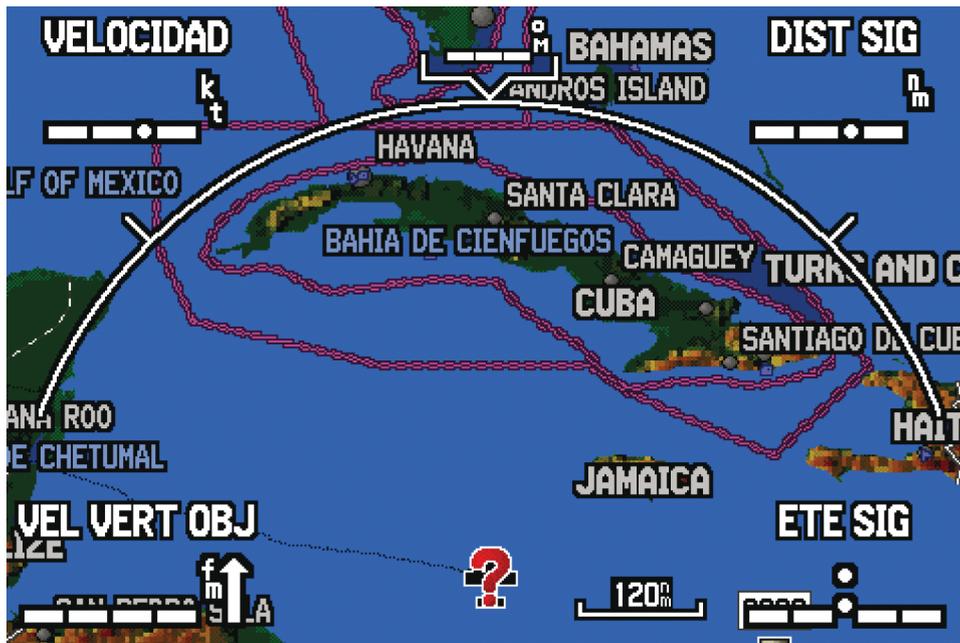
Following recovery to the AAIB's facilities at Farnborough both GPS units were downloaded. GPS A had an Active Route selected to a location in Venezuela near its border with Columbia. GPS B had an Active "GO TO" selected to a point mid way between Jamaica and the northernmost point of Columbia. It also contained a track log. The relevant sections of the track log commenced at Chetumal Airport, Mexico, crossed the border to Belize where the aircraft appeared to land, though not at the location of any known airfield, before departing to the east across the southern Caribbean Sea. This track log terminated at 0202 hrs, at a point 196 nm south of Cayman Brac when either power to the GPS or a satellite signal was lost. Figure 1 is a screen dump taken from GPS B of the map page which would have been available at the time of the power/signal loss. This page also shows the track. The recorded altitude at this point was 8,450 feet amsl. The end of the track log was 300 nm short of the Active "GO TO" point which is just visible on the lower right edge of Figure 1.

GPS map display showing track (thin black line at bottom left) to the point where power/signal was lost (indicated by question mark). (Note Cayman Islands are not displayed)

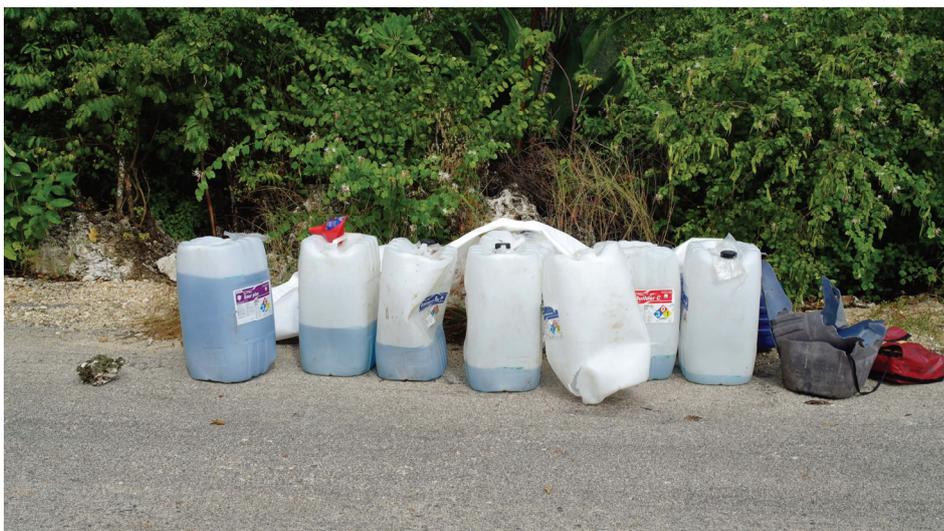
**Figure2**

The row of seats behind the pilots had been removed in order to accommodate the 10 plastic containers of fuel in the cabin. Three containers were ruptured and were empty; another was damaged but still contained approximately 12 litres. One was nearly full, containing an estimated 50 litres, with the remainder containing smaller amounts. The total fuel recovered was around 126 litres. The containers were fitted with screw caps, with pieces of polythene sheeting inserted into them, perhaps in an attempt to improve sealing or to minimise the escape of fuel vapour. A photograph of the fuel containers, taken after they had been removed from the wreckage, is shown in Figure 2.

Fuel containers carried in the aircraft cabin
