ACCIDENT

Aircraft Type and Registration:	Aeronca 7AC Champion, G-TECC	
No & Type of Engines:	1 Continental Motors Corp C85-12 piston engine	
Year of Manufacture:	1946	
Date & Time (UTC):	26 July 2008 at 1215 hrs	
Location:	East Side of Coningsby, Lincolnshire	
Type of Flight:	Private	
Persons on Board:	Crew - 1	Passengers - None
Injuries:	Crew - None	Passengers - None
Nature of Damage:	Landing gear collapsed, damage to cowlings and lower engine bay and windscreen, right wing strut bent through 90 degrees and some damage to the right wing	
Commander's Licence:	Private Pilot's Licence	
Commander's Age:	56 years	
Commander's Flying Experience:	1,516 hours (of which 556 were on type) Last 90 days - 78 hours Last 28 days - 14 hours	
Information Source:	Aircraft Accident Report Form submitted by the pilot

Synopsis

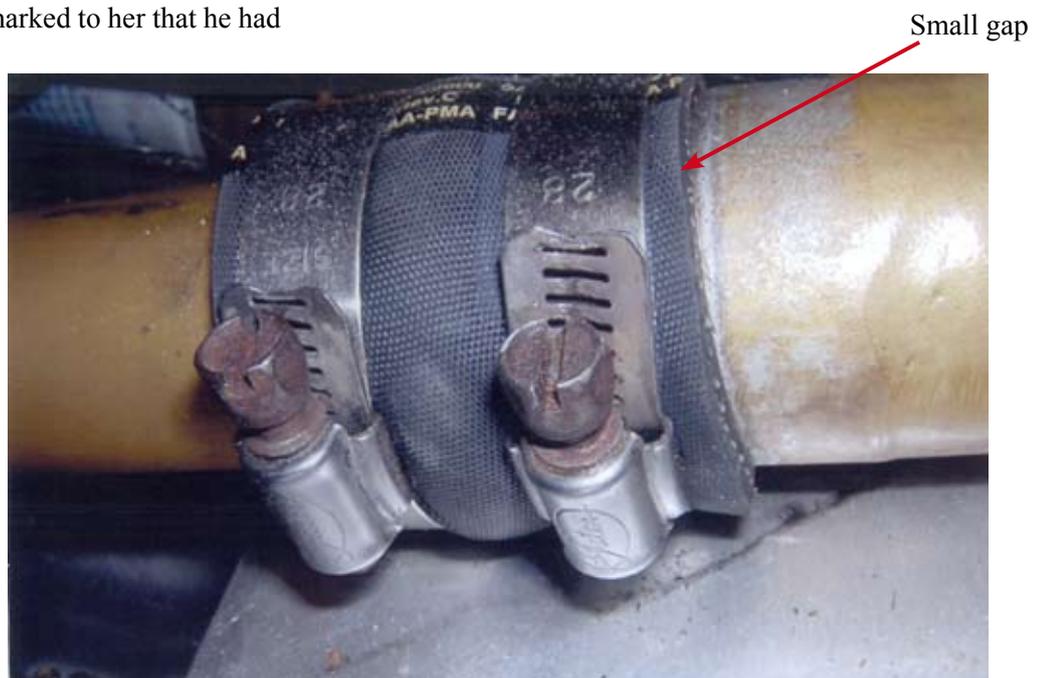
Figure 1

Subsequent examination of the engine by the owner revealed evidence from the exhaust stacks and spark plugs that the engine had been running with a very lean fuel/air mixture, although she reported that there had been no indication in flight of abnormally high oil temperature. Further inspection of the engine showed that the hose connecting the air intake duct to the No 3 cylinder to the inlet manifold, did not properly cover the end of one of the ducts, Figure 1.

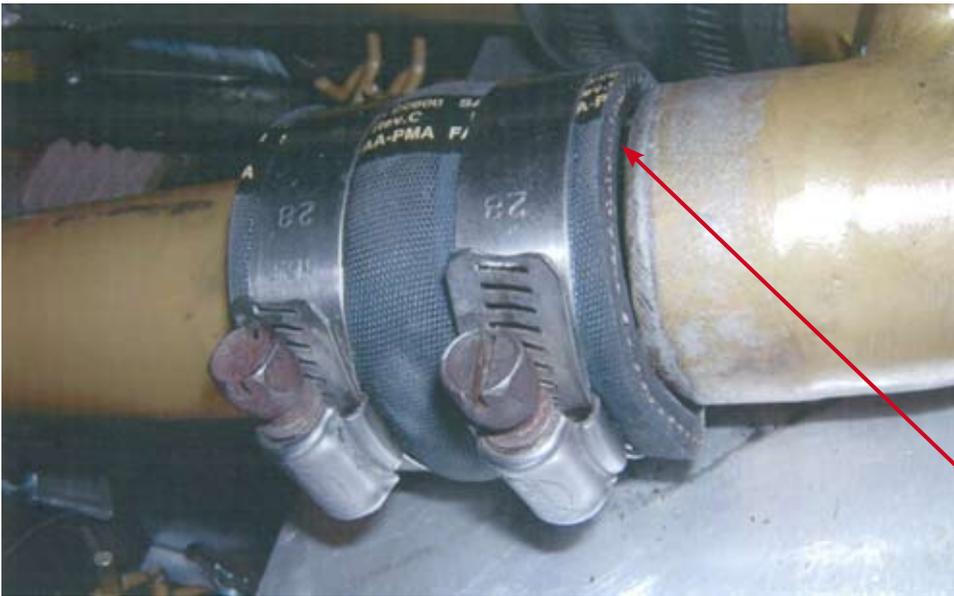
Figure 2

Hand pressure was sufficient to open up a significant gap between the hose and duct, Figure 2. It was possible, therefore, for air to be entrained through the joint and affect the mixture entering the engine, should the gap have opened whilst the engine was running.

Gap
