No: 1/92

Ref: EW/A91/7/1

Aircraft Type and Registration: Thunder and Colt Model 77A Hot Air Balloon, G-HOSI

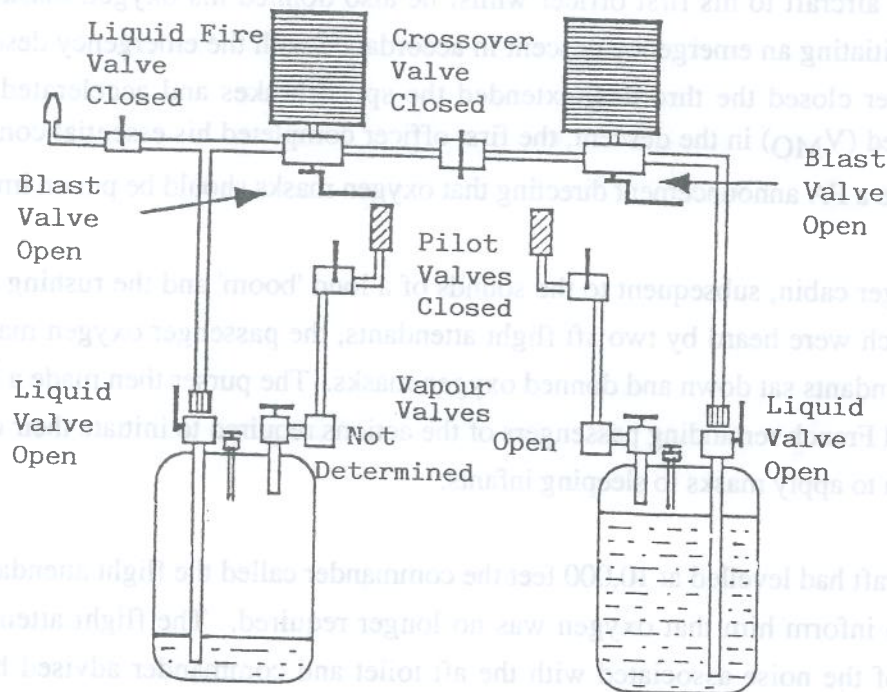
G-HOSI - Condition of fuel and burner systems

A schematic drawing in the attached Figure shows the burner and propane supply system fitted in G-HOSI. The steel pressure bottles had occupied the left upper and right upper positions in the basket. They had suffered a high external temperature but had not ruptured. On site it had been noted that the flexible hoses, although burned, appeared intact and connected and no other disconnections could be seen. The pressure reducing valves on both tanks had been destroyed and the aluminium knob on the vapour valve of the right upper tank had partially melted and resolidified. The valve handle positions were recorded on site and, on return to the UK, all the valves were dismantled and examined for evidence of their position during the fire and for any evidence of a defect or a failure. The results of these examinations are listed below.

Left		Right	
	Position on site	Internal evidence	Position on site	Internal evidence
Liquid Supply Valve	Open	None	Open	Open
Blast Valve	Open	Open	Open	Open
Liquid Fire Valve	Not determined	Closed		
Crossover Valve	Not determined	Closed		
Vapour Line Valve	Not determined	None	Open	Open
Pilot Valve	Closed	None	Closed	Near to closed

When the valves and lines were examined a number of anomalies were found. In the right hand blast valve (Worcester type) it was found that two of the four main assembly bolts were broken and there was some staining on the valve block mating face which would indicate that propane had leaked from the upstream side of the valve. However, when the bolts were examined by a metallurgist it was determined that they had failed while hot and had been affected by cadmium penetration, an embrittling process commonly seen in such components when fire damaged. The aluminium block of the right hand liquid valve (Worcester type with Rego self-sealing connector) also exhibited some unusual irregular grooving on its upstream mating face but this, again, under close examination proved to be a local melting effect evidently sustained during the fire. The threads of the two unions attaching the left and right liquid lines to their respective Rego connectors were markedly different in appearance; the right hand thread was soiled and the left was bright. It was thought that this could indicate that the right union had not been tight and that either propane had leaked, causing the staining, or that combustion products had entered from the outside. It also appeared that the outer of two O-rings in the connector was missing but closer examination showed that there was a residue of carbonised material in the seal groove which when analysed indicated the presence of a fluorinated polymer. An experiment was carried out with serviceable connector and a charged cylinder. With both seals in place the outside collar was unwound one and a half turns from tight to a position where the internal self-sealing valve had not closed. The connector O-rings were still effective and there was no leak. It was noticed that the right cylinder fittings showed more severe fire damage than the left and it may be that the staining of the union threads merely reflected this. It was concluded that there was no positive evidence of a mechanical problem within the balloon's propane system.
