ACCIDENT

Aircraft Type and Registration:	Jetstream 4100, G-MAJJ
No & Type of Engines:	2 Garrett Airesearch TPE331-14GR-807H turboprop engines
Year of Manufacture:	1993 (Serial no: 41024)
Date & Time (UTC):	28 May 2012 at 1456 hrs
Location:	Brussels National Airport, Belgium
Type of Flight:	Commercial Air Transport (Passenger)
Persons on Board:	Crew - 3 Passengers - 1
Injuries:	Crew - None Passengers - None
Nature of Damage:	Rear pressure bulkhead of nose landing gear bay, lower fuselage skin and keel plate aft of nose landing gear bay
Commander's Licence:	Air Transport Pilot's Licence
Commander's Age:	40 years
Commander's Flying Experience:	5,638 hours (of which 1,700 were on type) Last 90 days - 70 hours Last 28 days - 15 hours
Information Source:	AAIB Field Investigation

Synopsis

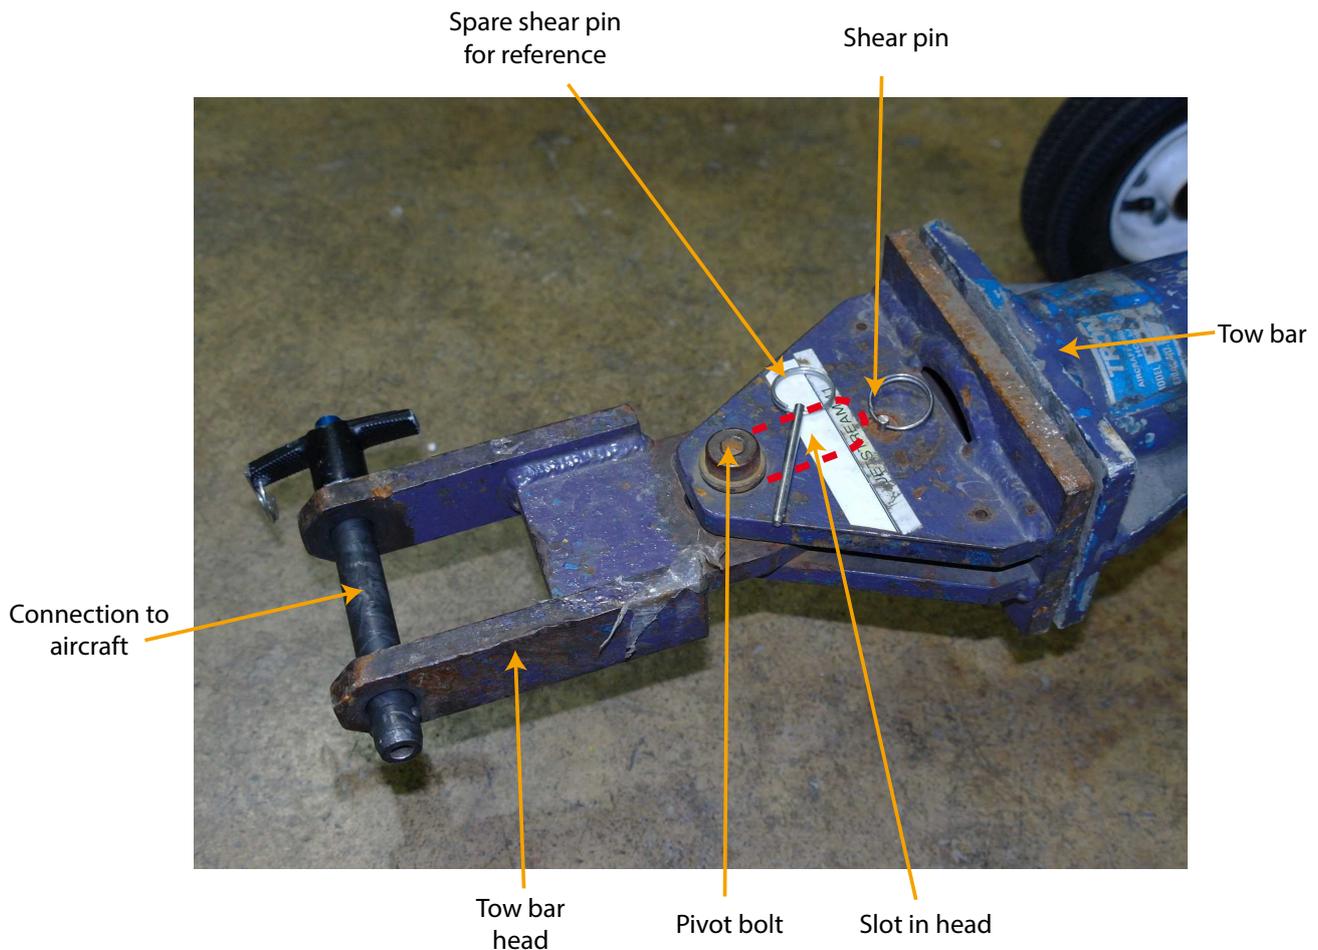
Figure 1

The pushback tractor was a SchopfMaschinenbau GmbH F100 Tug, which has an empty weight of 14,000 kg. The towbar was of a type approved for this aircraft and was fitted with the appropriate connecting head. The towbar incorporated a shear pin to protect the aircraft from excessive loads. The shear pin is designed to transmit normal loads but will break if a pre-determined load value is exceeded (Figure 1). If the shear pin breaks due to an excessive load in line with the towbar, the load will initially be removed but it will be reapplied as soon as the pivot bolt reaches the end of its slot in the towbar head.

Detail of towbar head, shear pin and head attachment to towbar

The tug used for the pushback weighed 14,000 kg, which was much heavier than the 4,500 kg recommended in the AMM, and this would have given it much more momentum than a lighter tug when the towbar pin sheared. Consequently, the tug was capable of applying a large longitudinal force to the aircraft as the pivot bolt reached the end of its slot. The investigation did not determine whether or not the use of a lighter tug would have caused similar damage.

A Ground Handling Instruction was issued to all Ground Handling Agents associated with this airline’s operation to ensure that suitable towing vehicles are used.

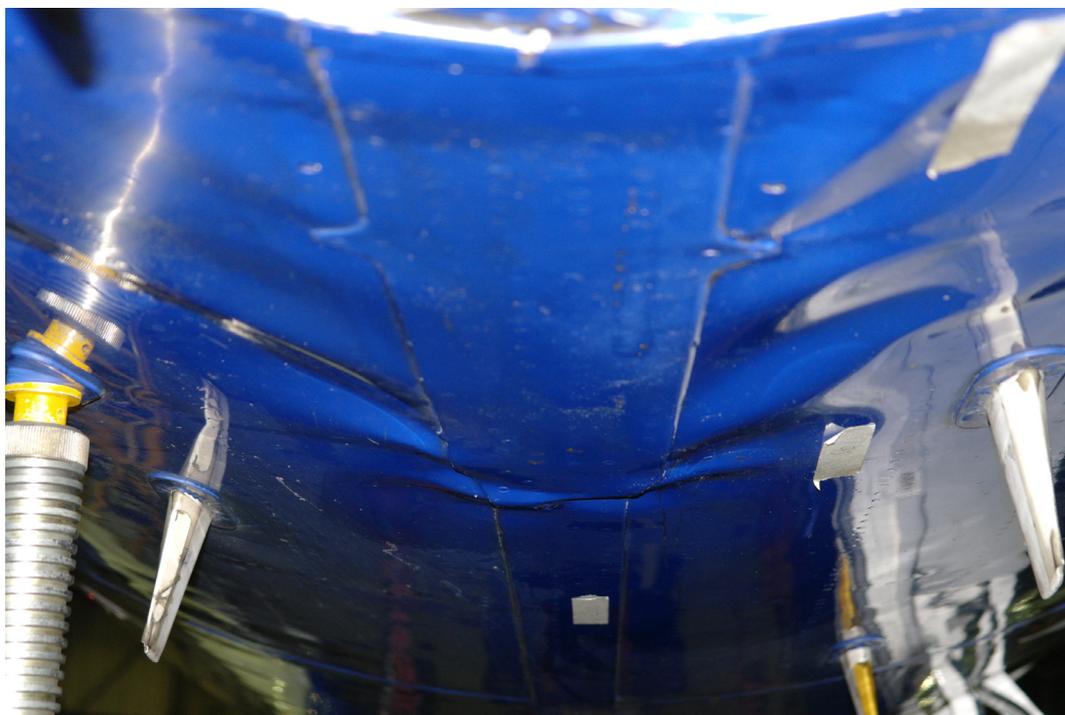
Figure 2

When the damage was found, the aircraft was removed from service and moved to a hangar for a full inspection and evaluation. The aircraft was jacked and the nose gear and some of the cockpit equipment removed to allow access. The rear pressure bulkhead of the nose gear bay, the lower fuselage skin and keel plate immediately behind the nose gear bay and its supporting frames were found to be damaged (Figure 2).

View, looking aft following removal of the nose leg, of damage to lower fuselage skin and keel plate aft of nose gear bay

It is highly likely that damage occurred during the pushback in Brussels on 28 May 2012. Witness evidence, recorded flight data and a video recording from a camera at the airport showed that the aircraft experienced a significant jolt that caused the towbar shear pin to fail. Further damage may have occurred as a consequence of operation with a weakened structure during subsequent flights.

The aircraft was subject to a number of routine inspections by both flight crew and maintenance staff between the pushback incident and the time at which damage was identified. Damage was not discovered during these inspections even though the relevant check lists required the damaged skin area to be inspected. There were a number of factors that made identification more difficult. The damaged area was located at the bottom of the fuselage, which is approximately waist high above the ground. It is not visible from a standing position and to inspect the area effectively a person would have to crouch down and look up. The lower

fuselage is painted blue and in poor lighting conditions, such as a floodlit ramp at night (similar to when the service check was completed), identification of damage would be difficult, even when using a torch.

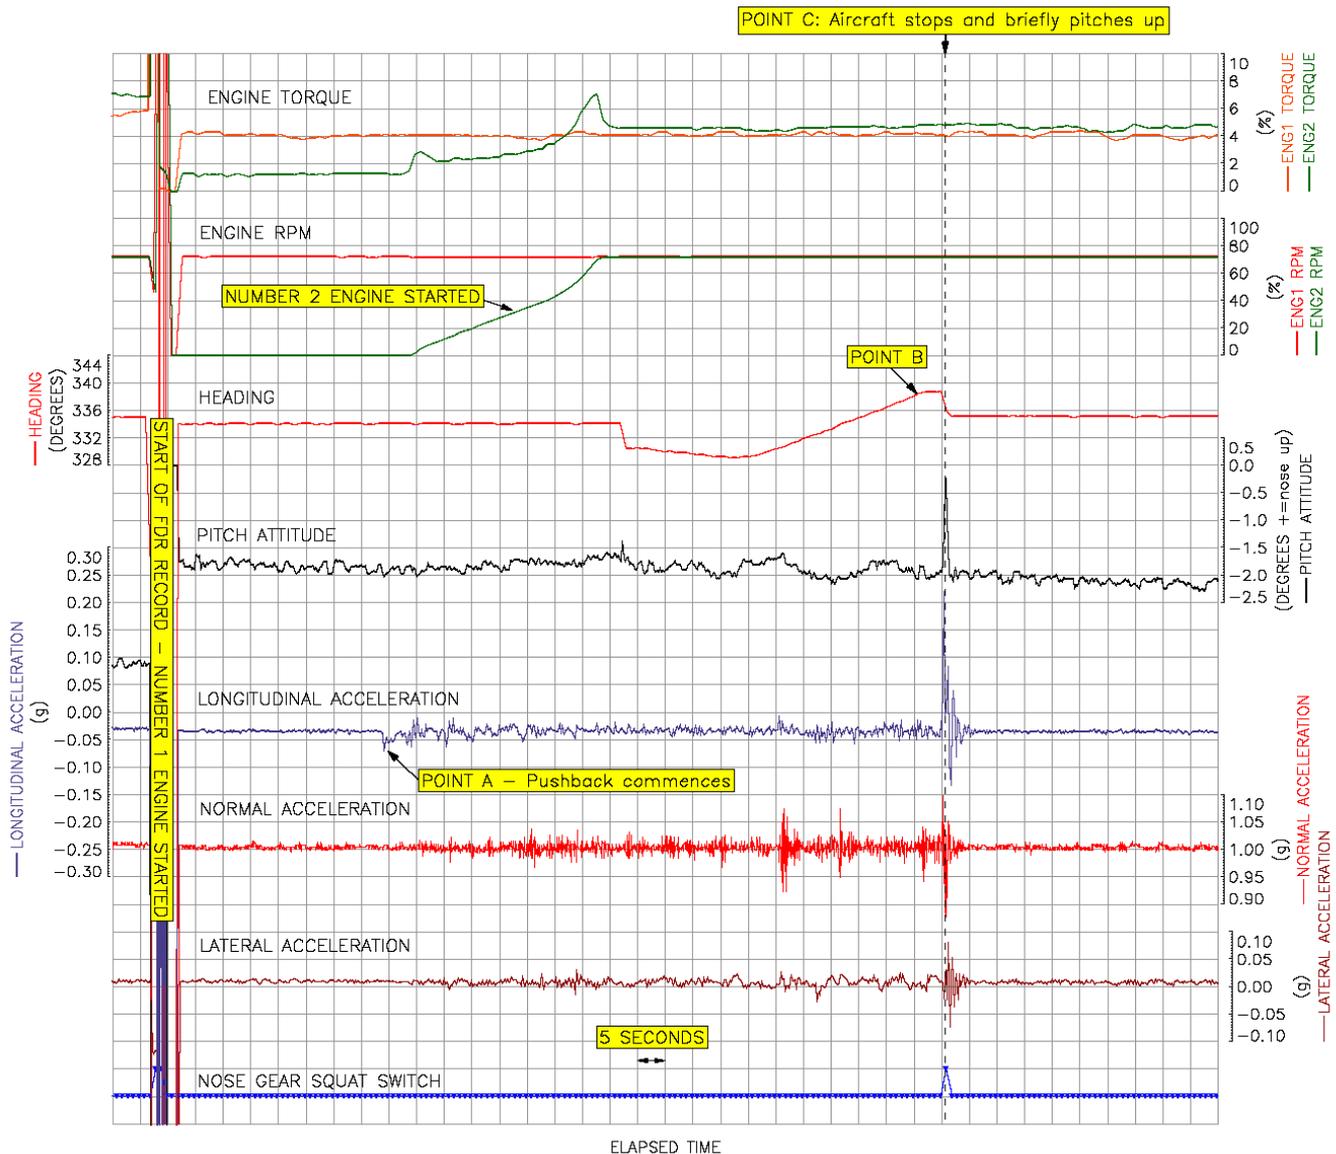
Because the towbar shear pin had broken during pushback at Brussels Airport on the 28 May 2012, the relevant FDR data was analysed. The FDR started to record when the number one engine was started while the aircraft was stationary on the stand. About 40 seconds

later, the pushback began (refer to Figure 3 - Point A), followed several seconds later by the number two engine being started. During the initial 43 seconds of the pushback, the aircraft heading remained constant at 334° before turning slightly onto a heading of 330°. Over the following 19 seconds, the aircraft heading remained constant to within 1°, after which the aircraft was turned onto a heading of 338° over a period of 34 seconds (refer to Figure 3 - Point B). Three seconds later, the aircraft came to a stop with its nose briefly pitching up by just less than 2°, but sufficient to cause the weight-on-wheels switch to change state briefly (refer to Figure 3 - Point C). During this short period, aircraft heading changed by 3° to a heading of 335°.

Pushback at Brussels Airport 28 May 2012
