ACCIDENT

Aircraft Type and Registration:	Piper PA-28RT-201T Turbo Cherokee Arrow IV, G-OPJD	
No & Type of Engines:	1 Continental Motors Corp TSIO-360-FB piston engine	
Year of Manufacture:	1982 (Serial no: 28R-8231028)	
Date & Time (UTC):	14 January 2014 at 1405 hrs	
Location:	Thruxton Airfield, Hampshire	
Type of Flight:	Private	
Persons on Board:	Crew - 1	Passengers - 2
Injuries:	Crew - None	Passengers - None
Nature of Damage:	Damage to right wingtip and flap, right entry step, right landing gear and underside aerial	
Commander's Licence:	Private Pilot's Licence	
Commander's Age:	55 years	
Commander's Flying Experience:	1,565 hours (of which 1,435 were on type) Last 90 days - 20 hours Last 28 days - 6 hours	
Information Source:	Aircraft Accident Report Form submitted by the pilot

Synopsis

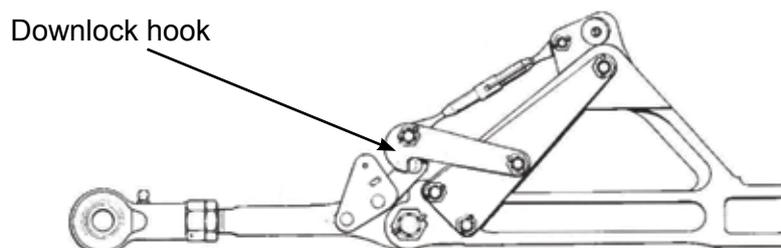
Figure 1

Downlock mechanism with hook correctly engaged on pin

The aircraft was examined during and after recovery. It was initially found that the downlock hook had not engaged on the pin and that the hook movement was stiff due to an apparent build-up of dirt and/or light corrosion; light finger assistance was, however, sufficient to get the hook to engage.
