**ACCIDENT**

<b>Aircraft Type and Registration:</b>	Piper PA-34-200T, G-BEJV	
<b>No &amp; Type of Engines:</b>	2 Teledyne Continental TSIO-360-EB piston engines	
<b>Category:</b>	1.3	
<b>Year of Manufacture:</b>	1976	
<b>Date &amp; Time (UTC):</b>	30 March 2004 at 1810 hrs	
<b>Location:</b>	Oxford Airport, Oxfordshire	
<b>Type of Flight:</b>	Training	
<b>Persons on Board:</b>	Crew - 2	Passengers - 1
<b>Injuries:</b>	Crew - None	Passengers - None
<b>Nature of Damage:</b>	Damage to bulkhead aft of nose wheel	
<b>Commander's Licence:</b>	Commercial Pilot's Licence, with Instrument and Instructor ratings	
<b>Commander's Age:</b>	68 years	
<b>Commander's Flying Experience:</b>	12,300 hours (of which 5,100 were on type) Last 90 days - 102 hours Last 28 days - 45 hours	
<b>Information Source:</b>	Aircraft Accident Report Form submitted by the pilot and additional AAIB enquiries

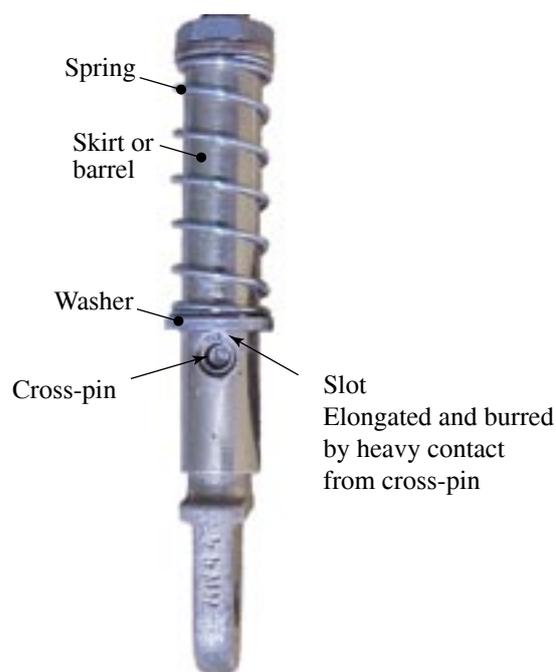
**Figure 3**

The downlock link had suffered some distortion in its upper eye end, and the aperture, or slot, had been slightly elongated to the extent that a burr had been raised at the upper end, with the result that the spring-end washer rested on the burr, rather than the shank of the pin (see Figure 3, right). It was not clear if the slot elongation had occurred over a number of landings, or as a result of this incident.

Damaged Downlock link showing distortion of slot and washer jammed on burr
