Sikorsky S61 Main gearbox — arrangement of the input stages

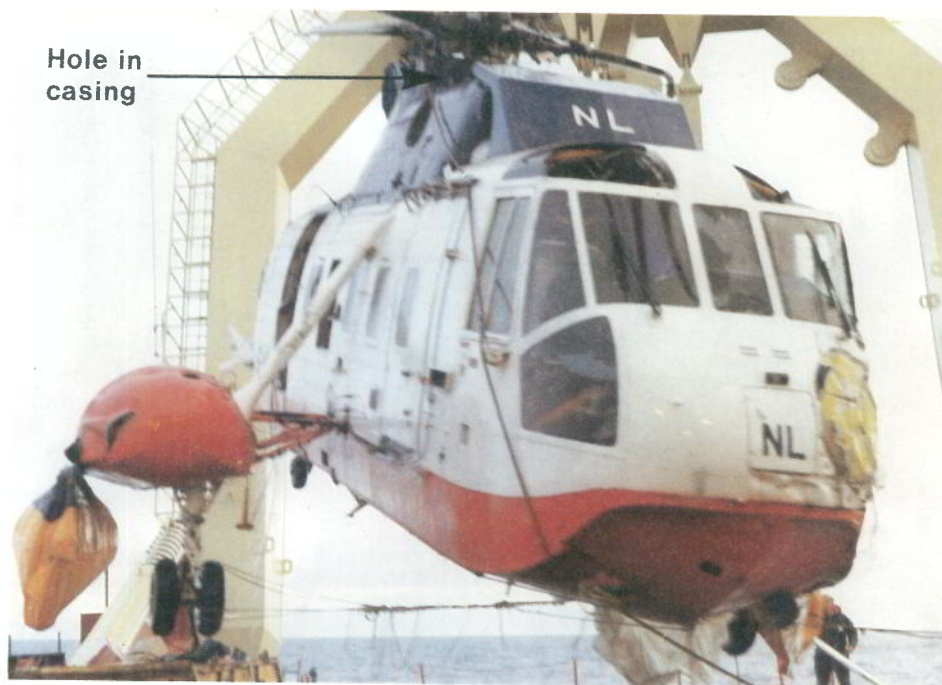
Hole in casing

Lifting of Helicopter off seabed

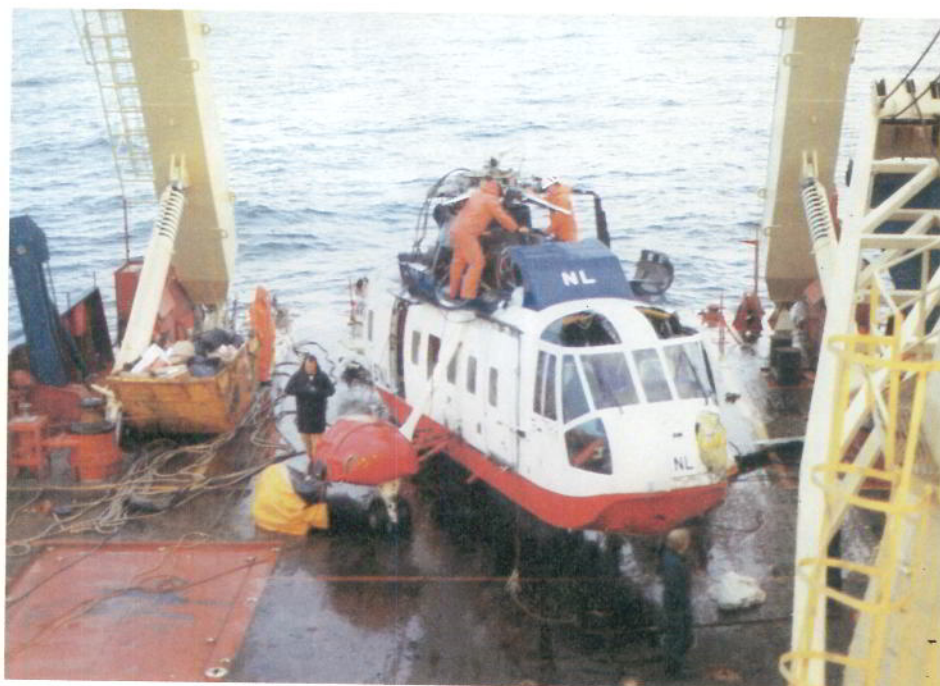
The Helicopter on deck of "SHEARWATER AQUAMARINE"

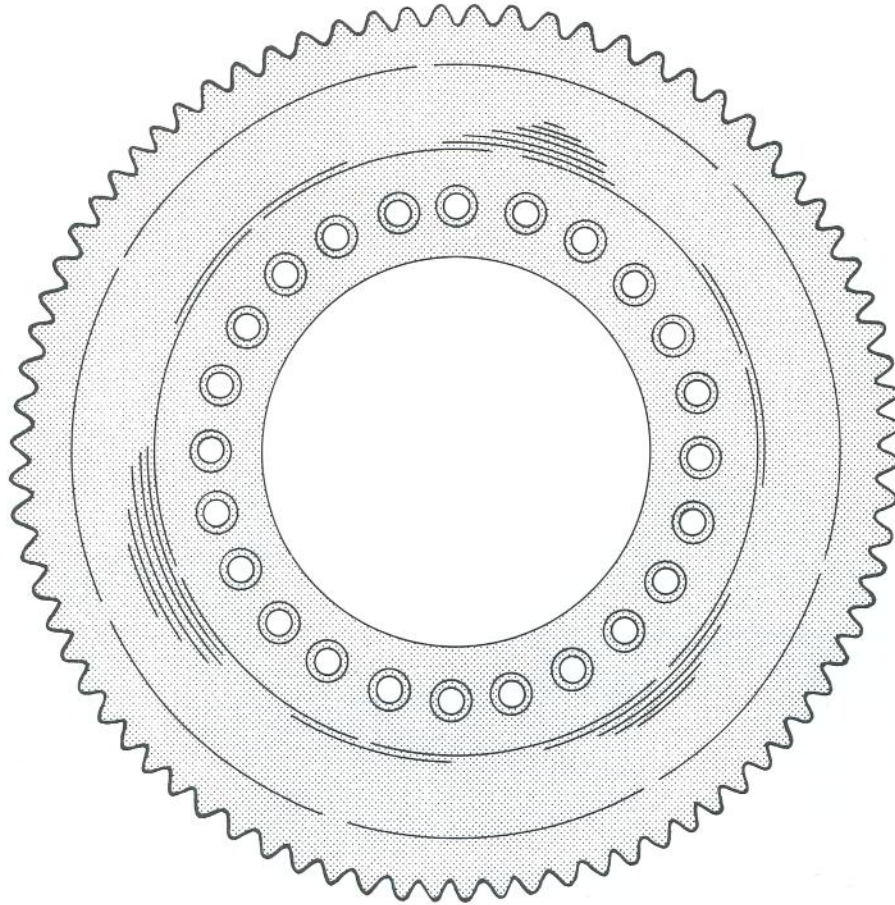
Plan view of spur gear

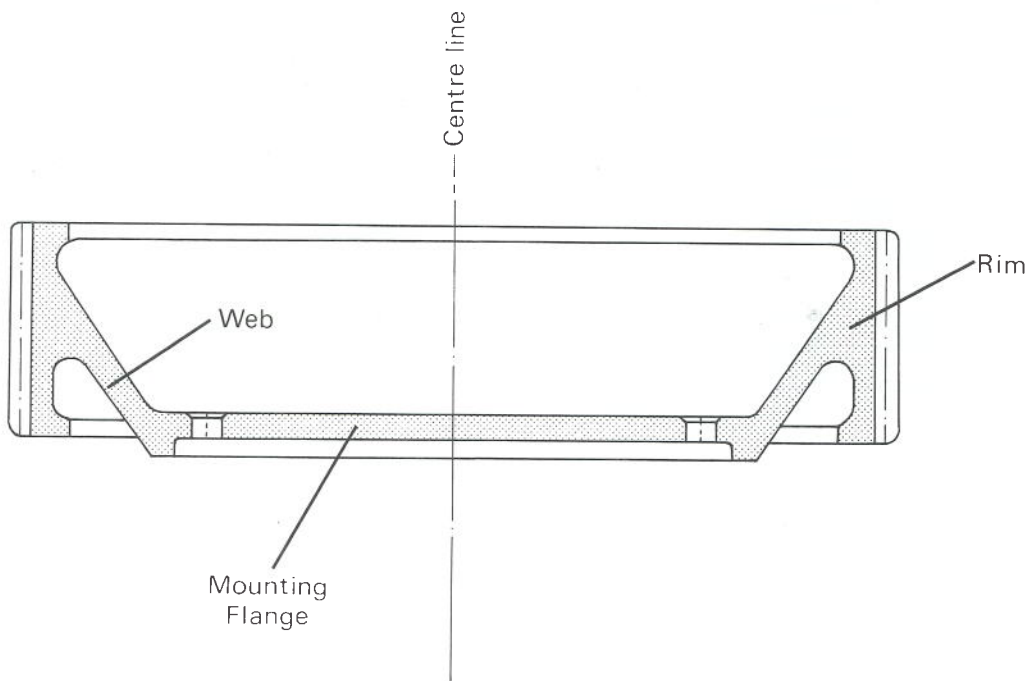
Sectional view of spur gear

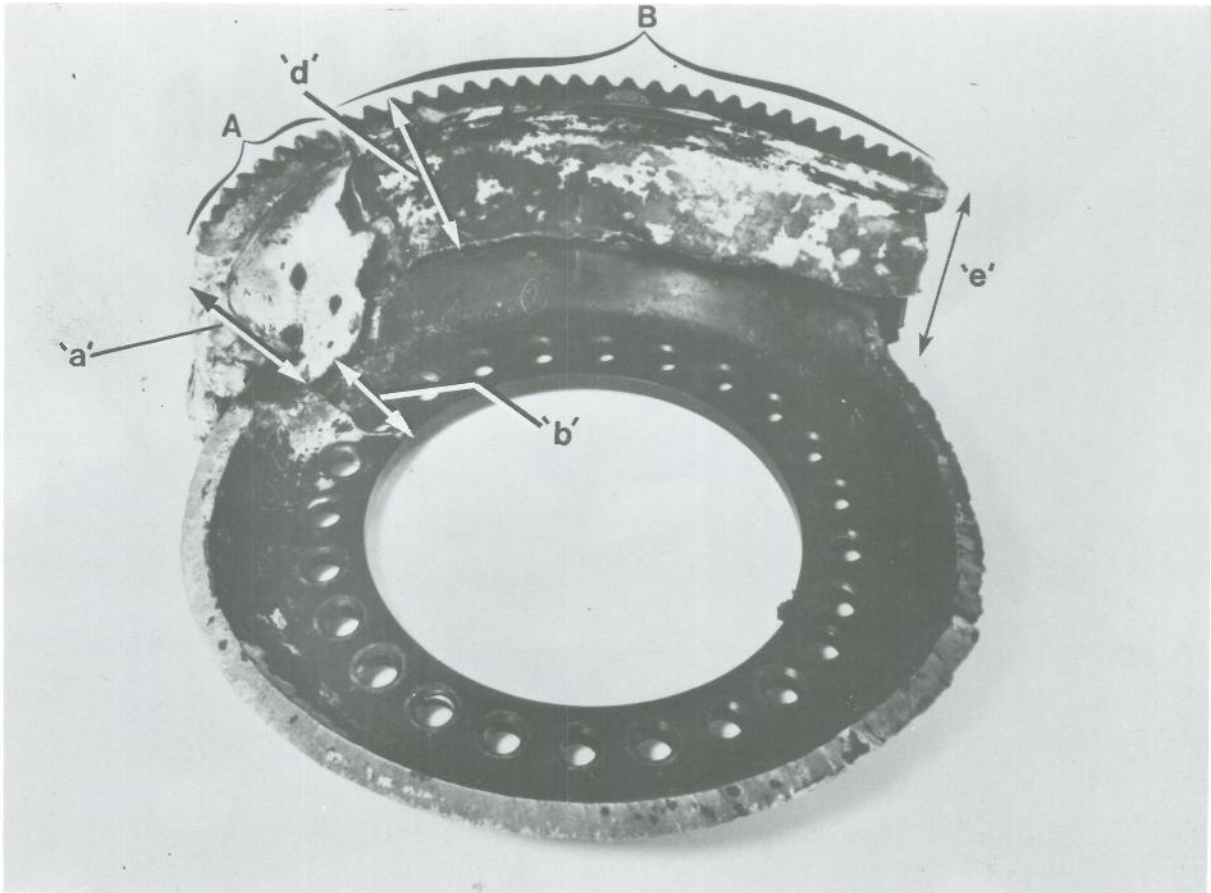
Fig 1 Spur gear flange and remaining sections of rim

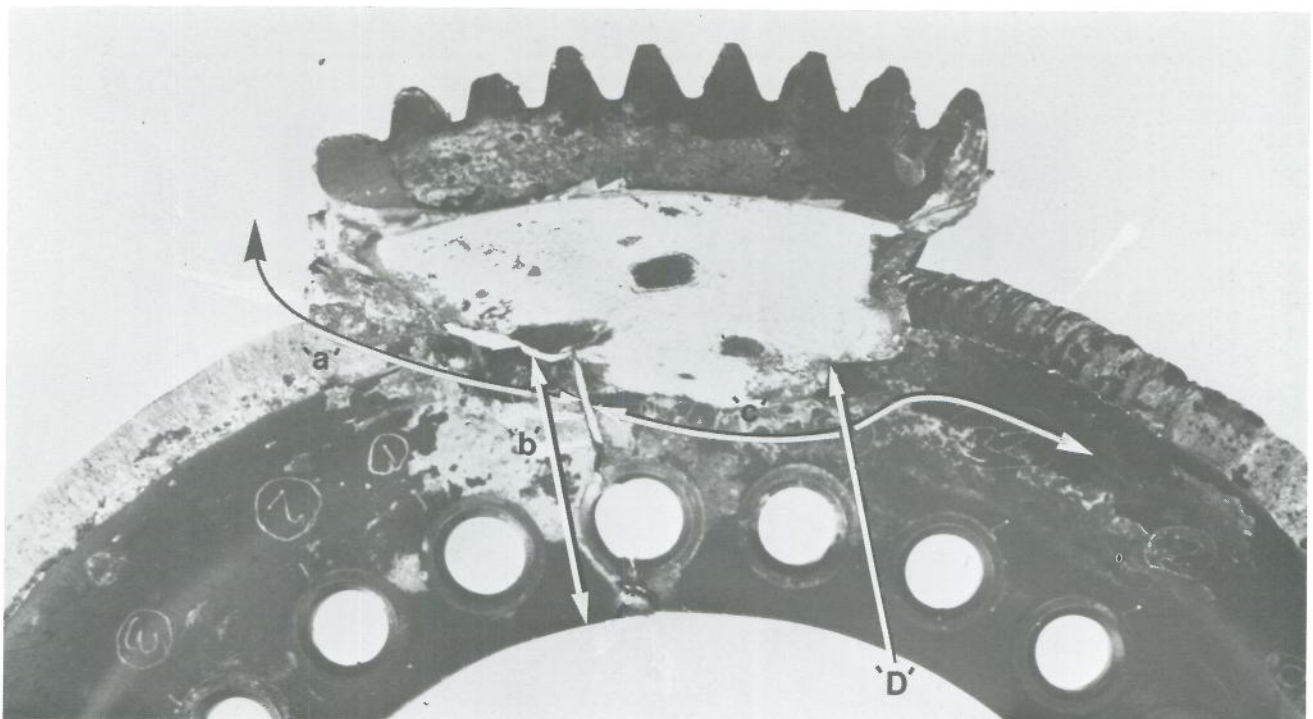
Fig 2 Showing difference in crack path through rim and flange

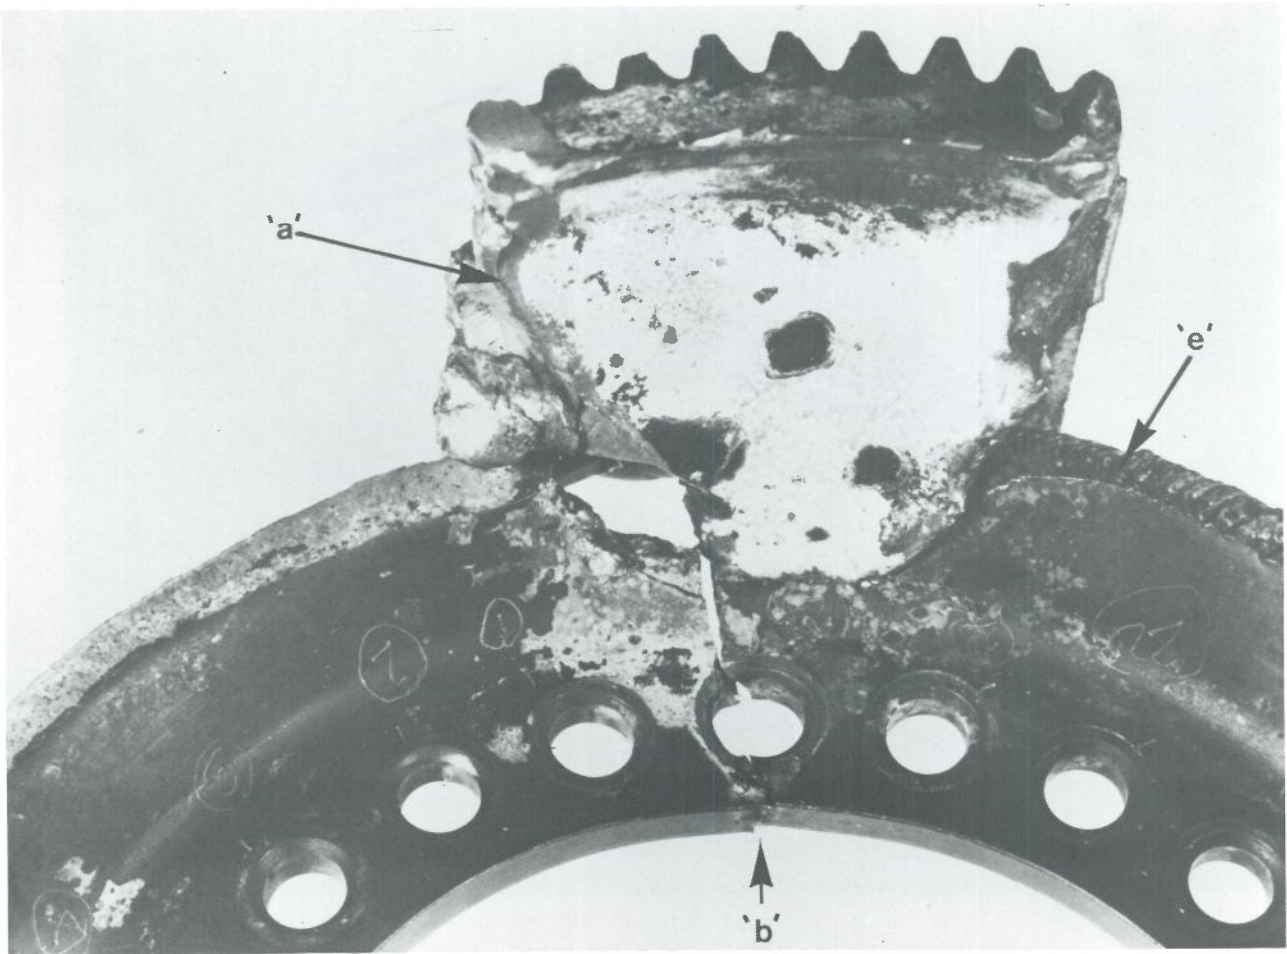
Fig 3 Showing position of fatigue evidence, 'a' and 'e', and crack through flange, 'b'

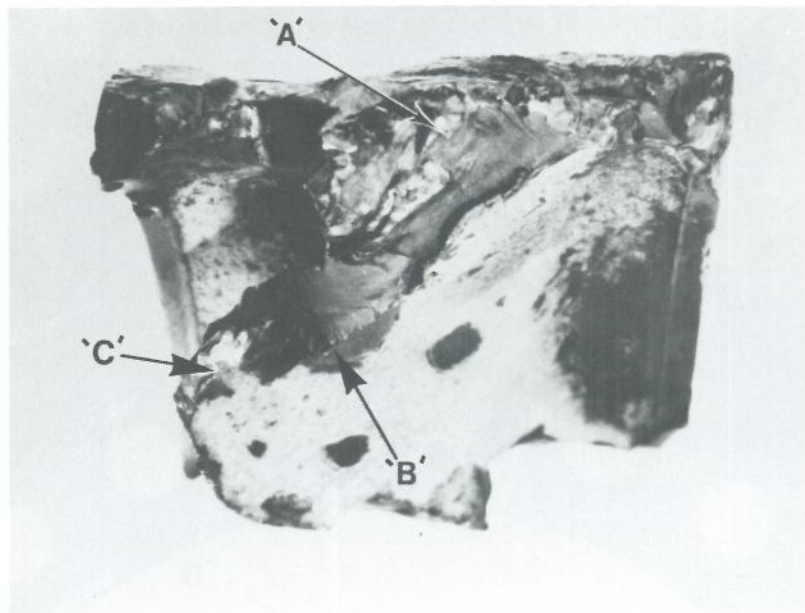
Fig 4 Fatigue damage on rim section

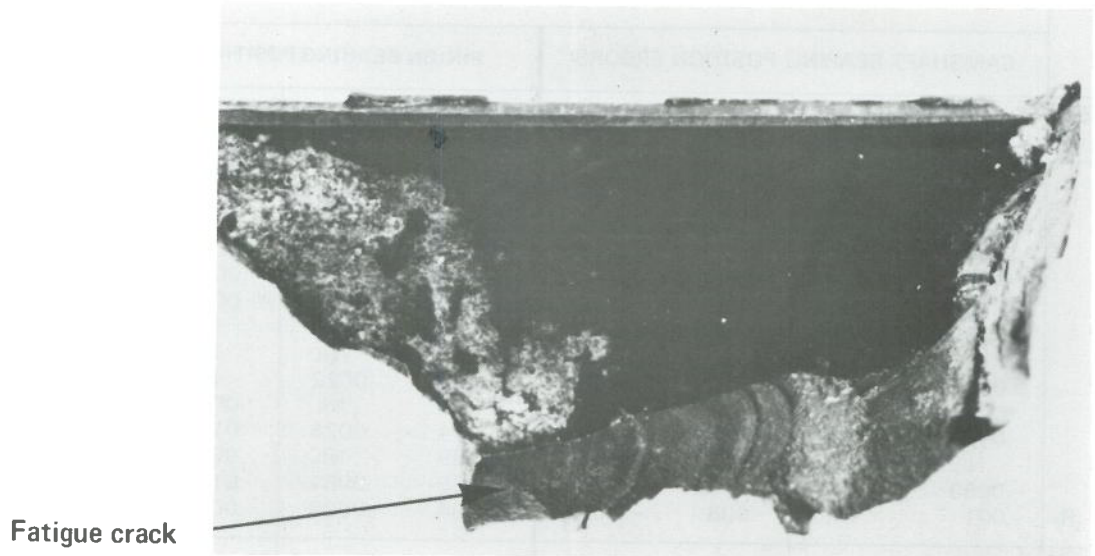
Fatigue crack

Fig 5a Fragment of tooth recovered from gearbox x6

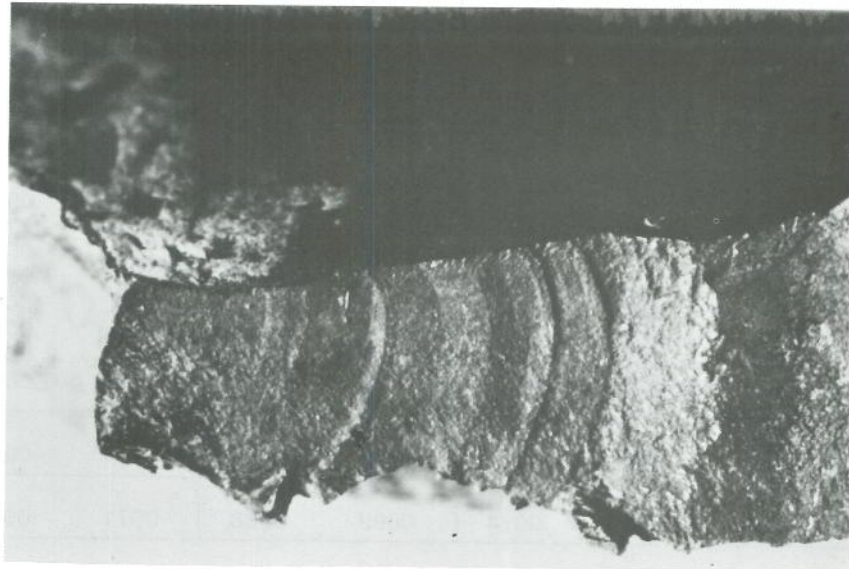
Fig 5b Fatigue evidence exhibited by fragment shown in Fig 5a
