## Pegasus/Flight Design CT2K Microlight, G-CBWA

<b>AAIB Bulletin No: 6/2003</b>	Ref: EW/G2003/02/14	Category: 1.4
<b>Aircraft Type and Registration:</b>	Pegasus/Flight Design CT2K Microlight, G-CBWA	
<b>No &amp; Type of Engines:</b>	1 Rotax 912ULS piston engine	
<b>Year of Manufacture:</b>	2003	
<b>Date &amp; Time (UTC):</b>	18 February 2003 at 1650 hrs	
<b>Location:</b>	Wycombe Air Park	
<b>Type of Flight:</b>	Private	
<b>Persons on Board:</b>	Crew - 1	Passengers - 1
<b>Injuries:</b>	Crew - None	Passengers - None
<b>Nature of Damage:</b>	Nose wheel and propeller	
<b>Commander's Licence:</b>	Private Pilot's Licence	
<b>Commander's Age:</b>	47 years	
<b>Commander's Flying Experience:</b>	1,194 hours (of which 55 were on type)	
	Last 90 days - 55 hours	
	Last 28 days - 23 hours	
<b>Information Source:</b>	Aircraft Accident Report Form submitted by the pilot

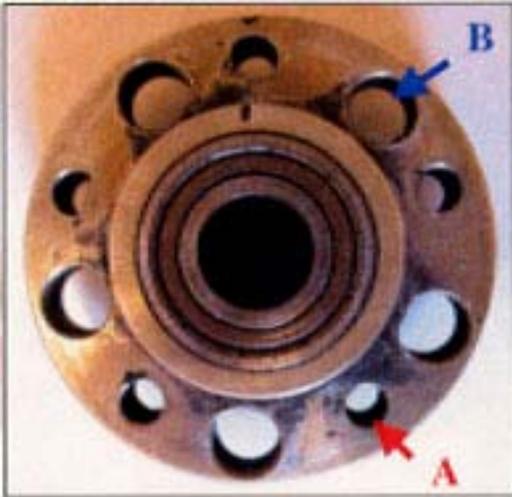
which contains the wheel bearing, is mounted on a 15 mm diameter plain shank bolt which passes through the nosewheel forks and forms the nosewheel axle. The wheel is held centrally between the forks by tubular spacers on either side of the hub. In addition to the holes for attaching the wheel halves, the hub also has five 10 mm diameter lightening holes which have the same spacing and pitch circle diameter as the 6.5 mm holes used for mounting the wheel, as shown in Figure 1.

**Figure 1:**  
Wheel hub showing wheel mounting holes (A) and lightening holes (B)

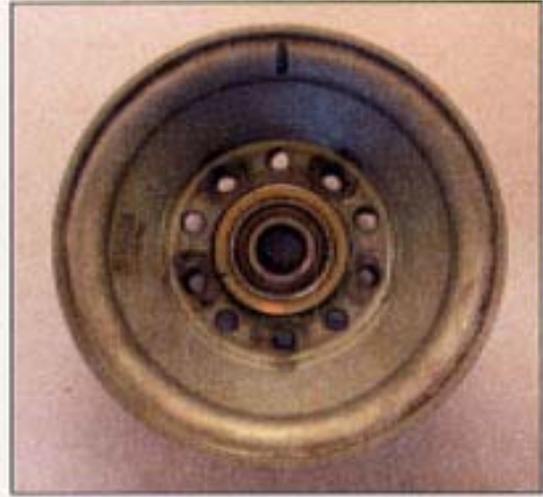
**Figure 2:**  
Undamaged wheel half overlaid on top of hub, showing alignment of holes in wheel with holes in hub. (Alignment mark on wheel rim was made subsequently by the AAIB)

Examination of the damaged wheel halves showed that they had been drilled with ten 6.5 mm diameter holes, the arrangement of which was such that they lined up exactly with the ten holes in the hub, as shown in Figure 2. Once the wheel halves were placed in position prior to inserting the attachment bolts, it was difficult to ascertain which were the correct holes for the wheel attachment bolts in the hub and which were the lightening holes. It was also noted that the bolts used for attaching the wheel were threaded along their entire shank, rather than having a more suitable plain shank with a threaded end, but this was not considered to have been a significant factor in the failure.

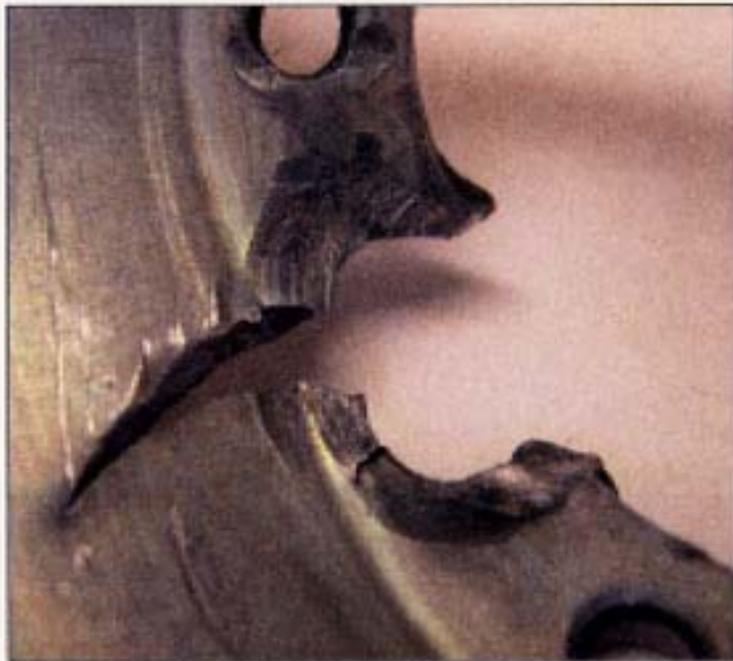
**Figure 3:**  
Failed wheel half showing typical overload failure originating at edge of wheel mounting hole

It was evident from the nature of the damage to the wheel halves and bearing hub that, during assembly, the wheel mounting bolts had been inadvertently inserted through the lightening holes instead of the intended wheel mounting holes. This meant that the wheel halves relied solely on the friction induced by the clamping force of the bolts to keep the nosewheel firmly fixed to the hub. However, this clamping force had clearly not been sufficient to prevent the wheel halves from moving relative to the hub, as evidenced by the elongation of, and the deep impressions from the threads of the bolts in the bores of, the lightening holes. The wheel halves were also heavily fretted around the bolt holes from motion of the washers as the bolts moved around in the hub. The nosewheel had ultimately failed due to overload failures in one of the wheel halves at multiple locations in the mounting bolt holes, as shown in Figure 3, and this allowed the wheel to separate from the hub.

The nosewheel failure was caused as a result of the mis-assembly of the nosewheel. The wheel mounting bolts had been inadvertently inserted into the larger lightening holes in the wheel hub instead of the correct wheel mounting holes. Causal factors were the design of the wheel, which allows the possibility of mis-assembly, and the absence of written instructions explaining how to change the nosewheel.

It is recommended that the aircraft manufacturer, Pegasus Aviation, should modify the nosewheel assembly to minimise or eliminate the possibility of incorrect assembly by insertion of the wheel half mounting bolts in to the wrong holes in the nosewheel hub.

It is recommended that the aircraft manufacturer, Pegasus Aviation, should issue written instructions to owners of the CT2K microlight explaining how to correctly install the nosewheel assembly.

It is recommended that the aircraft manufacturer, Pegasus Aviation, should take appropriate measures to ensure that recently replaced nosewheel assemblies have been correctly installed.
