<b>Aircraft Type and Registration:</b>	(i) Piper PA-28-140 Cherokee, G-AVFP (ii) Thruster T600N, G-BZBG
<b>No &amp; Type of Engines:</b>	(i) 1 Lycoming O-320-E2A piston engine (ii) 1 Rotax 582 UL-DCDI piston engine
<b>Year of Manufacture:</b>	(i) 1967 (ii) 2000
<b>Date &amp; Time (UTC):</b>	21 June 2002 at 1450 hrs
<b>Location:</b>	Manchester (Barton) Airfield
<b>Type of Flight:</b>	(i) Training (ii) Training
<b>Persons on Board:</b>	(i) Crew - 2                      Passengers - None (ii) Crew - 1                     Passengers - None
<b>Injuries:</b>	(i) Crew - None                  Passengers - N/A (ii) Crew - 1(Serious)Passengers - N/A
<b>Nature of Damage:</b>	(i) Damage to fin and rudder (ii) Aircraft destroyed
<b>Commander's Licence:</b>	(i) Basic Commercial Pilot's Licence with Instructor Rating (ii) Student Pilot
<b>Commander's Age:</b>	(i) 55 years (ii) 35 years
<b>Commander's Flying Experience:</b>	(i) 13,350 hours (of which 1,300 were on type) Last 90 days - 243 hours Last 28 days - 75 hours  (ii) 36 hours (all on type) Last 90 days - 19 hours Last 28 days - 5 hours

<b>Information Source:</b>	AAIB Field Investigation

### Synopsis

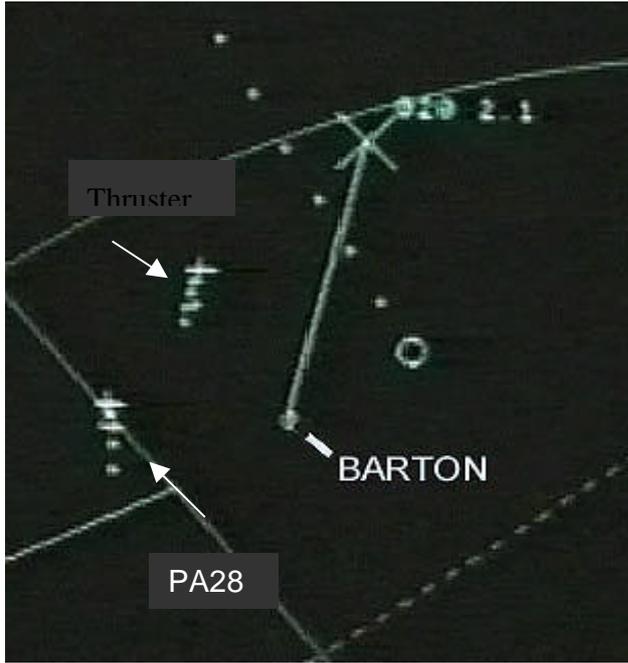
**Figure 1** "G-BG DOWNWIND" 1447:17 hrs

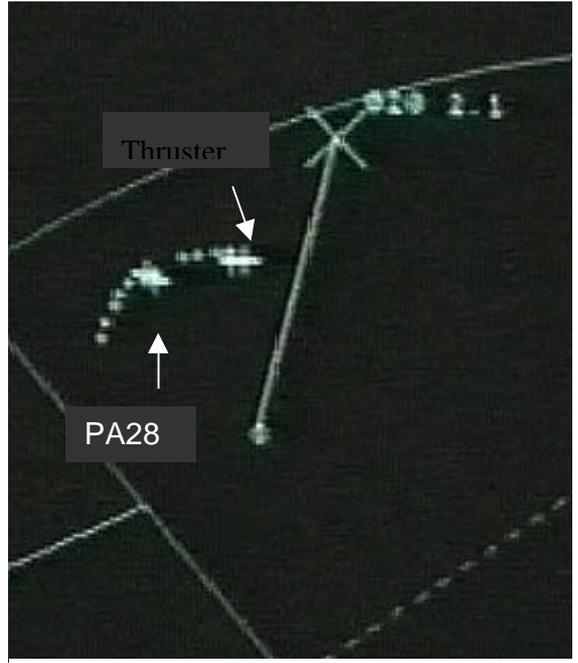
**Figure 2** "G-FP DOWNWIND" 1447:58

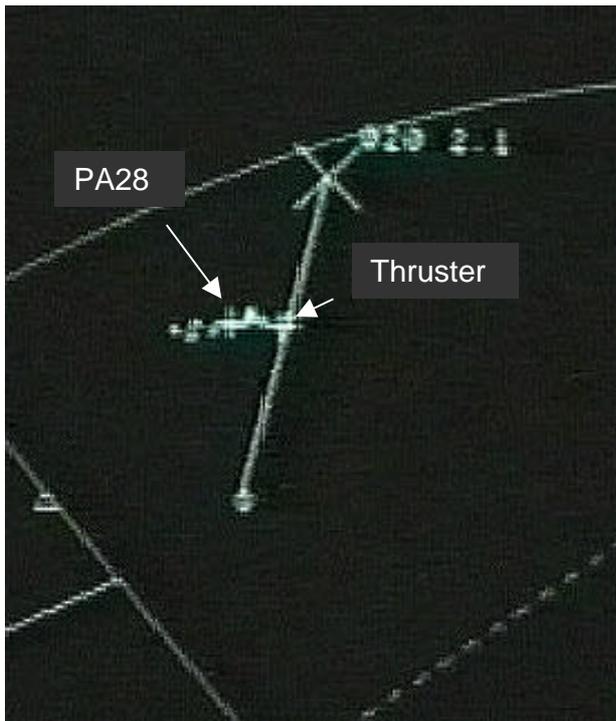
**Figure 3** Both aircraft on base leg 1448:25

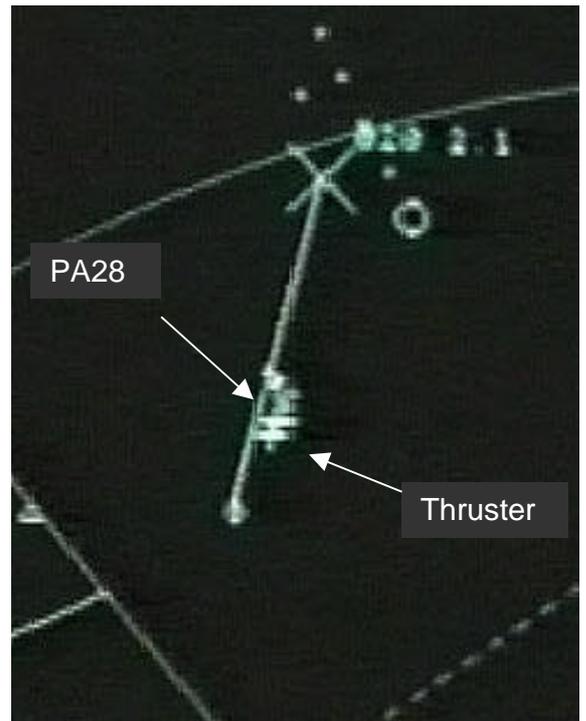
Most of the circuit activity at Barton was detected and recorded by the radar situated at Manchester Airport. Due to limitations of the radar there are no radar returns recorded when aircraft, flying at Barton, are operating below approximately 300 feet agl. The relative positions of the two subject aircraft however were shown when above that altitude. The photographs at figures 1 to 4 were taken from the radar recording. At the time the microlight pilot made his downwind position call, the radar shows two aircraft on the downwind leg following the same ground track and separated by approximately 1.5nm, (figure 1). When 'FP' made its downwind position report, (figure 2), the microlight can be seen on a base leg where the separation between the two aircraft has reduced to 0.8nm. From this position, both aircraft follow the same ground track as they fly a base leg (figure 3) and onto final approach; their separation however is reducing all the time. They were last detected by the radar approximately one minute before the collision, (figure 4).

**Figure 4** Last Contact 1449:15
