ABERDEEN AIRPORT

CAA EMERGENCY AIRWORTHINESS DIRECTIVE NO. 008-02-84
AEROSPATIALE SA 330 WITH TURBOMECA TURMO IVC ENGINE
USE OF MAXIMUM CONTINGENCY POWER AND ENGINE AIR BLEED

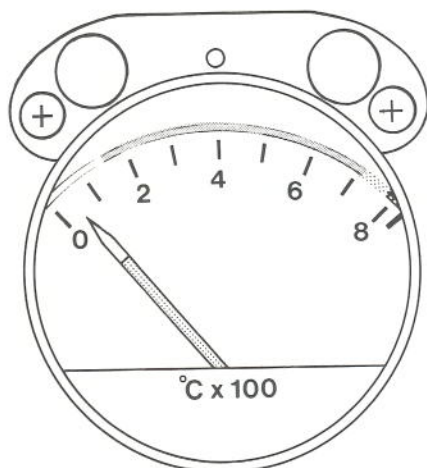
T4 TEMPERATURE INDICATORS

- Green arc from 150 C to 710 C
- Single yellow arc from 710 C to 770 C
- Double yellow arc from 770 C to 790 C
- Red arc from 790 C to 830 C
- Red line at 830 C
