ACCIDENT

Aircraft Type and Registration:	Bolkow BO 208C Junior, G-ATXZ	
No & Type of Engines:	1 Continental O-200-A piston engine	
Year of Manufacture:	1966	
Date & Time (UTC):	23 September 2006 at 1420 hrs	
Location:	Tatenhill Airfield, Staffordshire	
Type of Flight:	Private	
Persons on Board:	Crew - 1	Passengers - None
Injuries:	Crew - None	Passengers - N/A
Nature of Damage:	Damage to the propeller, nose landing gear, engine exhaust, carburettor airbox and lower engine cowling	
Commander's Licence:	Private Pilot's Licence	
Commander's Age:	45 years	
Commander's Flying Experience:	144 hours (of which 57 were on type) Last 90 days - 1 hour Last 28 days - N/K	
Information Source:	AAIB Field Investigation

Synopsis

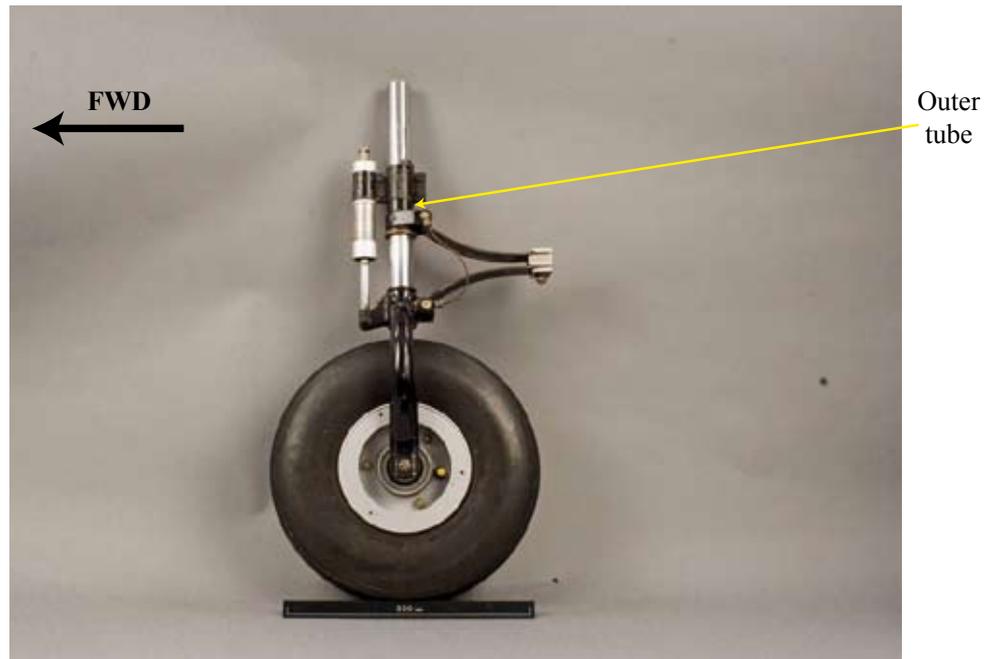
Figure 1

The detached NLG assembly (Figure 1) was taken to the Materials and Failures Department, Qinetiq, for metallurgical examination.

Section of NLG that detached from the aircraft

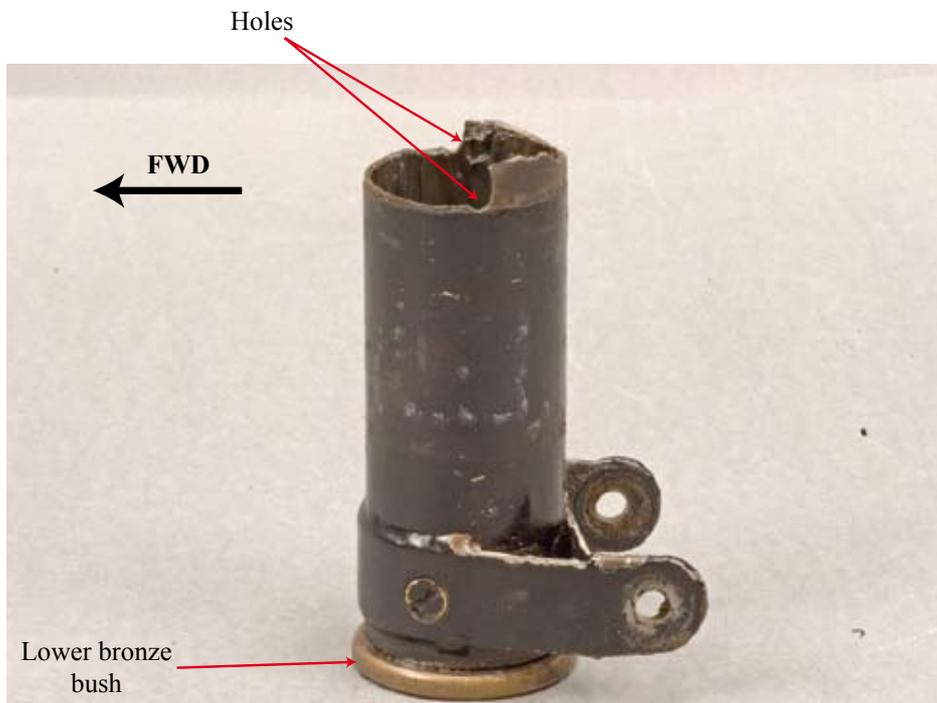
Figure 2

The outer tube had fractured between two holes that were located on either side of the tube in the area between the two bronze bushes (Figure 2). It was noted that the internal surface of the tube was well greased. Visual

Fractured outer tube removed from NLG

examination of the fracture surface showed that it was masked by grease and corrosion deposit. The majority of the fracture appeared to be angled at 45°, which is characteristic of overload failure in thin walled plate and tube. Adjacent to the holes, some areas of flat fracture were observed. After cleaning, examination of the tube showed an area on the forward section where paint had been removed and a small indent was visible from damage that had occurred prior to the application of the paint. The surrounding tube surface exhibited light grinding marks suggestive of local

blending-out of corrosion-affected areas indicating that the tube had been in use prior to the last coat of paint being applied.

The cleaned fracture surface was examined in a scanning electron microscope (SEM). Unfortunately it was so severely corroded, and had suffered post-failure mechanical damage, that little surface detail was visible. Within the areas of the flat fracture, parallel markings were observed, which could have been possible striations or 'beach marks'. However, due to the degree of corrosion, it was not possible to confirm this. To summarize, areas of flat, fatigue-like crack growth were observed adjacent to the side holes. Outside these areas the fracture surface was typical of overload failure. The rear section showed less corrosion damage so it is assumed to have failed last, allowing the NLG to detach from the aircraft. It was not possible to establish the length of time that the fatigue cracking had been present prior to the final failure.

Safety Recommendation 2007-038

It is recommended that the European Aviation Safety Agency (EASA) review the inspection requirements of Airworthiness Directive No 72-92 to ensure the continued airworthiness of Bolkow BO 208 nose landing gears.
