ACCIDENT

Aircraft Type and Registration:	DA40D Diamond Star, G-HASO	
No & Type of Engines:	1 Thielert TAE 125-01 Diesel piston engine	
Category:	1.3	
Year of Manufacture:	2003	
Date & Time (UTC):	29 June 2004 at 1345 hrs	
Location:	Field near Old Stratford, Northamptonshire	
Type of Flight:	Training	
Persons on Board:	Crew - 1	Passengers - None
Injuries:	Crew - None	Passengers - N/A
Nature of Damage:	Nose gear collapsed, broken propeller blade and right winglet damaged	
Commander's Licence:	Student Pilot	
Commander's Age:	23 years	
Commander's Flying Experience:	77 hours (all on type) Last 90 days - 49 hours Last 28 days - 26 hours	
Information Source:	Aircraft Accident Report Form submitted by the pilot plus component examination and further enquiries by the AAIB

Synopsis

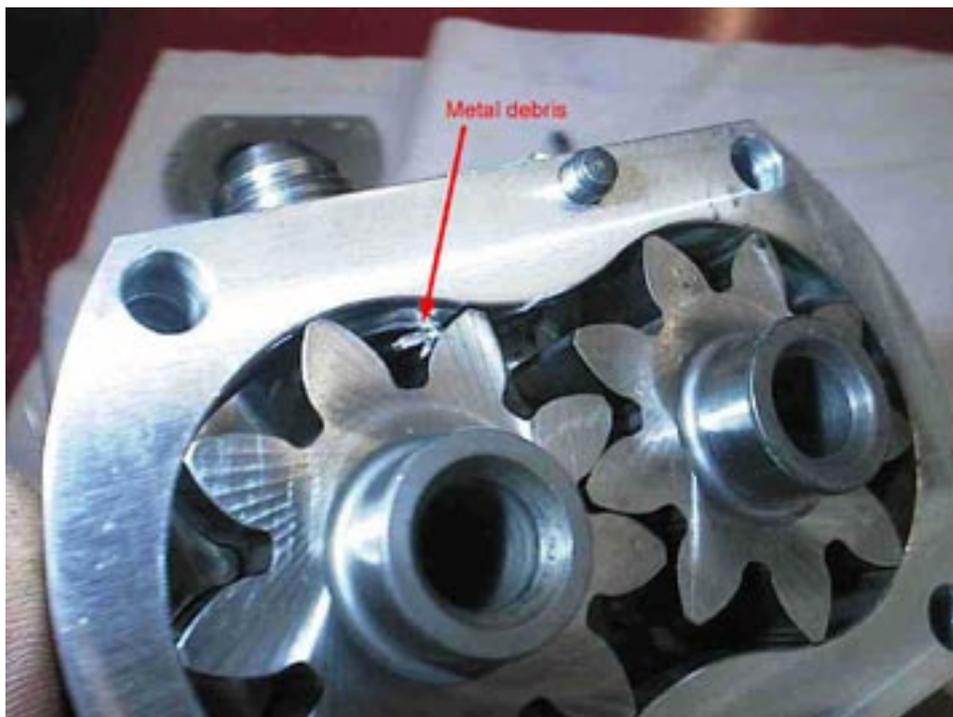
Figure 4

The engine was stripped and examined by the aircraft manufacturer but it was also inspected by an air accident investigator from the German BFU (Federal Bureau of Aircraft Accidents Investigation). An examination of the combustion chamber revealed severe overheating damage as a result of loss of lubrication. The oil scavenge pump was found seized and its driveshaft had sheared. Disassembly of the scavenge pump revealed a piece of metal debris wedged between the gears (see Figure 4). The metal debris was identified as a part from the turbocharger radial and axial bearing.

Metal debris wedged between gears of oil scavenge pump

Thielert Aircraft Engines should modify the TAE-125-01 diesel engine's oil system to reduce the likelihood of sections from a failed turbocharger causing seizure of the oil scavenge pump.

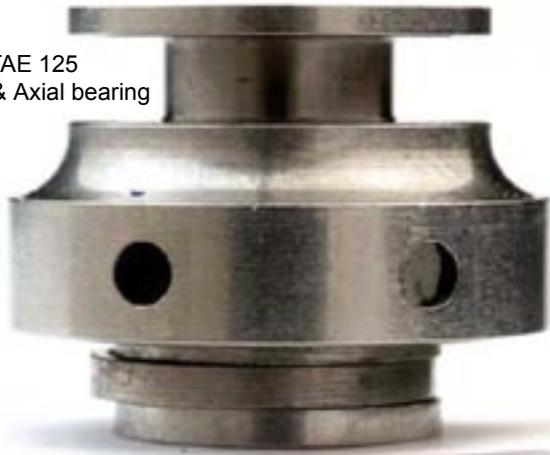
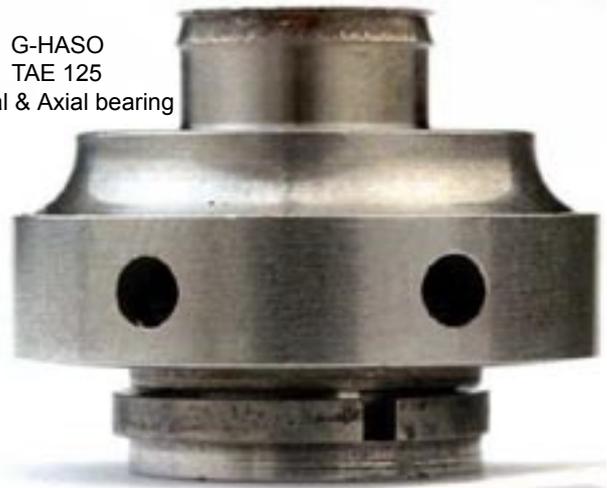
Figure 5

The turbocharger examination revealed that the radial and axial bearing had failed in three pieces. The thrust collar of the bearing had broken off and separated into two pieces (see Figures 5 and 6), one of which was found wedged inside the scavenge pump and the other was located inside the turbocharger catchtank. The bearing was examined by an independent metallurgist whose microscopic examinations revealed that the bearing had failed due to fatigue. The bearing was also examined by another engine manufacturer who concluded that the fatigue failure of the bearing was caused by increased vibrational loads.

New radial & axial bearing on the left and failed radial & axial bearing on the right (note the missing thrust collar)

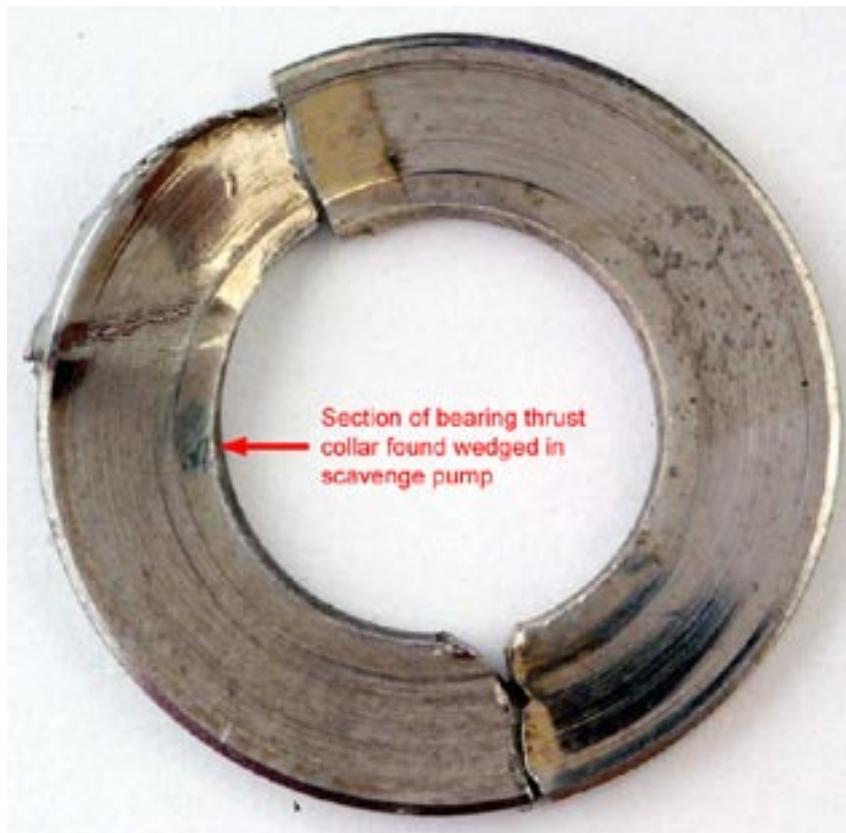
Figure 6

Failed thrust collar from radial & axial bearing (left section found inside scavenge pump; right section found inside turbocharger catchtank)

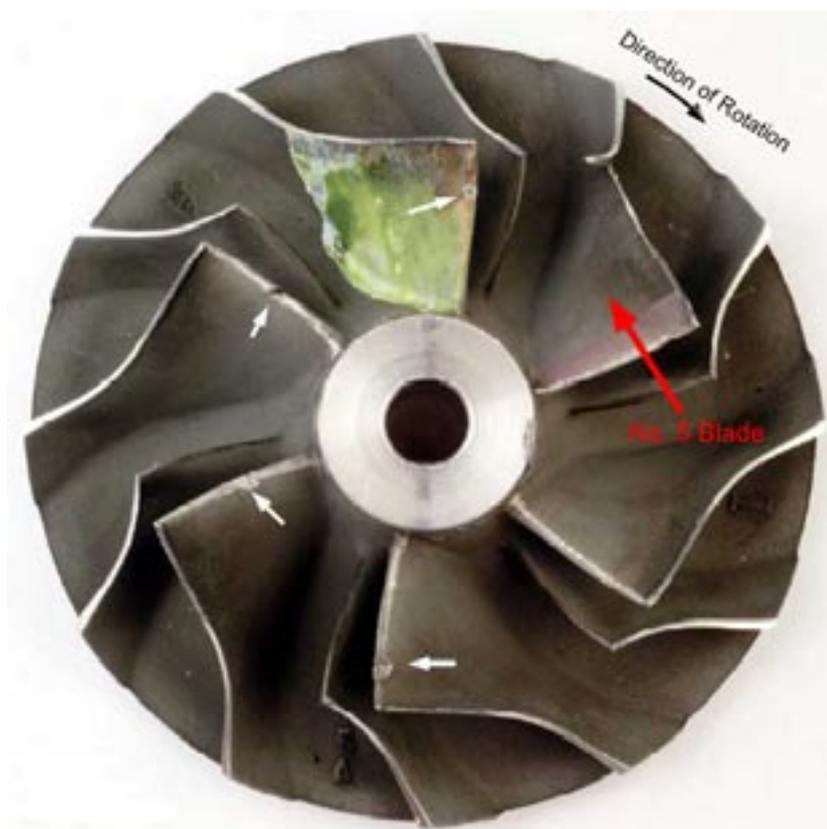
Figure 7

The compressor wheel had suffered leading edge damage to many of its blades. To establish the cause of this damage the compressor wheel and its casing were sent to an independent engine manufacturer for examination. The compressor blade tips had evidence of tip rub.

Four of the compressor blades had sharp nicks on their leading edges, as indicated with white arrows in Figure 7. Compressor blade No 5 had suffered the most damage with a 4 mm section of its leading edge torn away against the direction of rotation. Blade No 5 also exhibited small shallow impact marks on its concave side (hidden side in Figure 7) close to the leading edge damage. These impact marks were darker and therefore older than all the other shinier impact marks. The compressor casing exhibited rotational scoring marks where the compressor blade tips had rubbed against it, and a small (1.4 mm long) piece of debris was found in the gap between the casing and the inlet cone. This debris was analysed using energy dispersive x-ray which revealed that it consisted primarily of aluminium with small amounts of nickel and iron. Some of the damaged areas of the compressor were also analysed which revealed small amounts of iron at concentration levels exceeding those

in the compressor's base material. Although iron is an element within the material of the compressor, the nickel found on the debris was a foreign element - no part of the compressor section contains nickel. The examining engineer concluded from this evidence that some foreign object containing nickel had entered the compressor section and then either impacted a blade directly or become wedged between the blades and the compressor casing, causing casing rub and chipping of the blades. This would have led to an imbalance which would have caused vibration and rotational forces that could explain the bearing failure. Once the bearing had failed the compressor wheel would have moved forward causing additional damage and blade deformation (possibly causing the torn leading edge on blade No 5).
