ACCIDENT

Aircraft Type and Registration:	Yak-52, G-YAKH	
No & Type of Engines:	1 Ivchenko Vedeneyev M-14P radial piston engine	
Year of Manufacture:	1989	
Date & Time (UTC):	31 May 2010 at 0910 hrs	
Location:	Runway 03, White Waltham Airfield, Berkshire	
Type of Flight:	Private	
Persons on Board:	Crew - 1	Passengers - None
Injuries:	Crew - None	Passengers - N/A
Nature of Damage:	Minor damage to left wing tip, left aileron and tail skid	
Commander's Licence:	Private Pilot's Licence	
Commander's Age:	37 years	
Commander's Flying Experience:	405 hours (of which 81 were on type) Last 90 days - 6 hours Last 28 days - 1 hour	
Information Source:	Aircraft Accident Report Form submitted by the pilot and further enquiries by the AAIB

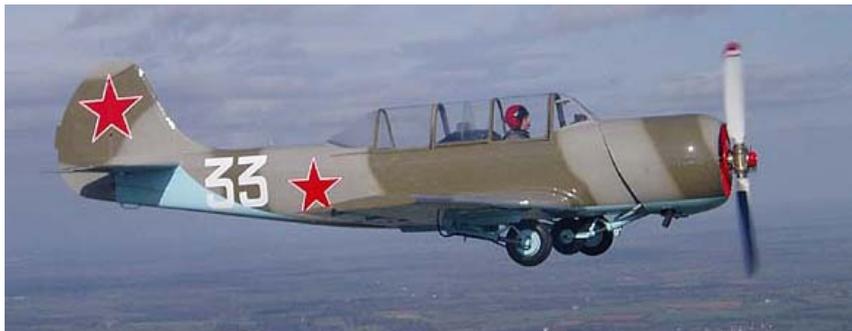
Figure 1

After landing and turning right off the grass runway the aircraft 'lurched' to the left. The pilot reached for the landing gear selector to ensure that it was DOWN, and in doing so may have inadvertently briefly selected it UP. The left main gear leg retracted, and during recovery the right main gear leg also retracted. Retraction and extension tests of the gear after the incident did not reveal any mechanical faults.

G-YAKH with its landing gear retracted
