**BULLETIN RE-ISSUED**

**ACCIDENT**

<b>Aircraft Type and Registration:</b>	Ponsford Bensen B8MR (modified), G-BIGU	
<b>No &amp; Type of Engines:</b>	1 Rotax 532 piston engine	
<b>Year of Manufacture:</b>	2001	
<b>Date &amp; Time (UTC):</b>	29 June 2003 at 1250 hrs	
<b>Location:</b>	Shipdham Airfield, near Dereham, Norfolk	
<b>Type of Flight:</b>	Private	
<b>Persons on Board:</b>	Crew - 1	Passengers - None
<b>Injuries:</b>	Crew - 1 (Fatal)	Passengers - N/A
<b>Nature of Damage:</b>	Aircraft destroyed	
<b>Commander's Licence:</b>	Private Pilot's Licence (Aeroplanes) and qualifications for the issue of a Private Pilot's Licence (Gyroplanes) <sup>1</sup>	
<b>Commander's Age:</b>	44 years	
<b>Commander's Flying Experience:</b>	324 hours (of which 43 were on gyroplanes) Last 90 days - 27 hours Last 28 days - 5 hours	
<b>Information Source:</b>	AAIB Field Investigation

**Synopsis**

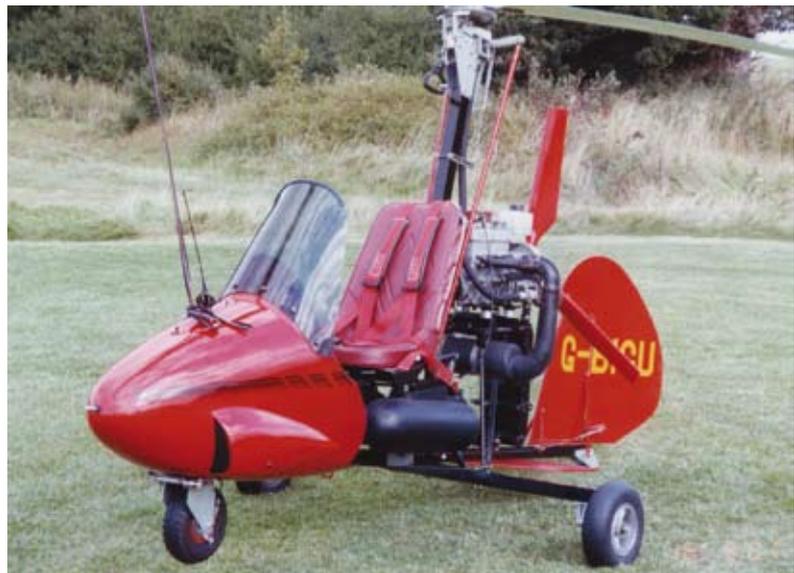
**Figure 1**

Aircraft prior to the accident (G-BIGU)

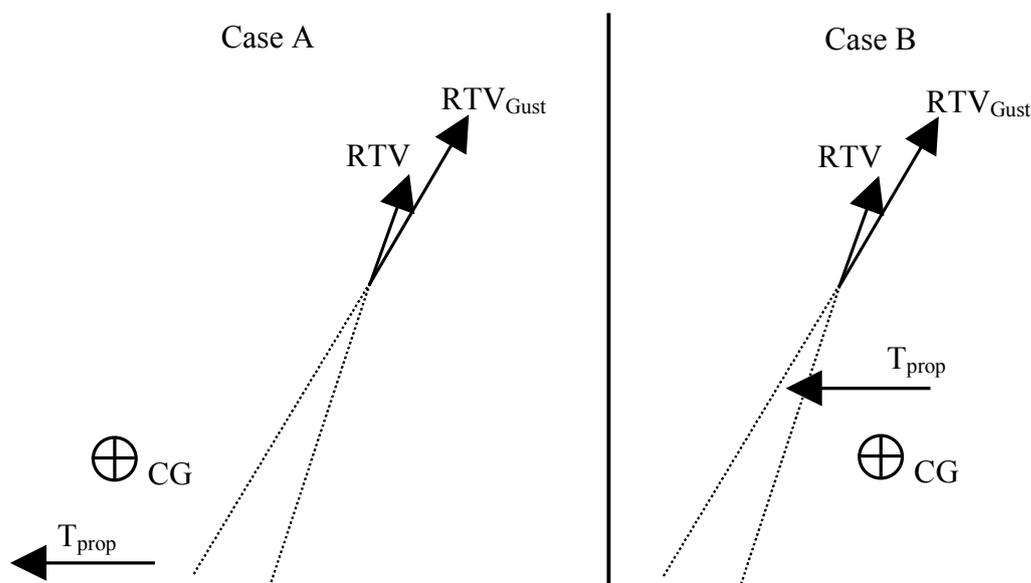
**Figure 2**

Diagram of Rotor Thrust Vector (RTV) change due to an upwards gust.

Case A: Propeller thrust line passes below CG.

Case B: Propeller thrust line passes above CG

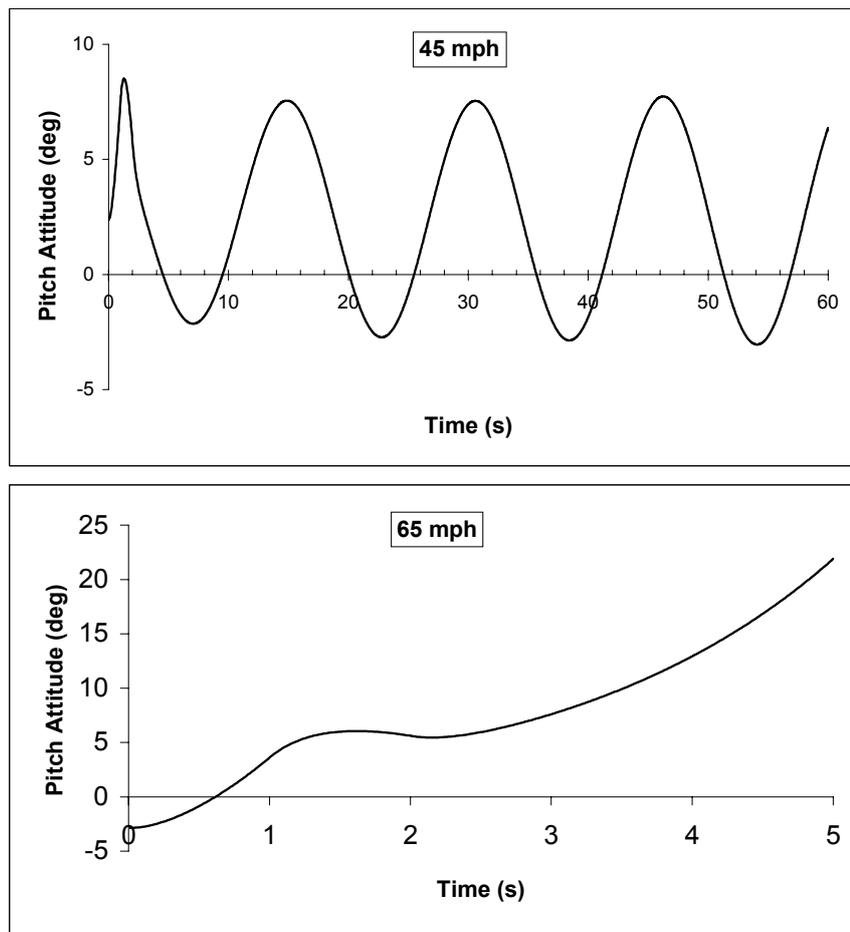
Figure 3

Modelled pitch response of accident aircraft at 45 mph and 65 mph following a fore and aft stick input

Unfortunately, this simulator model for G-BIGU cannot be validated against the real aircraft and therefore these results must be treated with some caution. However, taken together with the design characteristics of G-BIGU, the results indicate that the aircraft could have had an unstable mode in pitch and probably did not meet all the longitudinal stability criteria of BCAR Section T.

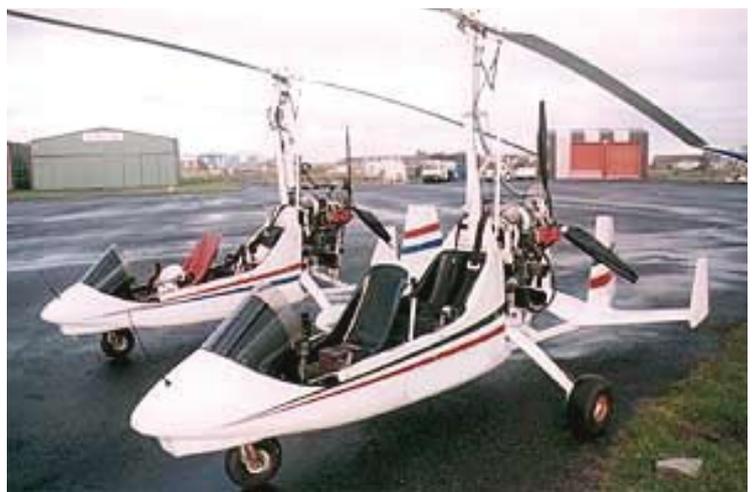
**Figure 4**

The accident pilot underwent the majority of his flight training on a VPM M-16. The VPM M-16 (shown in Figure 4) is a very different aircraft from G-BIGU. The VPM is a two seat aircraft and has a lower thrust-to-weight ratio than G-BIGU. Unlike G-BIGU, the VPM has a stabilising horizontal tail, a keel mounted stick and its thrust line is closer to the vertical CG than on G-BIGU (between 2.4 and 3.4 inches above CG). The University of Glasgow carried out a flight test programme on an instrumented VPM M-16 with a former military test pilot. Various longitudinal stability tests were carried out, including stick fixed pitch oscillations. The recorded flight test

In foreground, VPM M-16 used by accident pilot for majority of training
