**ACCIDENT**

<b>Aircraft Type and Registration:</b>	Piper PA-24-260 Comanche, G-ATIA	
<b>No &amp; Type of Engines:</b>	1 Lycoming IO-540-D4A5 piston engine	
<b>Year of Manufacture:</b>	1964	
<b>Date &amp; Time (UTC):</b>	8 August 2007 at 1057 hrs	
<b>Location:</b>	Approximately half a mile east of Leicester Airport	
<b>Type of Flight:</b>	Private	
<b>Persons on Board:</b>	Crew - 1	Passengers - None
<b>Injuries:</b>	Crew - 1 (Serious)	Passengers - N/A
<b>Nature of Damage:</b>	Aircraft damaged beyond economic repair	
<b>Commander's Licence:</b>	Private Pilot's Licence	
<b>Commander's Age:</b>	74 years	
<b>Commander's Flying Experience:</b>	1,222 hours (of which 200 were on type) Last 90 days - 37 hours Last 28 days - 4 hours	
<b>Information Source:</b>	AAIB Field Investigation

**Synopsis**

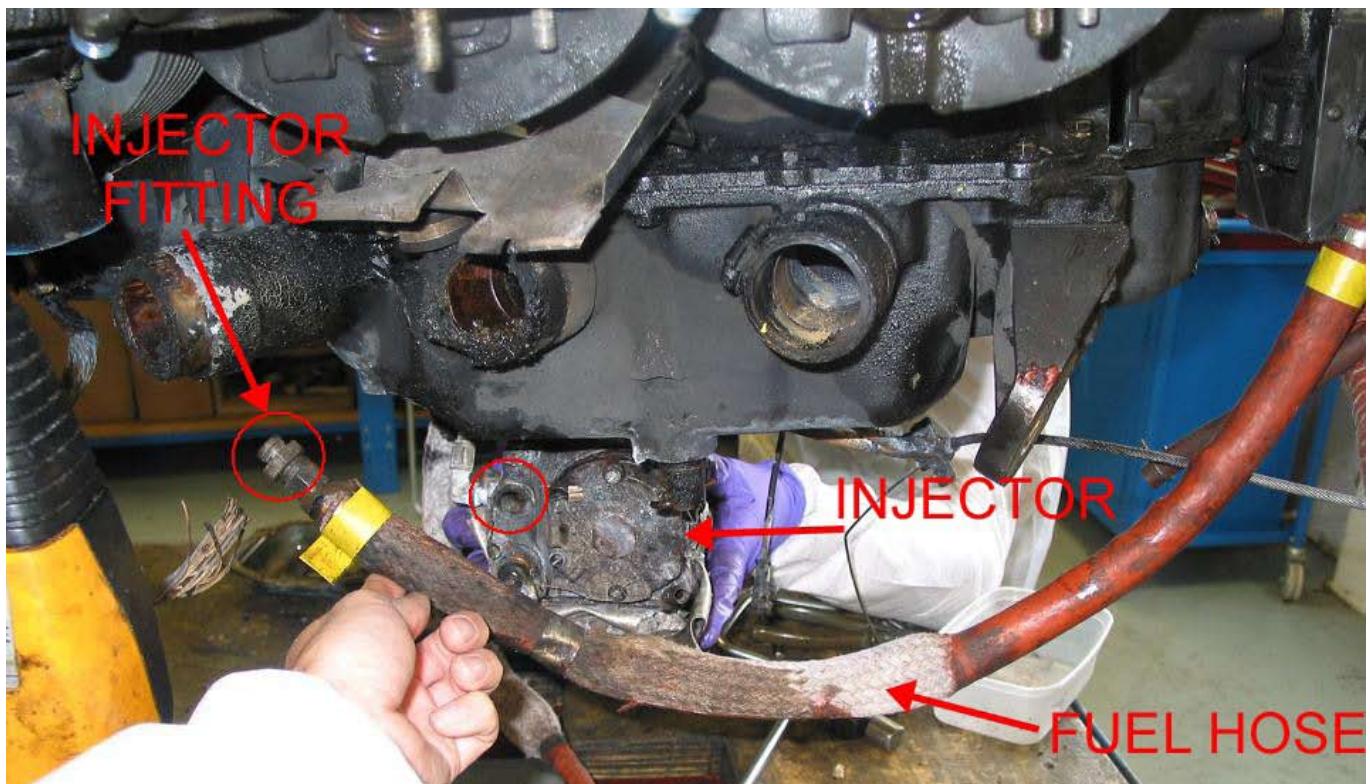
**Figure 3**

The fuel hose between the engine-driven fuel pump and the fuel injector had separated from the fuel injector (Figure 3). This was not one of the hoses that was replaced during the previous annual inspection. The fuel injector had also separated from the oil sump. The injector fitting (circled) is part of the injector body and connects to a threaded hole (also circled). Four threads from this hole had been stripped and one of the stripped threads was wrapped around the separated injector fitting (Figure 4).

Fuel hose between the engine-driven fuel pump and the fuel injector.  
It had separated from the injector at the injector fitting

The cause of the engine problems experienced by the pilot could not be established. There was sufficient fuel on-board and no evidence of fuel contamination was found. As the engine was fuel injected, carburettor icing can be ruled out as a cause. Satisfactory operation of the magnetos was verified and the spark plugs were in good condition. There were no mechanical defects with the engine and no evidence of an engine accessory defect. One possibility considered was a fuel leak from the fuel inlet fitting of the fuel injector. Insufficient fuel delivery could have caused rough running at a high power setting. Furthermore, if fuel had already been leaking from this fitting before impact, a fire would have more readily ignited at initial impact causing a narrow trail of scorched wheat. However, there were no records of this fitting having recently been disturbed;

the fuel hose that was replaced during the annual check was a different hose. Furthermore, an examination of the stripped threads could not establish if the fitting had been loose or not before the fitting was pulled out. Evidence from another accident showed that impact forces can cause the fitting to be pulled out. Therefore, no definitive cause of the engine power loss could be established.

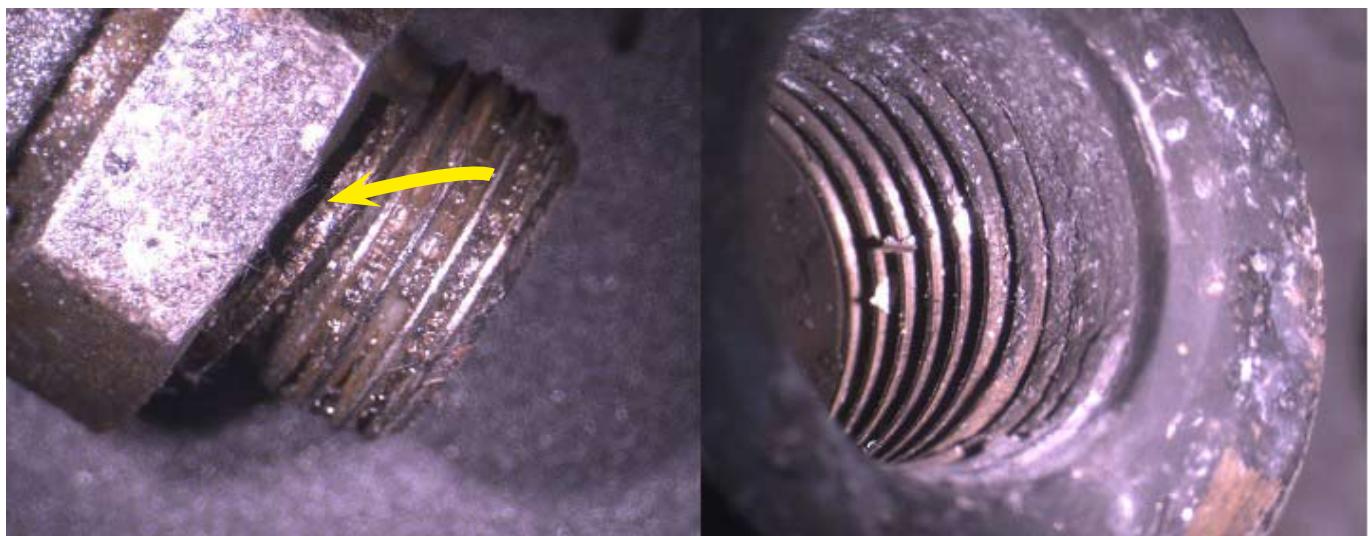
**Figure 4**

The injector fitting was confirmed to be of the correct type, with the correct number of threads. The silicone seal was missing, but could have been consumed by the post-impact fire. The fitting and injector body were examined by a metallurgist. Microscopic examination did not identify any material deficiencies. It was not possible to establish whether the fitting had been cross-threaded, nor was it possible to establish if the fitting had been tight when the separation occurred. The AAIB investigated a more recent accident to a Piper aircraft with a similar injector and injector fitting. In this accident, which did not involve suspicion of an engine problem, the injector fitting had pulled out and stripped the threads in a similar manner, probably due to impact forces.

Left: close-up of injector fitting with separated thread (arrowed).  
Right: close-up of threaded hole on the injector body showing the stripped threads
