ACCIDENT

Aircraft Type and Registration:	Jabiru J160, G-CFGH	
No & Type of Engines:	1 Jabiru Aircraft PTY 2200A piston engine	
Year of Manufacture:	2008	
Date & Time (UTC):	30 September 2010 at 1535 hrs	
Location:	Ludham Airfield, Catfield, Norfolk	
Type of Flight:	Private	
Persons on Board:	Crew - 1	Passengers - 1
Injuries:	Crew - 1 (Minor)	Passengers - 1 (Minor)
Nature of Damage:	Wing strut, nosewheel, nose leg	
Commander's Licence:	Private Pilot's Licence	
Commander's Age:	52 years	
Commander's Flying Experience:	1,056 hours (of which 43 were on type) Last 90 days - 56 hours Last 28 days - 13 hours	
Information Source:	Aircraft Accident Report Form submitted by the pilot and additional AAIB inquiries

Synopsis

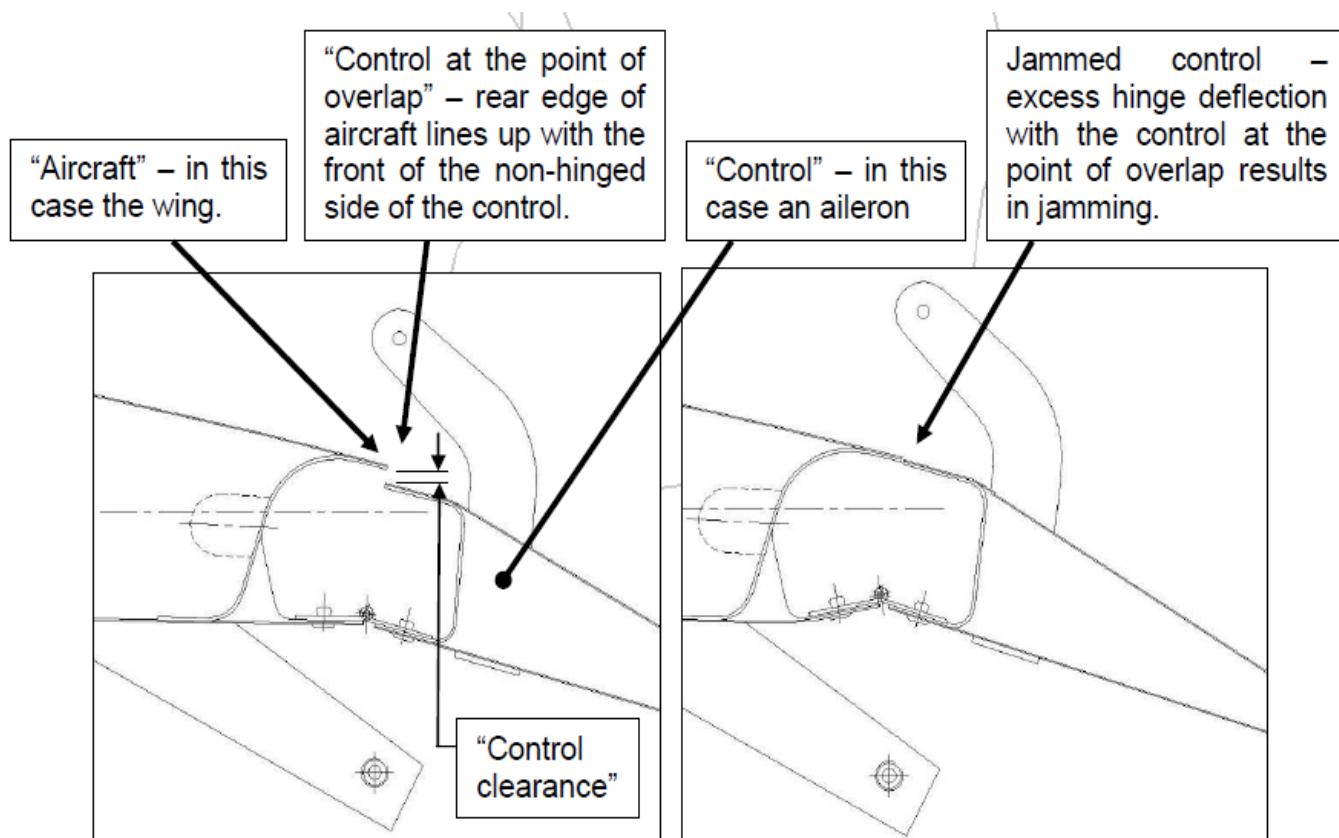
Figure 1 shows a generic control surface and how hinge deflection can result in a jammed condition. In this example it can be seen that a lack of clearance will result in rubbing, with a jam occurring when the surface moves to the point where there is no longer any overlap.

Illustration of a normal and jammed control, taken from JSB 019-2

G-CFGH had been checked against JSB 019-1 and was deemed to be compliant. However, the LAA's post-accident examination of the aircraft revealed that the clearance between rudder leading edge and the fin trailing edge was less than the 3 mm specified in the SB. Furthermore, it was apparent that any structural distortions arising from inertial and aerodynamic loads could act to close the gap (refer to Figure 1). Additional vulnerability could arise from there being a number of different control surface designs across the Jabiru range, and differences can occur between aircraft of the same type. There are two basic design configurations; one is where the shrouds of the moving control surface overlap throughout the full range of movement, whilst the other involves less overlap so that, after a small

The LAA wrote a letter, dated 10 November, to all Jabiru owners, re-explaining the reasons for the SB checks. It was additionally asked by the manufacturer to contribute suggestions to the content of a revised SB. These were all accommodated, with the result that the manufacturer subsequently issued JSB 019-2 on 24 November 2010, noting to the LAA that the revision was in response to problems that had occurred only in the United Kingdom. A significant addition in the revised version is a check in which each control is moved through its range of travel whilst pushing against the hinge, with a force of 5-7 kg, in a direction that reduces the control clearance. Any evidence of rubbing would require rectification work before the next flight.
