ACCIDENT

Aircraft Type and Registration:	Piper PA-28-140 Cherokee, G-AZWE	
No & Type of Engines:	1 Lycoming O-320-E2A piston engine	
Year of Manufacture:	1972	
Date & Time (UTC):	31 August 2005 at 1400 hrs	
Location:	Netherthorpe, Nottinghamshire	
Type of Flight:	Private	
Persons on Board:	Crew - 1	Passengers - 1
Injuries:	Crew - 1 (Serious)	Passengers - 1 (Serious)
Nature of Damage:	Aircraft destroyed	
Commander's Licence:	Private Pilot's Licence	
Commander's Age:	54 years	
Commander's Flying Experience:	415 hours (of which 321 were on type) Last 90 days -13 hours Last 28 days - 4 hours	
Information Source:	AAIB Field Investigation

Synopsis

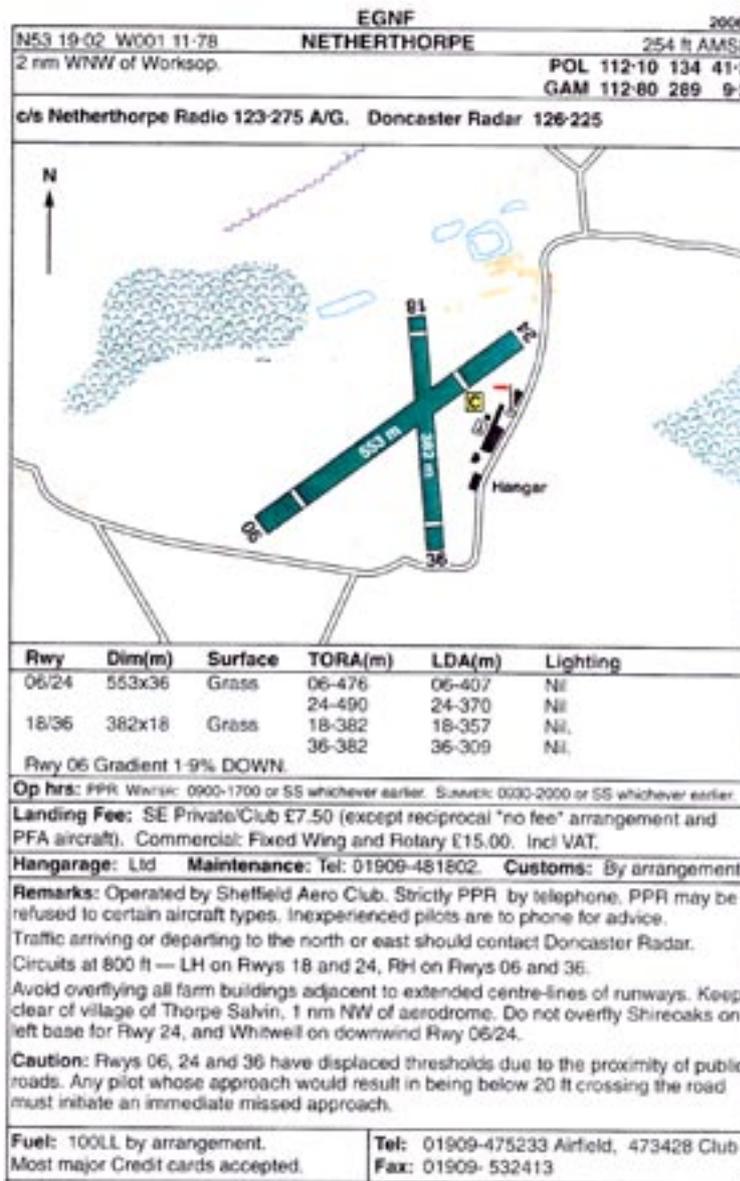
402
Published by kind permission of R Pooley
Figure 1

landed off the second approach to the same runway and took lunch in the clubhouse. The acting Chief Flying Instructor at Netherthorpe explained that both runways (06/24) were in operation as the wind was blowing directly across the runway and suggested that they used Runway 06 for departure due to its downhill slope¹. They accepted his suggestion and shortly afterwards taxied for Runway 06 which has a TORA of 476 m, Figure 1.

Runway 06 at Netherthorpe has a total runway length of 553 m and a TORA of 476 m. The TORA finishes 77 m from the end of the runway in order that departing aircraft can climb clear of any vehicles positioned on the public road adjacent to the airfield.

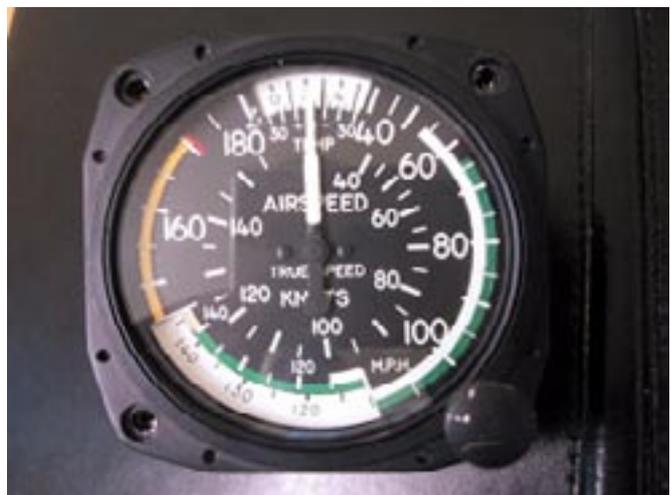
Figure 2

G-AZWE's air speed indicator. The larger figures are mph, the smaller figures are knots. Note that the legend 'KNOTS' is larger than that for 'MPH'.

² This type of ASI was implicated in an accident to a PA-28, G-OSOW, at Bournemouth International Airport. The report on this accident was published in the 8/2000 edition of the AAIB Bulletin.
