Boeing 757-236, EC-GCA, 23 January 1996

AAIB Bulletin No: 6/96 Ref: EW/C96/1/5 Category: 1.1

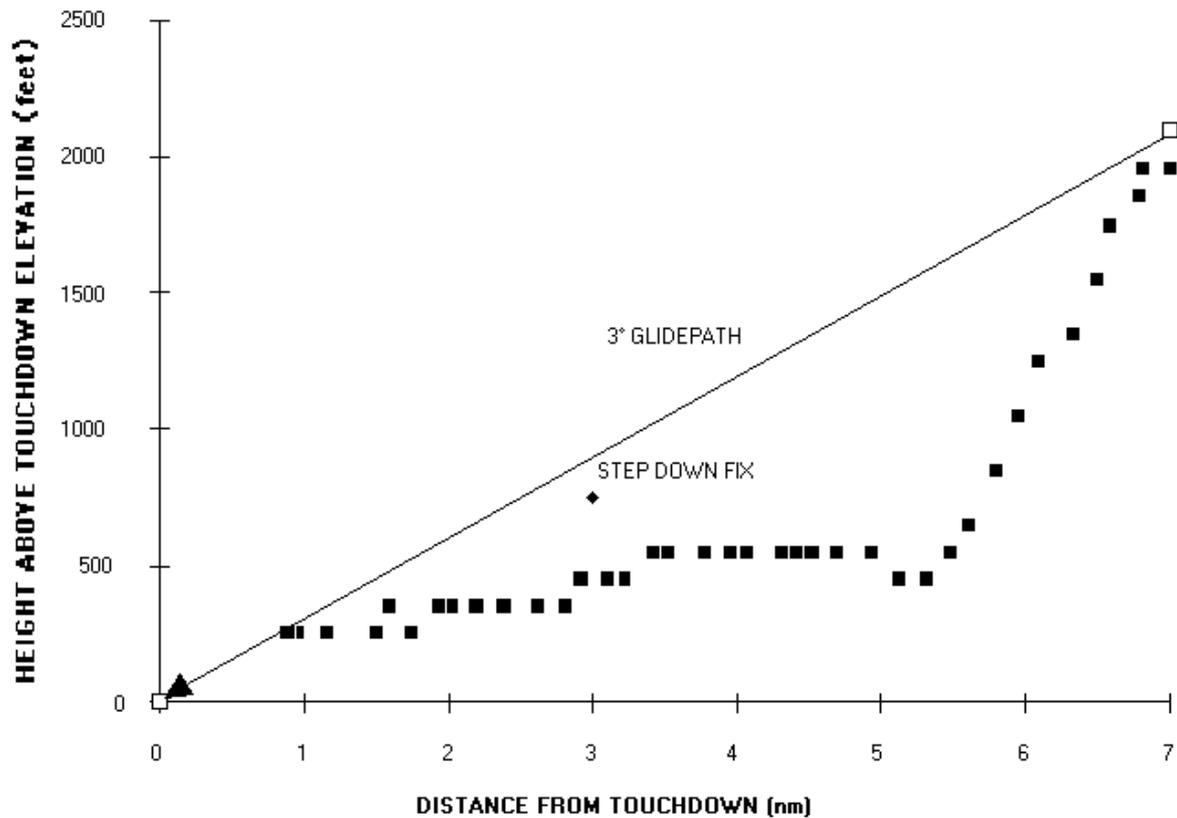
EC-GCA SRA 08 APPROACH BOURNEMOUTH 23 JAN 96

At 1250 hrs, the aircraft was approaching the 6.5 nm descent point for the SRA procedure. Landing clearance was issued to the aircraft and it was instructed to commence descent "to maintain a three degree glide path". The approach radar at Bournemouth is a secondary surveillance radar facility with altitude display. Between 6 nm and 5 nm from touchdown, the controller noted that EC-GCA had descended below the recommended descent profile. The crew was initially advised that they were "descending below the approved path" and then instructed on two occasions "do not descend any further". The descent profile of the aircraft, derived from the secondary radar data is shown below.

The commander's report into the incident indicated that the crew were under the impression that the approach was to be a radar-monitored NDB/DME approach, rather than an SRA. The MDA/H for this type of approach was 440 feet/400 feet, but there was NO Step Down Fix associated with the NDB/DME procedure. The aircraft did not comply with the Step Down Fix for the 08 SRA procedure.
