INCIDENT

Aircraft Type and Registration: Boeing 747-236B, G-BDXH

Date & Time (UTC): 3 February 1994 at 1650 hrs

Location: Manchester Airport

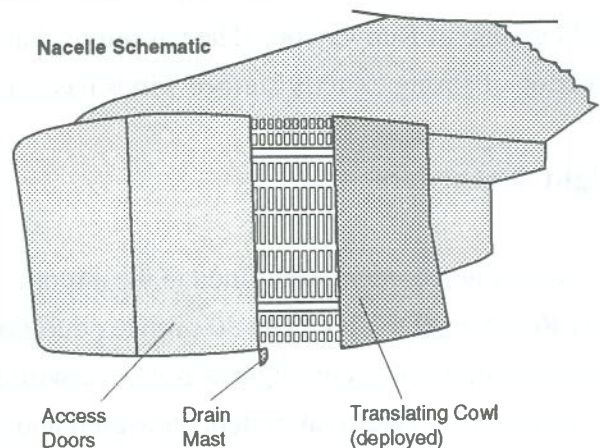
Checks showed that all tyres and landing gear oleos were at correct inflation pressures. Aircraft examination revealed that the underside of the No 4 engine nacelle had been heavily scraped and localised deformation had occurred. The nacelle comprises, from the front, a nose cowl, twin hinged access doors and a thrust reverser translating cowl. The aft edge of the access doors and the forward edge of the translating cowl, when in the forward thrust position, locate onto a fixed nacelle frame. In reverse thrust the translating cowl is driven rearwards approximately 0.8 metre to uncover a fan flow cascade assembly. The fixed frame carries a drain mast at the bottom that protrudes below the nacelle contour. The scraping chiefly affected the translating cowl, with an area approximately 1.1 x 0.8 metre of its under surface heavily abraded and locally distorted. In addition, a small area of the aft lower corner of the each of the access doors had been scraped, the drain mast had been bent backwards through 90° and the central frame had

been scraped and distorted. The damage pattern made it clear that the translating cowl had been well away from its forward thrust position when ground contact occurred, quite possibly in its fully deployed reverse thrust position. Measurements based on the assessed plane of the damage suggested roll and pitch angles of approximately 5.5° and 4.6°, respectively, close to the values recorded 3 seconds after touchdown.

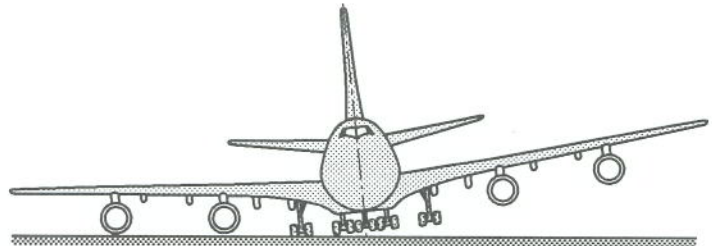
General Arrangement Schematic with Aircraft Rolled 6 ° Right, 0° Pitch angle

With the aircraft static and unladen the outboard nacelle ground clearance was measured as 1.8 metre. Because the swept wing places the outboard engine nacelles slightly behind the wing main landing gear this clearance would be somewhat reduced by aircraft nose-up pitch with one or both wing landing gears in contact with the runway, as well as by roll angle. Manufacturer's data showed that the DFDR recorded combination of 5.8° roll and 4.7° pitch occurring 3 seconds after initial touchdown was close to the envelope for simultaneous ground contact of a wing landing gear, with its oleo compressed, and the outboard nacelle. This was the only point during the landing and ground roll at which the pitch/roll angle combination approached the envelope. Nacelle ground clearance would also be affected by wing bending and torsional deflection due to dynamic loading, but this could not be adequately quantified in this case.

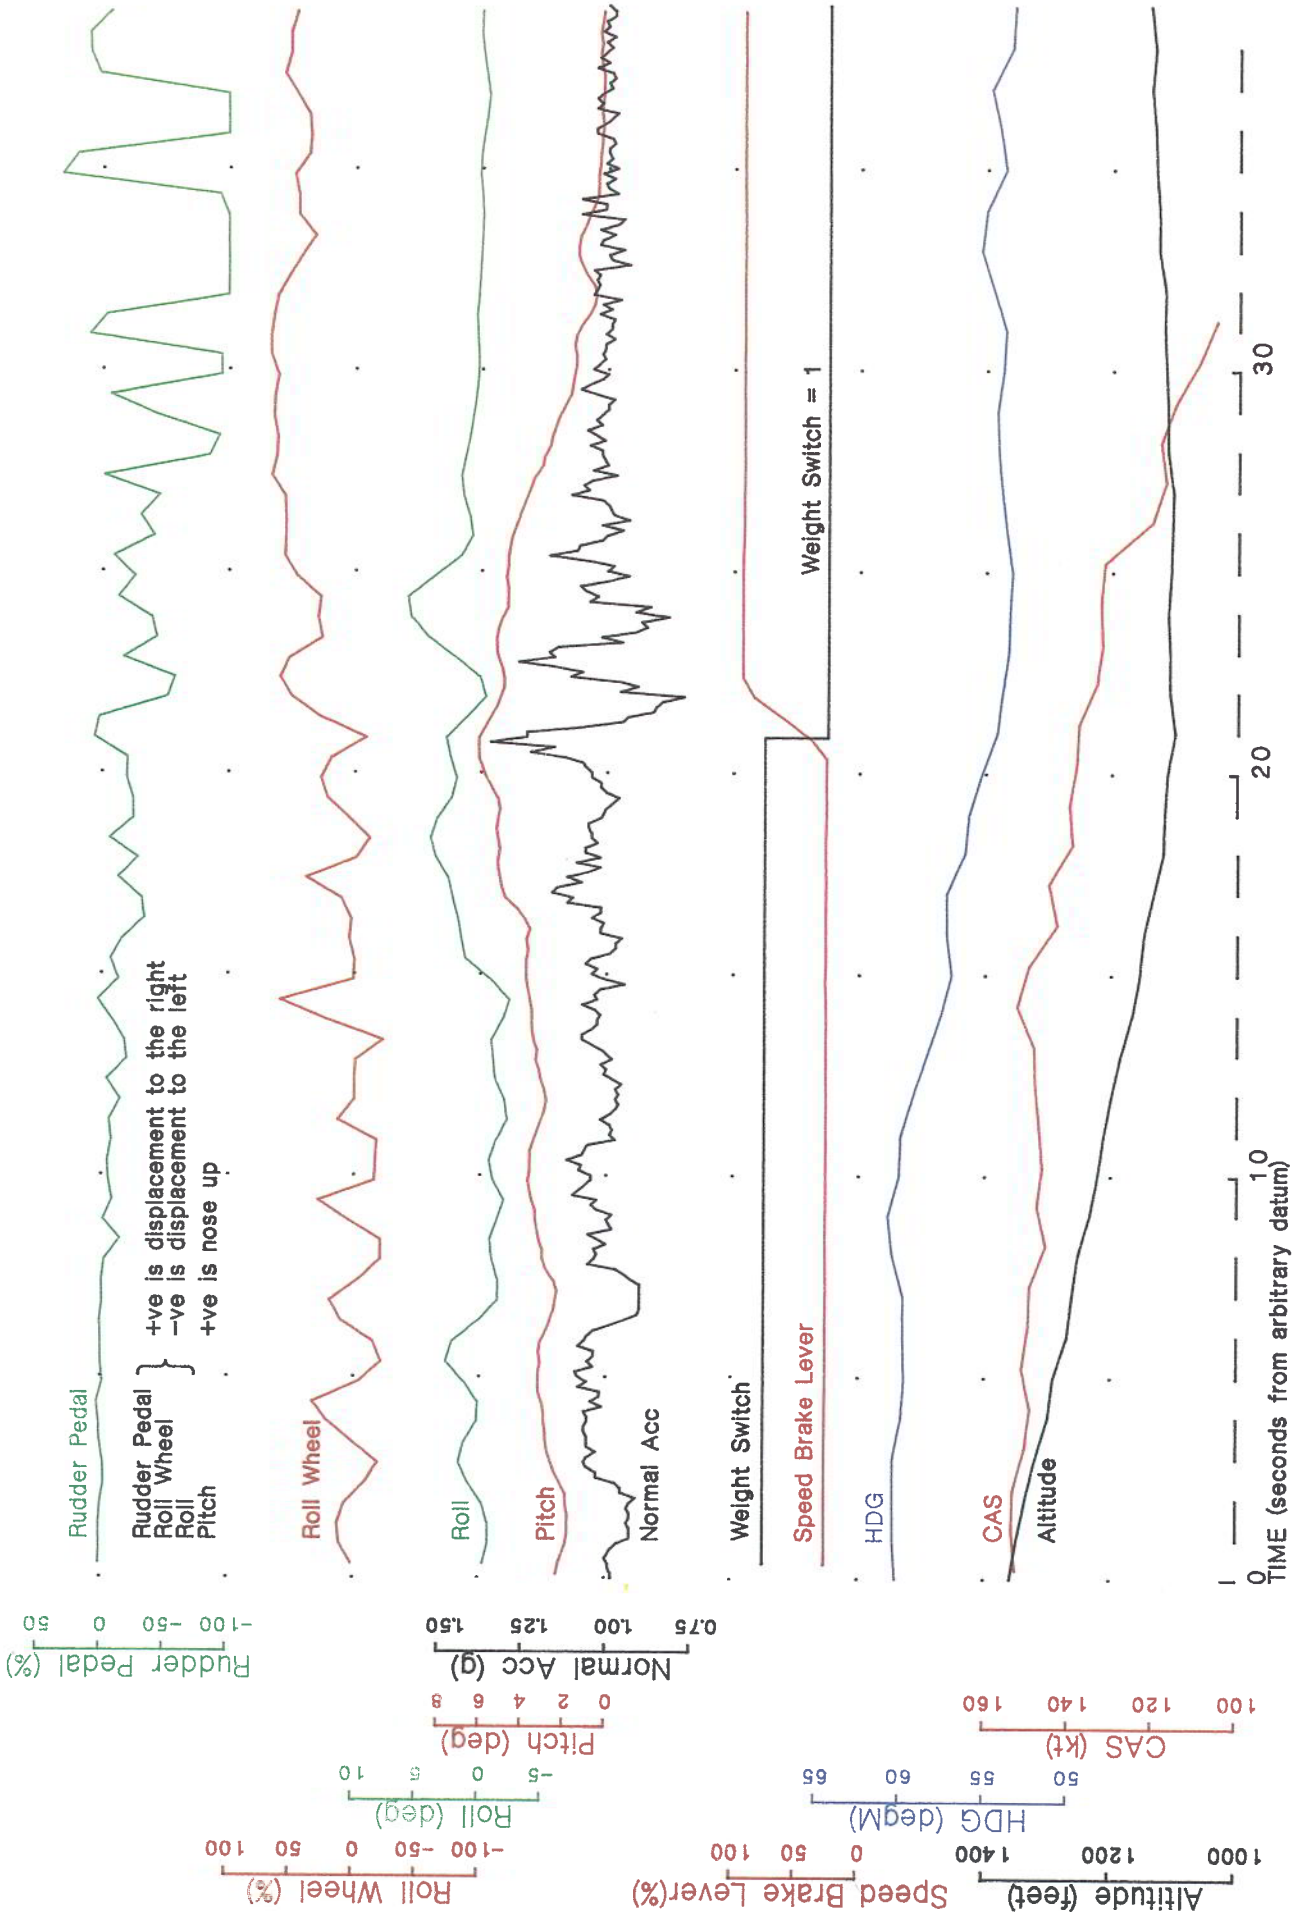
747-236B G-BDXH LANDING INCIDENT ON 3 FEBRUARY 1994

A plot of relevant recorded data, from 20 seconds before touchdown to 19 seconds afterwards, is at Figure 1. Altitude is referenced to 1013 mb. The landing gear weight switch was sampled once per second and took a value of 'one' when both a left and a right main truck were tilted to the landed position. Peak excursions in aircraft attitude may not have been recorded due to the sampling rates of pitch attitude, four times a second, and roll attitude, two times a second.

The final approach was flown on a heading of 60°M at a descent rate of 700 ft/min and a computed airspeed between 145 kt and 153 kt. The variations in normal acceleration and the degree of control inputs used indicate an approach in turbulent air. Two seconds before touchdown the roll attitude was 4° right wing down, left rudder was being applied and the pitch attitude had increased to 5.2°. The aircraft touched down firmly, banked 2.7° to the right with a pitch attitude at its recorded maximum of 6.1°. Within one second the speed brake lever had started to move and 'aircraft on ground' indications were being recorded. A normal acceleration of 0.75g indicates that the aircraft then bounced or lifted on its oleos before settling again, coincident with a control wheel input of 60% right wing down; two seconds later the aircraft's attitude was recorded as 5.8° right roll and 4.7° of pitch. Over the next 15 seconds large right wing down control wheel and rudder pedal inputs, at times full left rudder, were used to maintain the aircraft on a heading that averaged 55°M.
