## Piper PA-34-200 Seneca, G-EMER

<b>AAIB Bulletin No: 10/2004</b>	<b>Ref: EW/G2004/06/23</b>	<b>Category: 1.3</b>
<b>Aircraft Type and Registration:</b>	Piper PA-34-200 Seneca, G-EMER	
<b>No &amp; Type of Engines:</b>	2 Lycoming IO-360-C1E6	
<b>Year of Manufacture:</b>	1973	
<b>Date &amp; Time (UTC):</b>	29 June 2004 at 0950 hrs	
<b>Location:</b>	Old Sarum Airfield, Salisbury, Wiltshire	
<b>Type of Flight:</b>	Training	
<b>Persons on Board:</b>	Crew - 1	Passengers - None
<b>Injuries:</b>	Crew - None	Passengers - N/A
<b>Nature of Damage:</b>	Damage to both propellers, nose landing gear and nose cone	
<b>Commander's Licence:</b>	Licence not required (see below)	
<b>Commander's Age:</b>	59 years	
<b>Commander's Flying Experience:</b>	5,695 hours (of which 22 were on type)	
	Last 90 days - 27 hours	
	Last 28 days - 10 hours	
<b>Information Source:</b>	Aircraft Accident Report Form submitted by the pilot and further AAIB enquiries

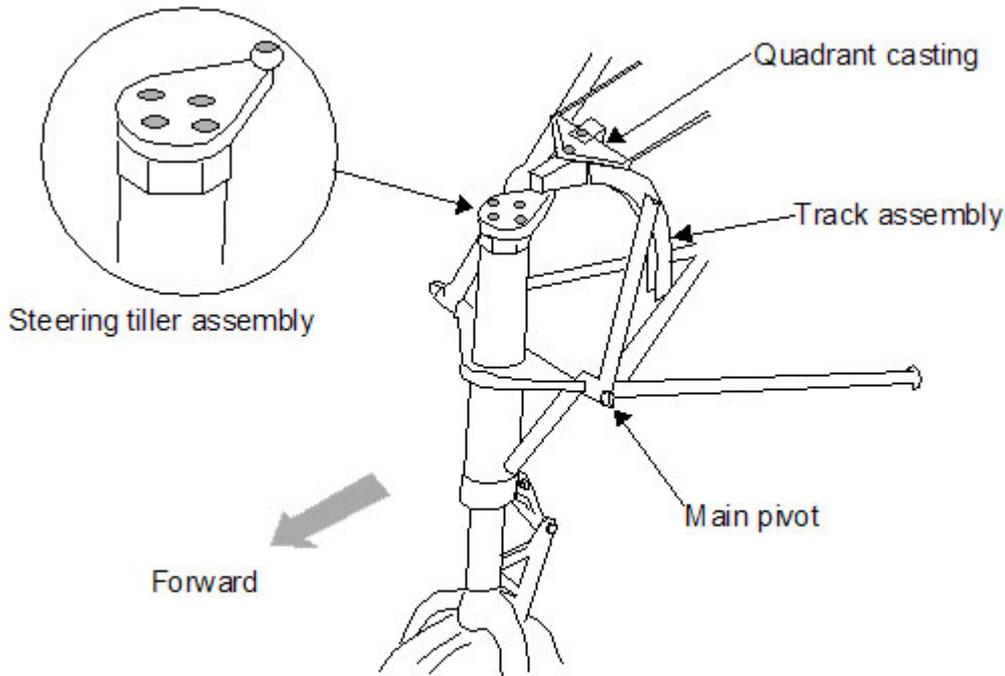
**Figure 1 Nose landing gear - general arrangement**

Mounted on the upper end of the nose leg is a tiller assembly, attached to which is a roller assembly. This roller sits within a curved track which it follows as the gear leg is raised (see Figure 1).

The track assembly itself is made up of two sections. The lower section is fixed to the aircraft structure, whilst the upper section is attached to a hinged quadrant casting, to allow for nose wheel steering. This quadrant is attached by cables to the steering arm. With the gear locked down, the roller assembly remains within the upper hinged section of track, movement of which is transmitted to the nose wheel from the quadrant via the tiller. As the nose landing gear starts to retract, the nose wheel and tiller is centred automatically, and the hinged and fixed sections of track line up, allowing the roller assembly to follow the track as the nose leg retracts.

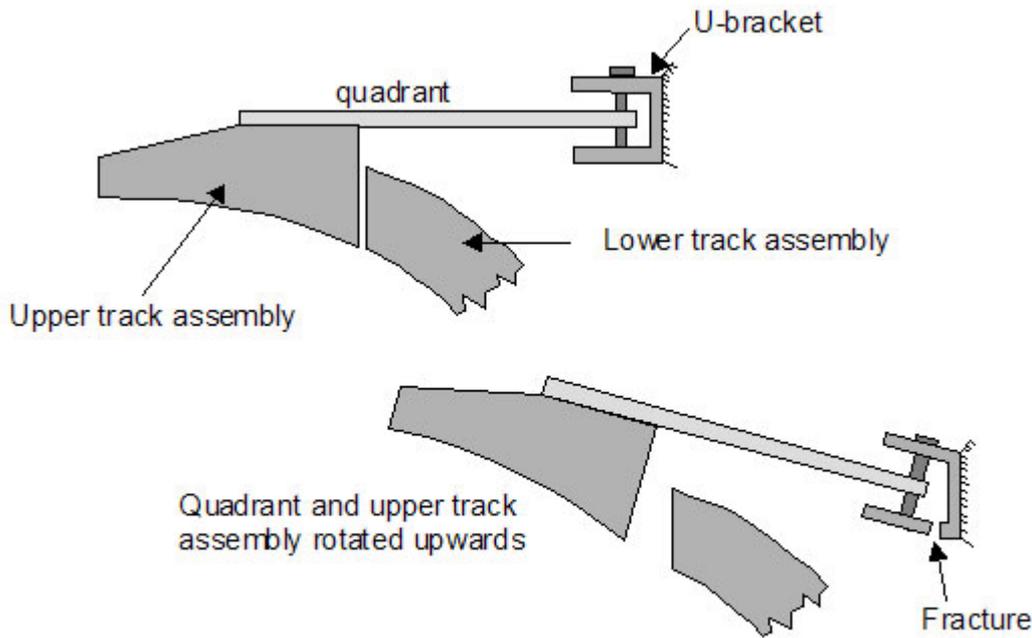
**Figure 2 Quadrant Assembly - side view**

Inspection of the nose landing gear assembly showed that the lower arm of the U-bracket had fractured, allowing the quadrant casting and the upper section of track to pivot upwards (see Figure 2). This in turn placed bending loads on the upper arm of the U-bracket that showed initial signs of failure as a result of these loads. The two fracture faces had suffered significant abrasion and it was not possible to determine the reason for the fracture.

The roller assembly, which would normally be captive within the track assembly, was found to be out of the track, and against the outer side of the track mounting.

With the quadrant and the hinged section of track able to pivot upwards, a larger than normal gap formed in the channel of the curved track assembly. With the nose landing gear down and locked, this had no effect, as the roller assembly was still captive within the upper track section, which was still able to transmit steering commands to the nose wheel via the tiller. However, as the nose leg commenced retraction, the roller assembly moved along the track until it encountered the gap, at which point it left the channel and continued aft and down in contact with the outside of the track mounting. The leg continued to retract until, still short of the fully up position, the loads associated with the abnormal condition of the leg could no longer be overcome by the hydraulic actuator.

The accident was caused by the failure of the U-bracket which allowed the nose landing gear roller assembly to leave the guide track, making it impossible to lock the nose landing gear down.
