ACCIDENT

Aircraft Type and Registration:	Schweizer 269C-1, G-LINX	
No & Type of Engines:	1 Lycoming HIO-360-G1A piston engine	
Year of Manufacture:	2006	
Date & Time (UTC):	22 September 2009 at 1103 hrs	
Location:	East bank of River Wyre, near Stalmine, Lancashire	
Type of Flight:	Training	
Persons on Board:	Crew - 1	Passengers - 1
Injuries:	Crew - 1 (Fatal)	Passengers - 1 (Fatal)
Nature of Damage:	Aircraft destroyed	
Commander's Licence:	Commercial Pilot's Licence	
Commander's Age:	38 years	
Commander's Flying Experience:	1,524 hours (of which 894 were on type) Last 90 days - 59 hours Last 28 days - 12 hours	
Information Source:	AAIB Field Investigation

Synopsis

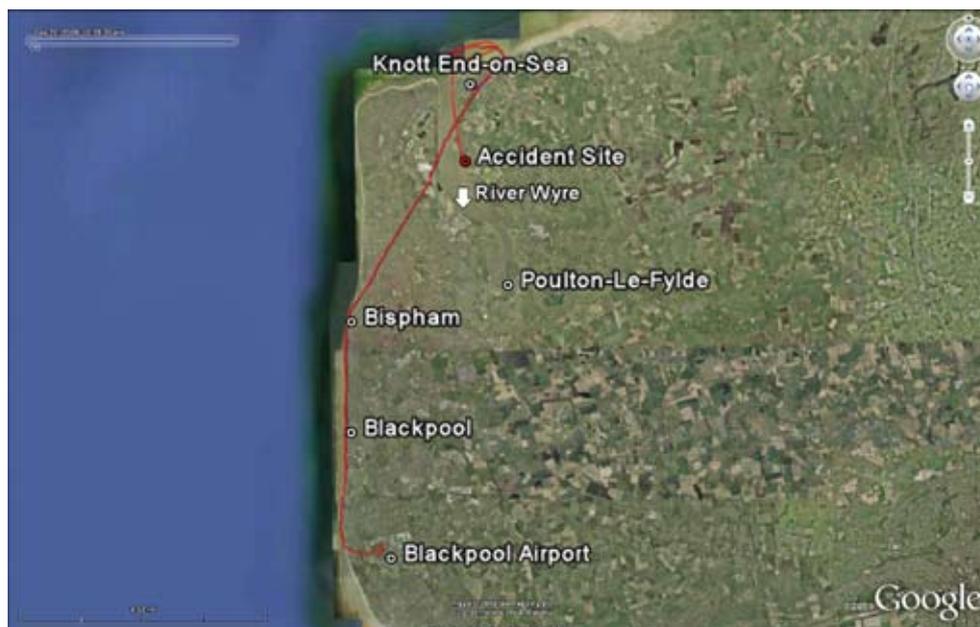
Figure 1

G-LINX –Radar track

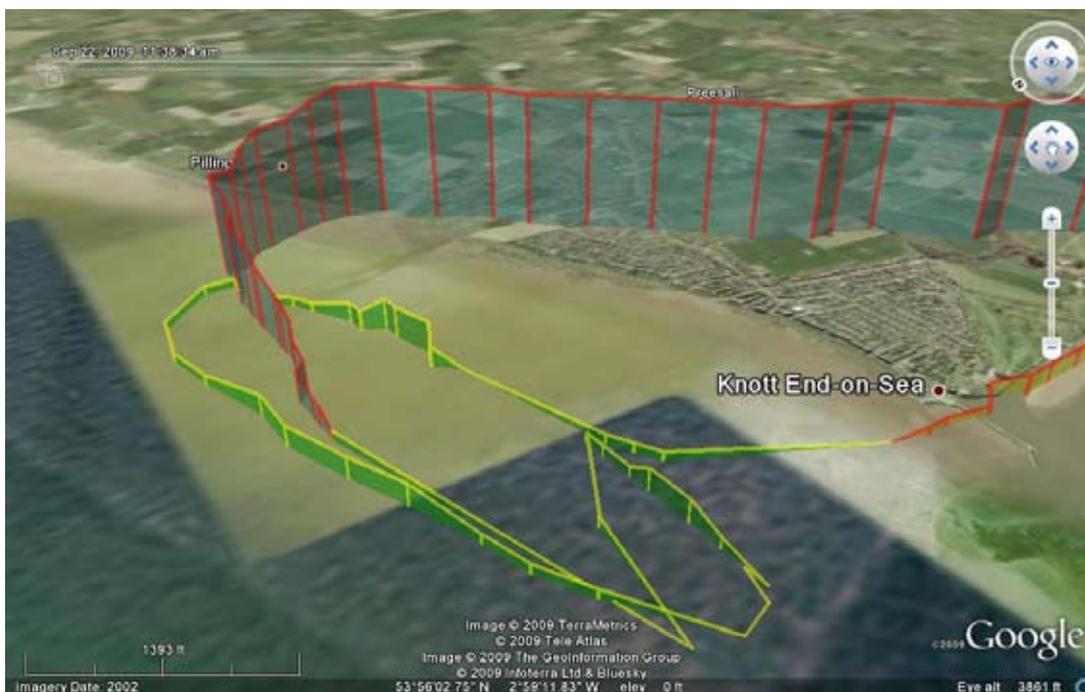
Figure 2

flew in a predominantly right-hand circuit direction, at heights not above about 400 ft. During this period the helicopter climbed and descended twice (Figures 2 and 3). Both descents occurred whilst heading into wind. During the first descent, the average descent rate was 1,570 ft/min +/- 786 ft/min and the second was 1,570 ft/min +/- 524 ft/min. The average ground speeds during both descents were similar, at about 35 kt, giving an airspeed of approximately 50 to 55 kt in the prevailing conditions.

G-LINX - Flight in the vicinity of Knott End-on-Sea

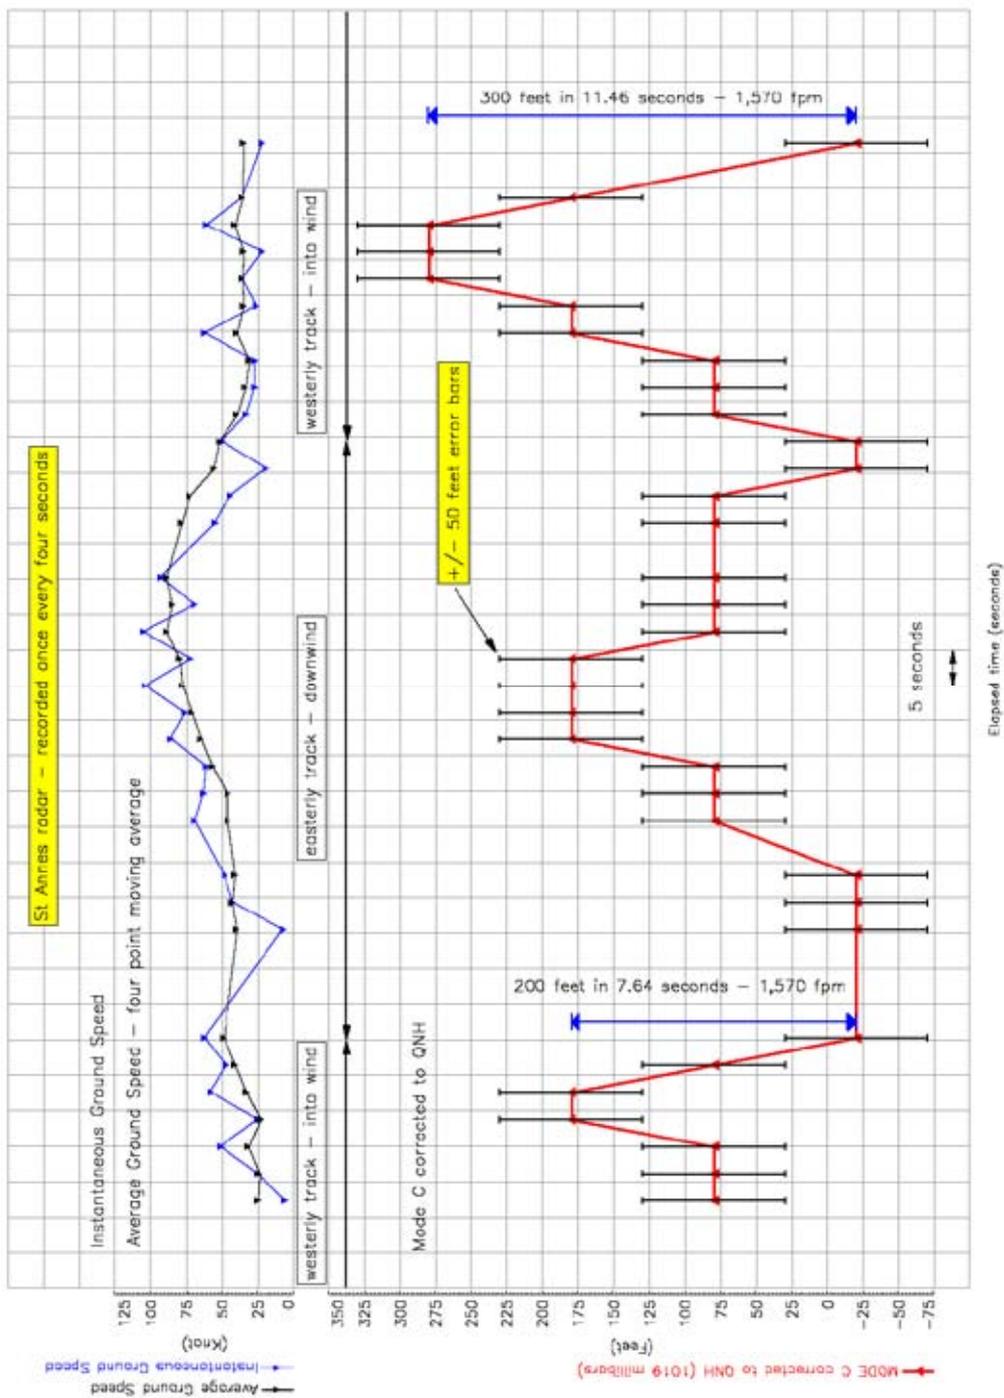
Figure 3

G-LINX - Flight in the vicinity of Knott End-on-Sea

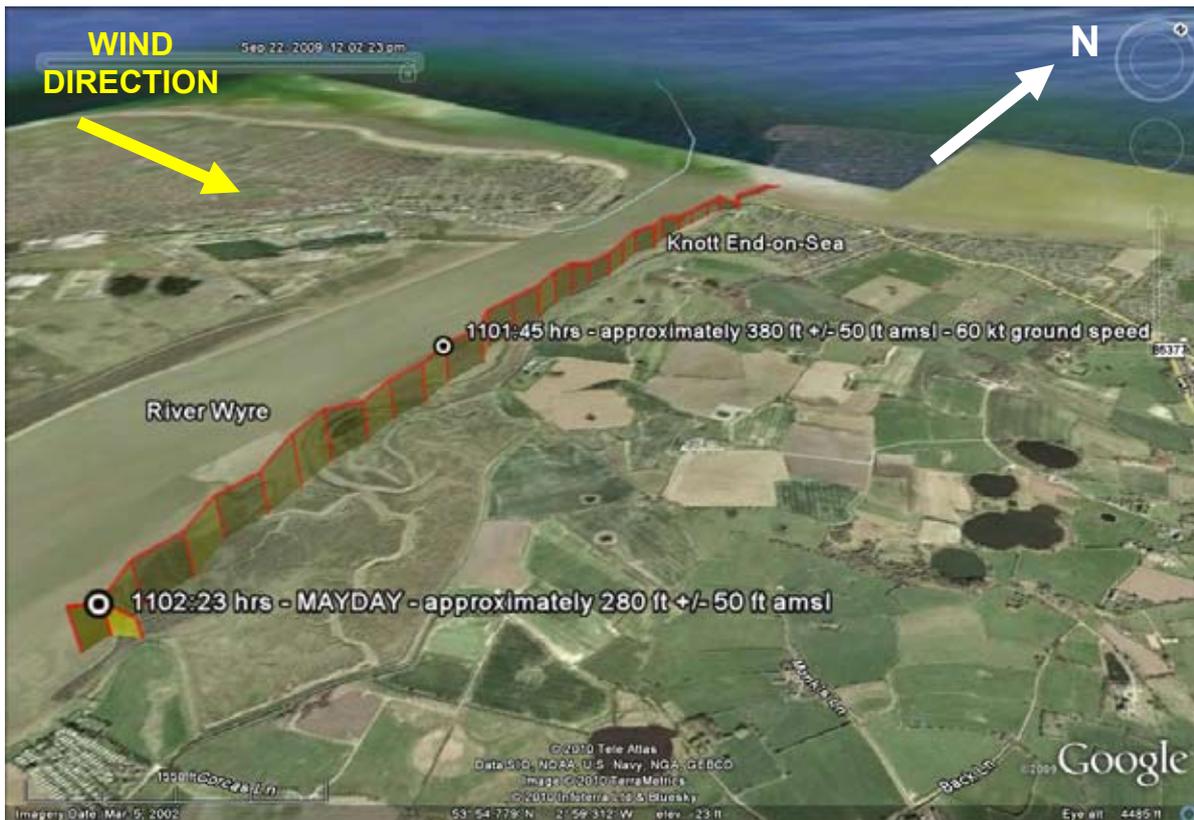
Figure 4

indicating that G-LINX was at about 430 ft. The ground speed remained stable at about 60 kt after departing the area near Knott End (Figures 4, 5 and 6).

G-LINX - Flight from Knott End-on-Sea

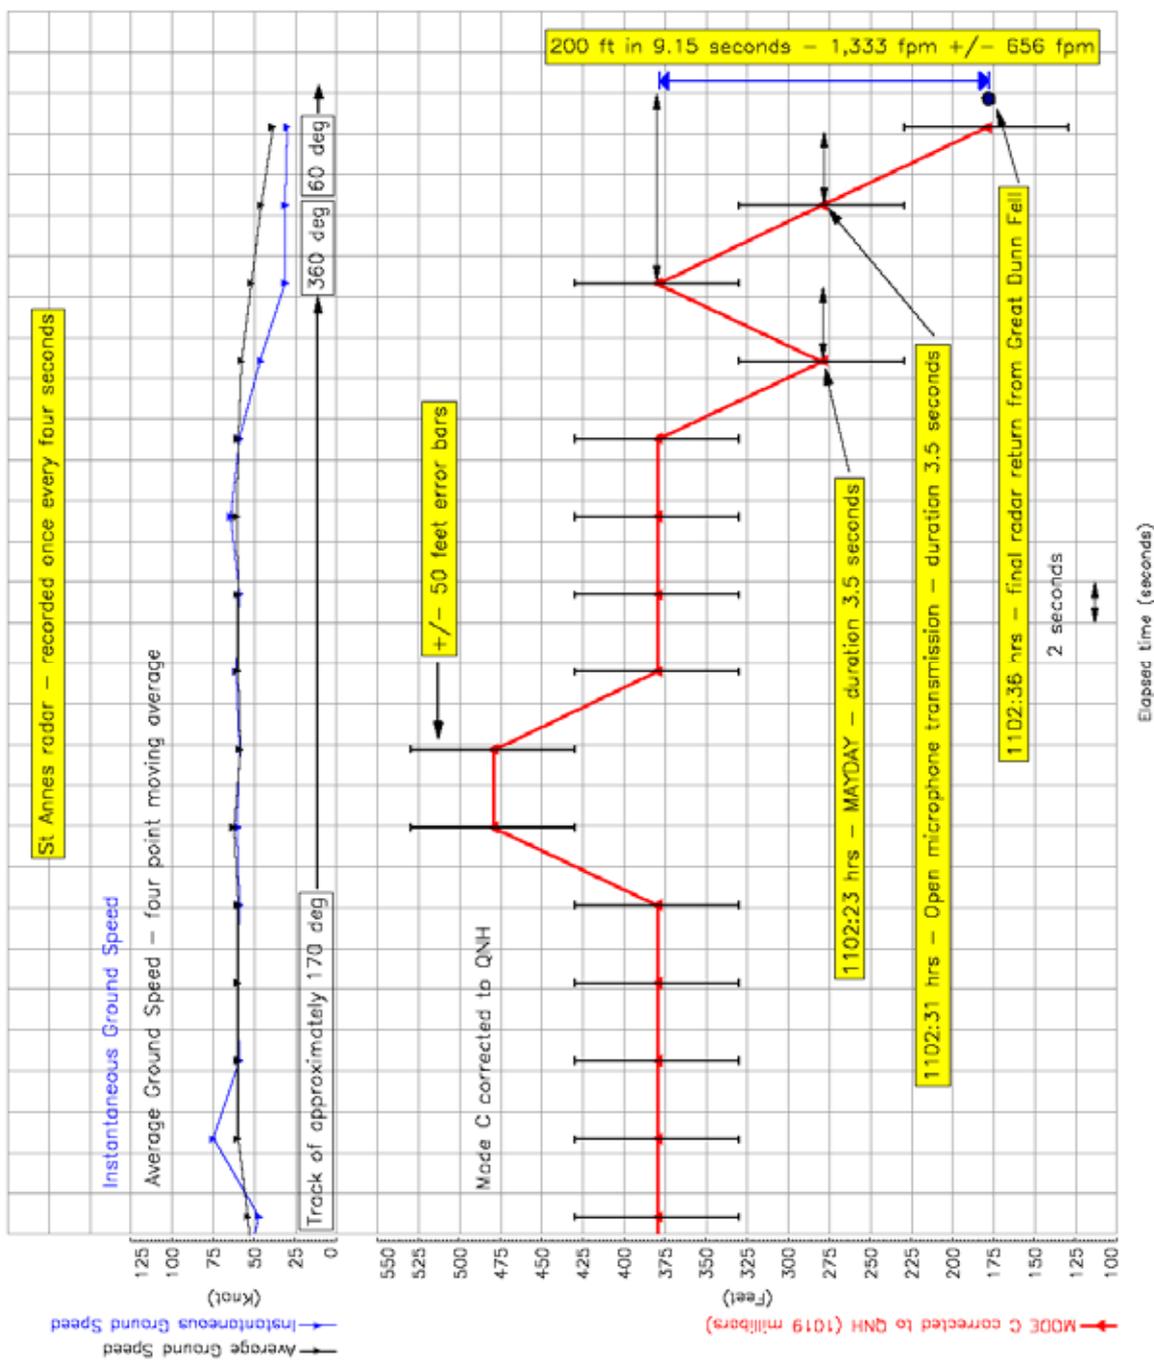
Figure 5

G-LINX - Flight from Knott End-on-Sea

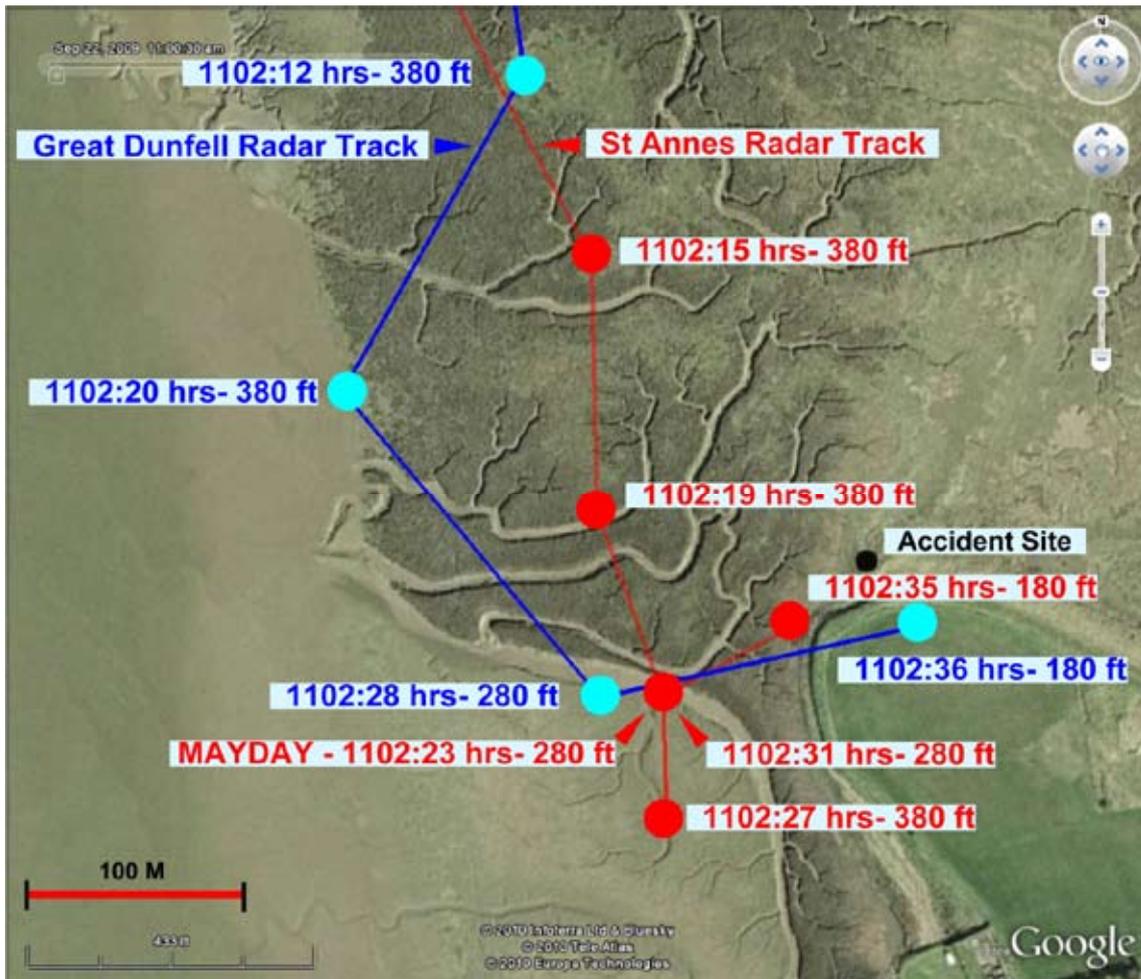
Figure 6

At 1102:23 hrs, the instructor transmitted a MAYDAY on the Blackpool Approach frequency. At that moment the helicopter was at a height of approximately² 280 ft +/- 50 ft, and its average ground speed had reduced from 60 kt to 45 kt. During the next 13 seconds, its ground speed stabilised at about 30 kt and the helicopter altered track to the east and descended. It was then approximately 0.5 nm east of the west (upwind) bank of the River Wyre. The final radar point, recorded at 1102:36 hrs, indicated the helicopter was at a height of about 180 ft +/- 50 ft. The average descent rate during the final nine seconds of data was 1,311 ft/min +/- 656 ft/min.

G-LINX – Final radar positions

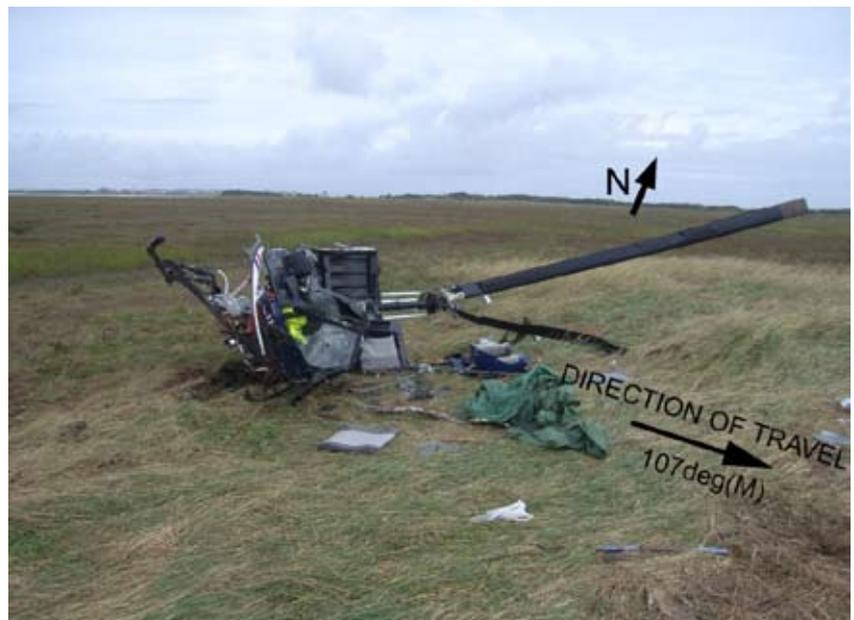
Figure 8

The helicopter had struck the ground on the eastern bank of the River Wyre, 1.2 nm west of Stalmine. It was located in a grassy area of soft ground that sometimes floods at high tide. On the day of the accident the high tide occurred at 1320 hrs (UTC) at which time the river came to within a few metres of the wreckage but did not reach it. The evidence at the accident site indicated that the helicopter had hit the ground with a high vertical speed and a very low forward speed, on a heading of approximately $173^\circ(\text{M})$. There was a very limited spread of wreckage, mostly consisting of broken pieces of perspex, in the direction of $107^\circ(\text{M})$ (Figure 8), which

indicated that the helicopter had some sideways travel to the left at the time of impact. The furthest piece of wreckage, a piece of perspex, was located 16 m east of the main wreckage. The left skid had broken, the right skid had splayed outwards and both seat pans had been crushed, indicating that the helicopter had not initially struck the ground on its left side, but that it had rolled onto its left side after impact in a moderate left bank.

The three main rotor blades were intact with no damage to their leading edges, trailing edges or tips, indicating that they had little rotational energy at impact. One rotor blade was bent upwards, one was bent downwards, and the third had multiple bends and wrinkles from impact with the ground. Chordwise mud splatter on the tips of the blades indicated that some rotation was present at impact. The tail rotor gearbox had remained attached to the tail boom and both tail rotor blades were attached to the gearbox. One tail rotor blade was undamaged, and the other, which was buried, had a damaged tip. The

Accident site - parts of the cabin structure have been removed and the green tarpaulin was placed on the ground after the accident

horizontal stabiliser was undamaged. The tail boom had bent and split about 70 cm forward of the tail rotor gearbox, and the tail rotor driveshaft had sheared at the same location, although it did not exhibit evidence of a high-energy torsional failure. The eight transmission drive-belts were intact, although they had lost their tension as a result of failure of the H-frame supporting the upper and lower pulleys.

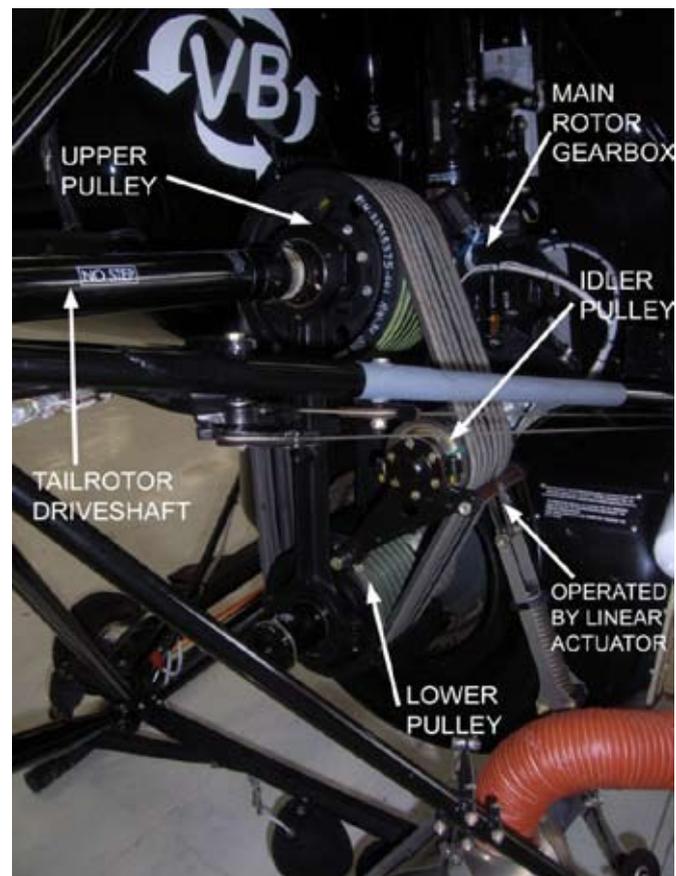
Figure 9

freely on its bearing. The eight belts were intact and in good condition, but tension had been lost as a result of overload failure of the H-frame between the upper and lower pulleys. Failure of this H-frame was consistent with the high vertical loads experienced at impact. The linear actuator which drove the 'idler' pulley was measured to be in the fully retracted position, corresponding to full belt tension having been applied. The main rotor gearbox and tail rotor gearbox chip detectors were found to be clean.

Schweizer 269C-1 transmission assembly
