ACCIDENT

Aircraft Type and Registration:	Cessna 401, N401JN	
No & Type of Engines:	2 Continental TSIO-520-E5B piston engines	
Year of Manufacture:	1966	
Date & Time (UTC):	21 January 2007 at 1206 hrs	
Location:	Blackpool Airport, Lancashire	
Type of Flight:	Private	
Persons on Board:	Crew - 2	Passengers - None
Injuries:	Crew - None	Passengers - N/A
Nature of Damage:	Right wing, right landing gear and right propeller damaged	
Commander's Licence:	Private Pilot's Licence	
Commander's Age:	58 years	
Commander's Flying Experience:	1,091 hours (of which 531 were on type) Last 90 days - 6 hours Last 28 days - 3 hours	
Information Source:	AAIB field investigation

Synopsis

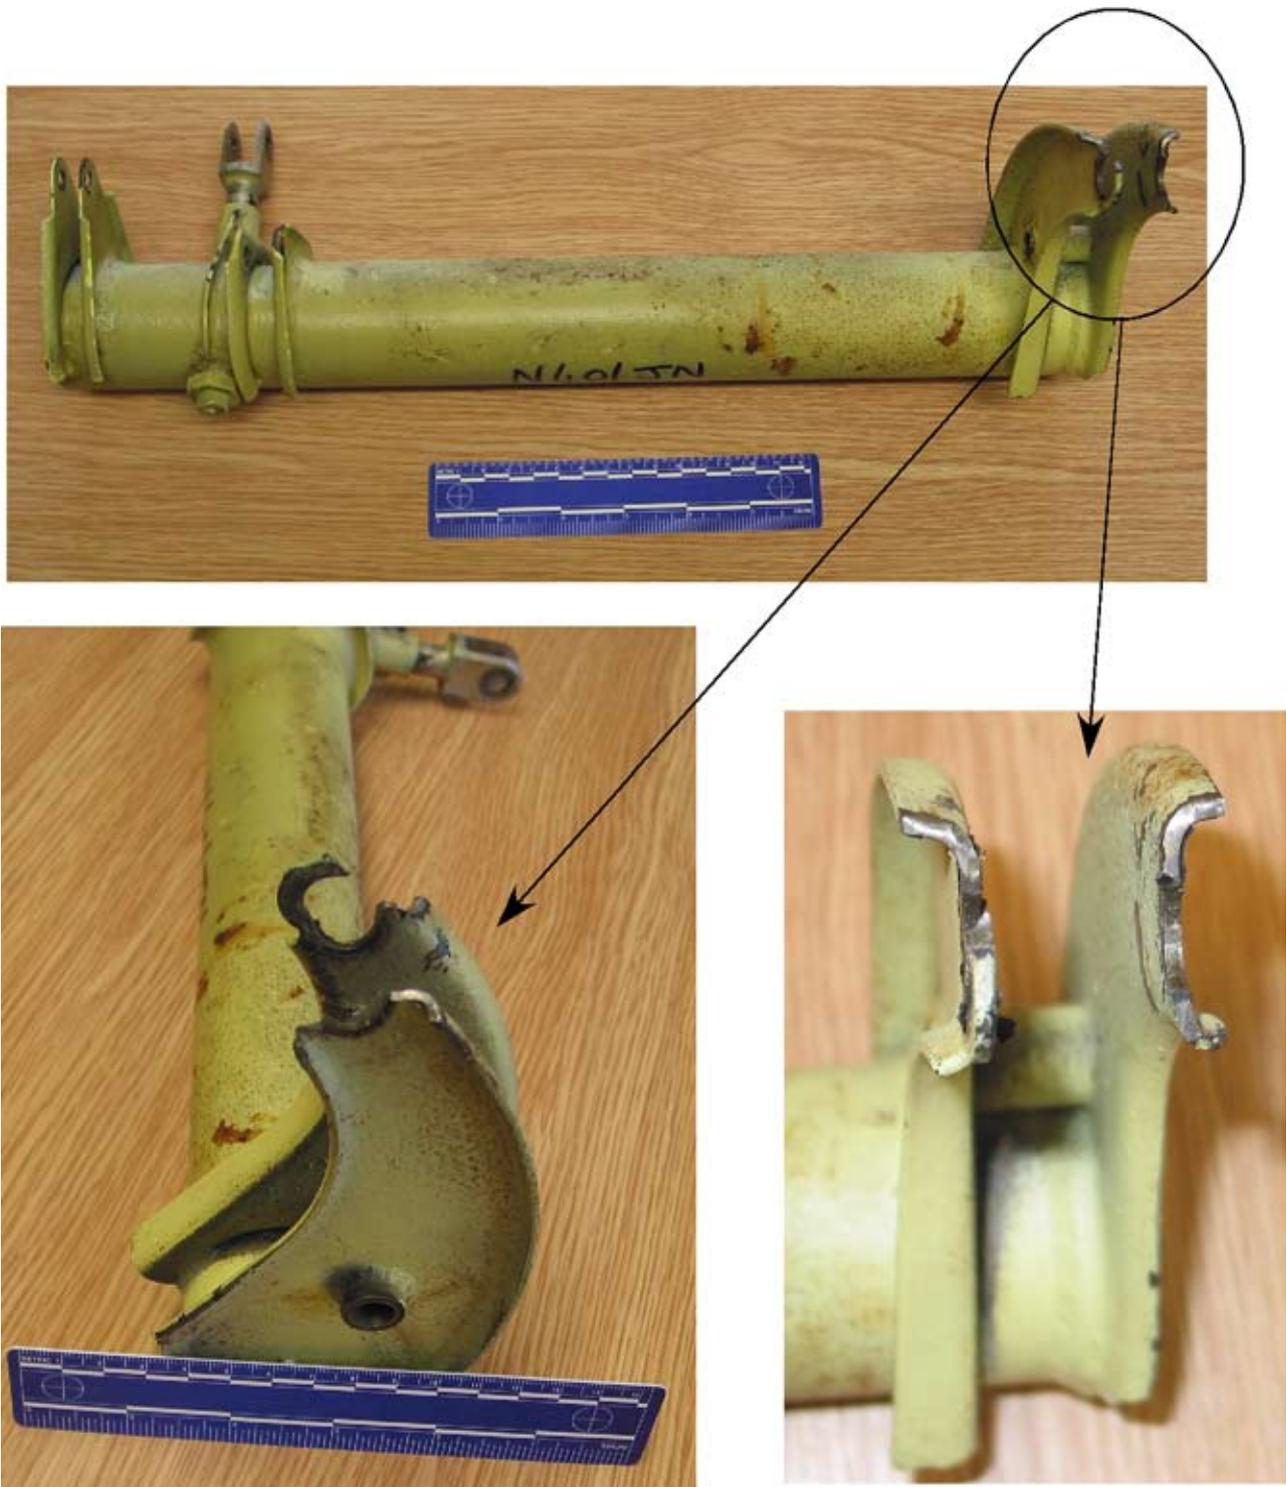
**Figure 2**

The aircraft was recovered from the runway and taken to a local hangar where it was found that the right main landing gear torque attachment holes had failed, (see

Figure 2). The failure was such that the pushrod that provided drive to the torque tube from the electrical retract/extend actuator had disconnected.

Failed right MLG torque tube removed from N401JN

The gear collapsed due to a failure of the arm attachment holes of the right main landing gear torque tube. The arm attachment holes had failed due to an initial fatigue

crack followed by a rapid overload. The fracture caused the pushrod from the electrical extend/retract actuator to disconnect and it is likely that this fracture occurred as the gear was extended for landing. Following the landing, a side load on the right gear caused it to collapse.

It is recommended that the Federal Aviation Administration mandate Cessna SID 32-10-05 for the Cessna 401/402 main landing gear torque tube, and mandate similar Cessna SIDs relating to main landing torque tubes of similar design.

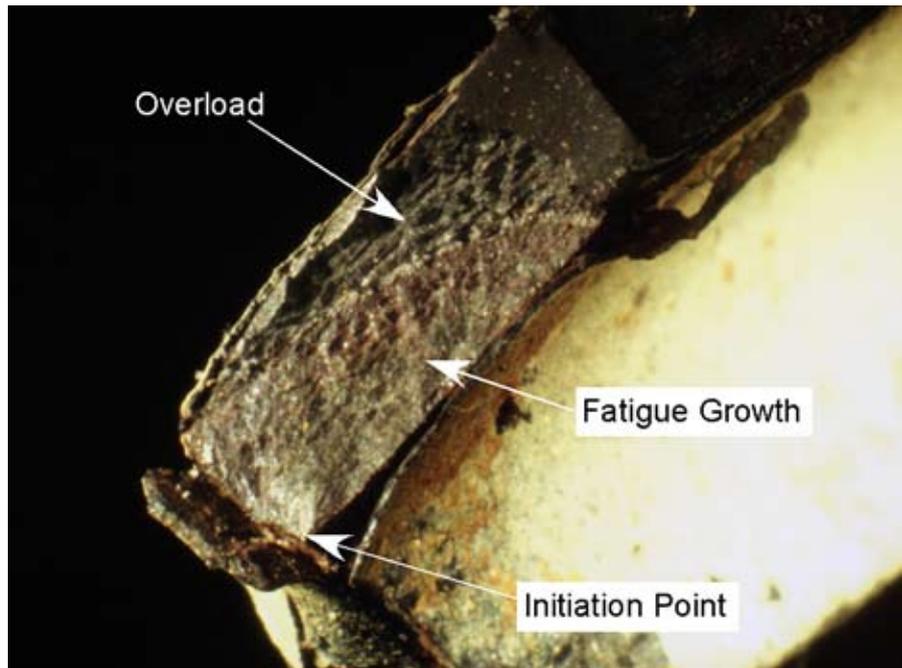
Figure 3

The torque tube was removed from the aircraft and sent for detailed metallurgic examination. This revealed a slow progressive fatigue failure, followed by a rapid overload, (see Figure 3). The fatigue crack striations indicated that it had suffered up to 250 cycles before the final overload. Each cycle was probably related to an extension/retraction cycle of the landing gear.

Microscopic image of the initiation and fatigue crack growth

It could not be determined what caused the initiation of the crack in the arm attachment holes, although, it had been present and growing for a considerable time. The fatigue striations indicate that the crack had been present over 250 cycles, estimated as being since May 2001. There was no specific mandatory requirement to inspect the torque tube and its location on the aircraft made it difficult to carry out a visual inspection. To detect the crack would have required removal of the torque tube and an NDI.
