Christen Eagle II, G-EEGL

AAIB Bulletin No: 4/2004	Ref: EW/C2003/11/10	Category: 1.3
Aircraft Type and Registration:	Christen Eagle II, G-EEGL	
No & Type of Engines:	1 Lycoming AEIO-360-A1D piston engine	
Year of Manufacture:	1985	
Date & Time (UTC):	16 November 2003 at 1535 hrs	
Location:	Andrewsfield, Great Dunmow, Essex	
Type of Flight:	Private	
Persons on Board:	Crew - 2	Passengers - None
Injuries:	Crew - None	Passengers - N/A
Nature of Damage:	Substantial damage to propeller, landing gear and underside of left lower wing	
Commander's Licence:	Private Pilot's Licence	
Commander's Age:	47 years	
Commander's Flying Experience:	372 hours (of which 101 were on type)	
	Last 90 days - 31 hours	
	Last 28 days - 7 hours	
Information Source:	Aircraft Accident Report Form submitted by the pilot and examination of the aircraft by the AAIB

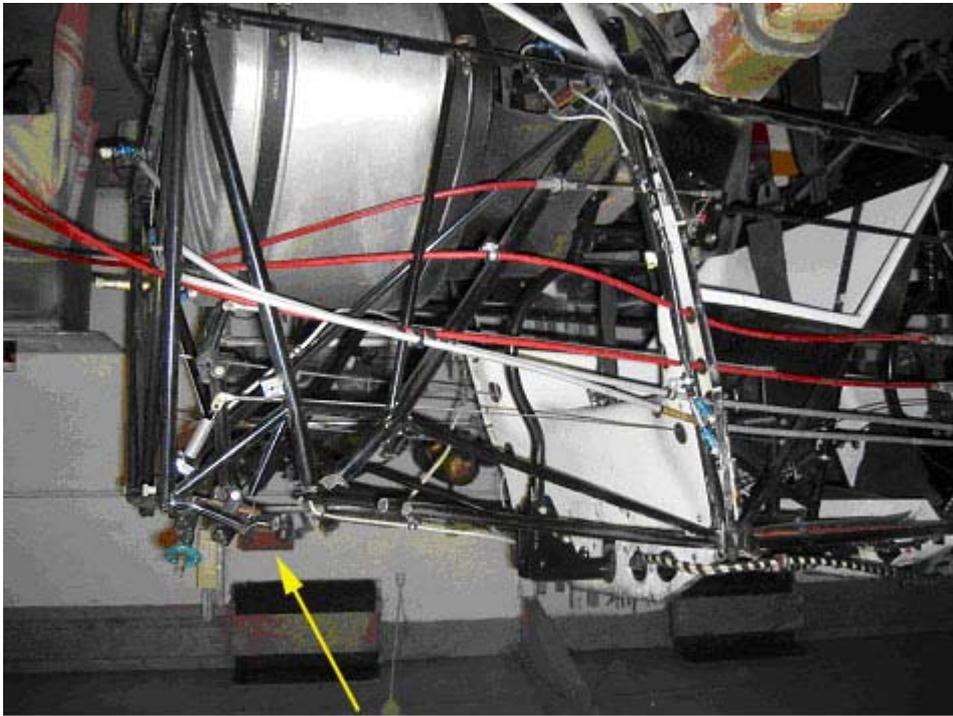
Figure 1 - Damage to tubular steel structure around spring beam attachment (cross bar removed)

The aircraft was examined in conjunction with the repair agency, paying particular attention to the tubular structure in the area of the spring beam attachment bar. A number of the tubes and their welded attachments to the cross bar had failed due to overload in a vertical direction. It was noted that corrosion had occurred on some of the fractures and in the internal bores of the tubes. The four 'nyloc' nuts attaching the left stub axle to the spring beam had detached, stripping their threads, and the bolts had deformed as a result of a combination of rearwards and vertical loads.

Whilst the degree of plastic deformation indicated that the failures occurred due to overload, the presence of corrosion suggested the possibility of damage occurring on successive landings. However, some time had elapsed between the accident and the examination of the aircraft by the AAIB. Furthermore, no evidence of damage in this area was noted by the Popular Flying Association (PFA) Inspector when the aircraft was inspected for its Permit renewal in October 2003.

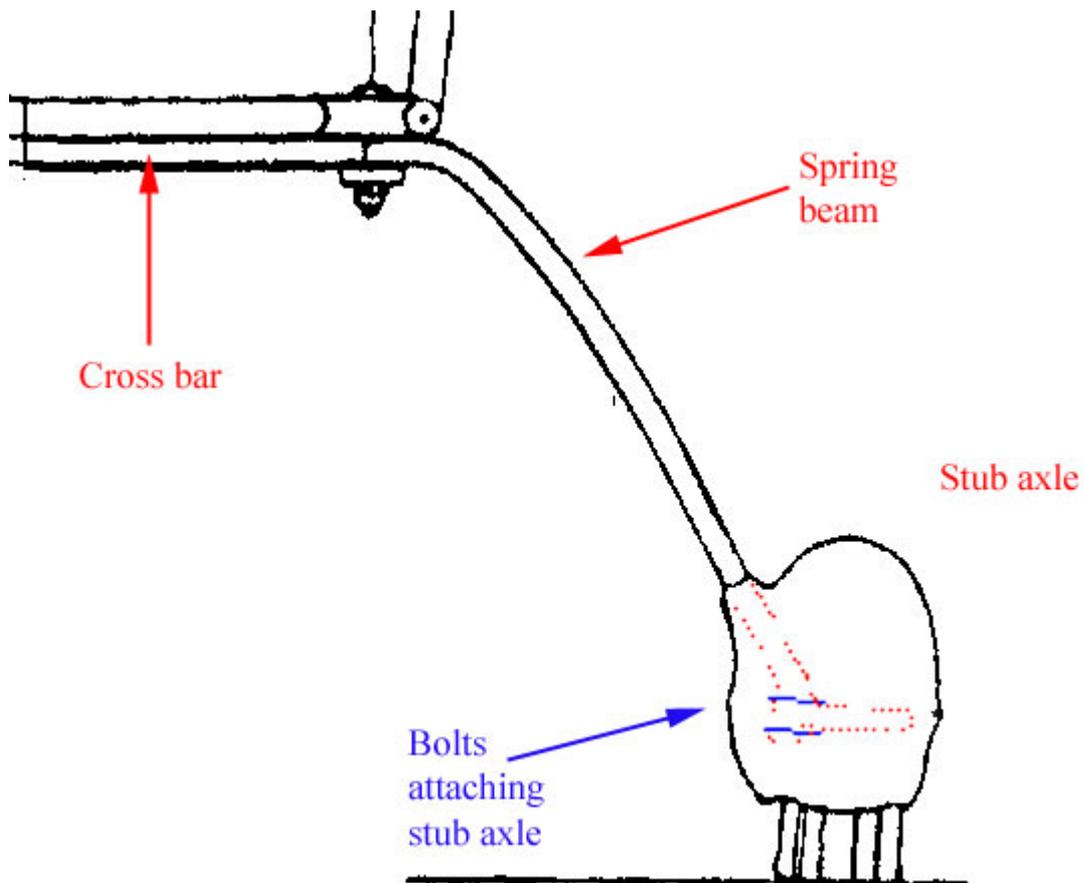
The aircraft fuselage has a tubular steel structure covered by fabric at the rear and aluminium alloy panels at the front. The main landing gear consists of a spring beam, which is bolted to the fuselage cross bar on the underside of the forward fuselage (see Figures 1 and 2). Stub axles, carrying the wheels, are attached to the spring beam ends.

Figure 2 - Landing gear arrangement left side (viewed from front)
