SERIOUS INCIDENT

Aircraft Type and Registration:	Boeing 777-236, G-YMMP	
No & Type of Engines:	2 Rolls-Royce RB211 Trent 895-17 turbofan engines	
Year of Manufacture:	2001	
Date & Time (UTC):	14 June 2010 at 1617 hrs	
Location:	Singapore International Airport	
Type of Flight:	Commercial Air Transport (Passenger)	
Persons on Board:	Crew - 12	Passengers - 202
Injuries:	Crew - None	Passengers - None
Nature of Damage:	Extensive damage at rear of right engine nacelle and further airframe damage	
Commander's Licence:	Airline Transport Pilot's Licence	
Commander's Age:	44 years	
Commander's Flying Experience:	14,770 hours (of which 4,934 were on type) Last 90 days - 192 hours Last 28 days - 79 hours	
Information Source:	AAIB Field Investigation

Synopsis

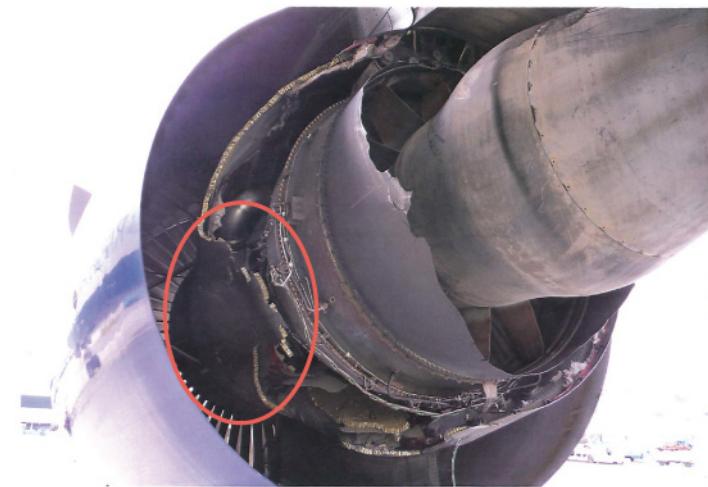
Figure 1

The operator and the airframe manufacturer made initial assessments at Amsterdam of the damage to the aircraft. It was clear that the left inner wall 'D-duct' on the right engine thrust reverser had separated from its engine and that a large portion of the turbine exhaust nozzle was missing (Figure 1). There was also damage to the inboard flap fairing and flaperon, consistent with the separation of the items from the engine, with scraping and gouge damage on the right lower wing skin and the right horizontal stabiliser.

The manufacturer's initial examination indicated that buckling damage to the inner wall D-duct was consistent with a:

'typical of loss of stability due to disbond of inner facesheet'

Thrust reverser buckled inner wall and missing nozzle

the separation of the turbine exhaust nozzle had been caused by the failure of the duct structure as the inward collapse of the inner wall applied bending loads to the nozzle supporting structure.

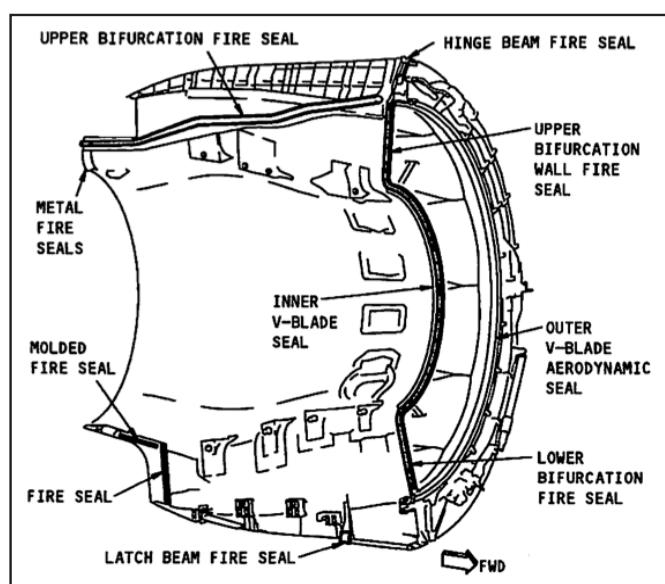
Figure 3

Location of thermal blanket seals in fan duct cowl
(courtesy Boeing)

without the thermal barrier. The barrier consists of thermal insulation blankets installed in the area bounded by the fire seals in Figure 3.

The integrity of the blanket-to-blanket seal, the blanket penetration seals and the blanket edge seals is critical to the success of the thermal barrier protection and to the preservation of the structural integrity of the thrust reverser inner wall. The maintenance manual states that large amounts of hot (leaked) compressor air:

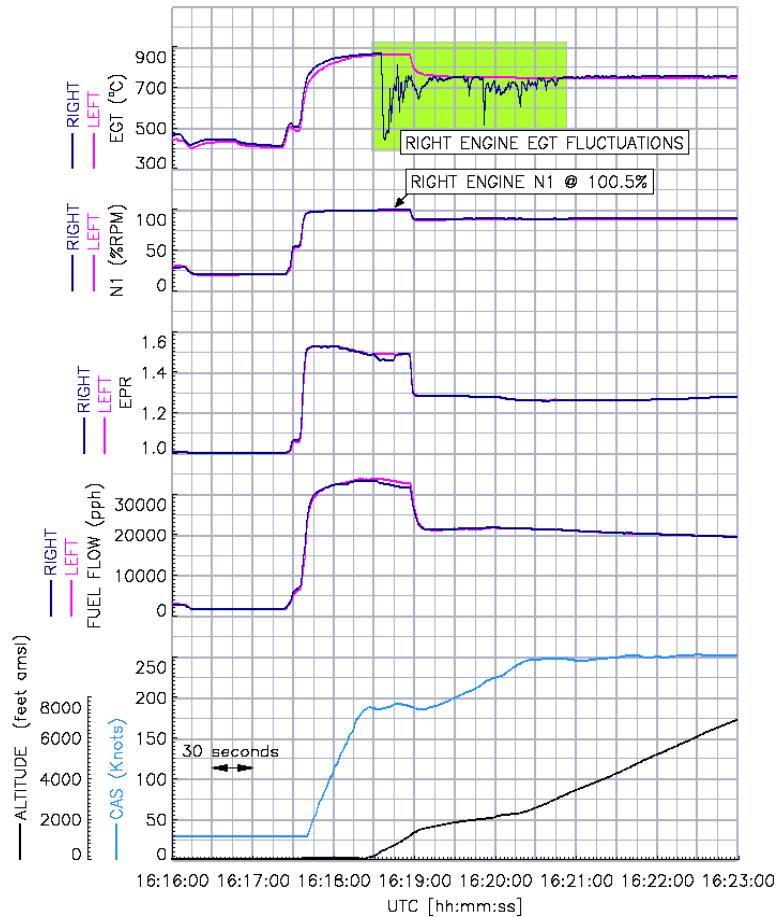
Data downloaded from the flight data recorder (FDR) for the incident flight is presented in Figures 4 & 5. Figure 4 shows the takeoff and climb to 7,000 ft amsl from Singapore International Airport. At 1618:35 hrs, as the aircraft climbed through 500 ft, the right engine

Figure 4
FDR data for the takeoff, showing right engine fluctuations

N1 increased from a nominal 99% to 100.5% and the left engine remained at 99%. At the same time, the right engine EGT dropped from 867°C to 448°C and then fluctuated around 700°C for about 130 seconds, before rising to 750°C; the left engine EGT remained steady at 865°C, dropping smoothly to 750°C as the engine thrust was reduced to climb thrust.

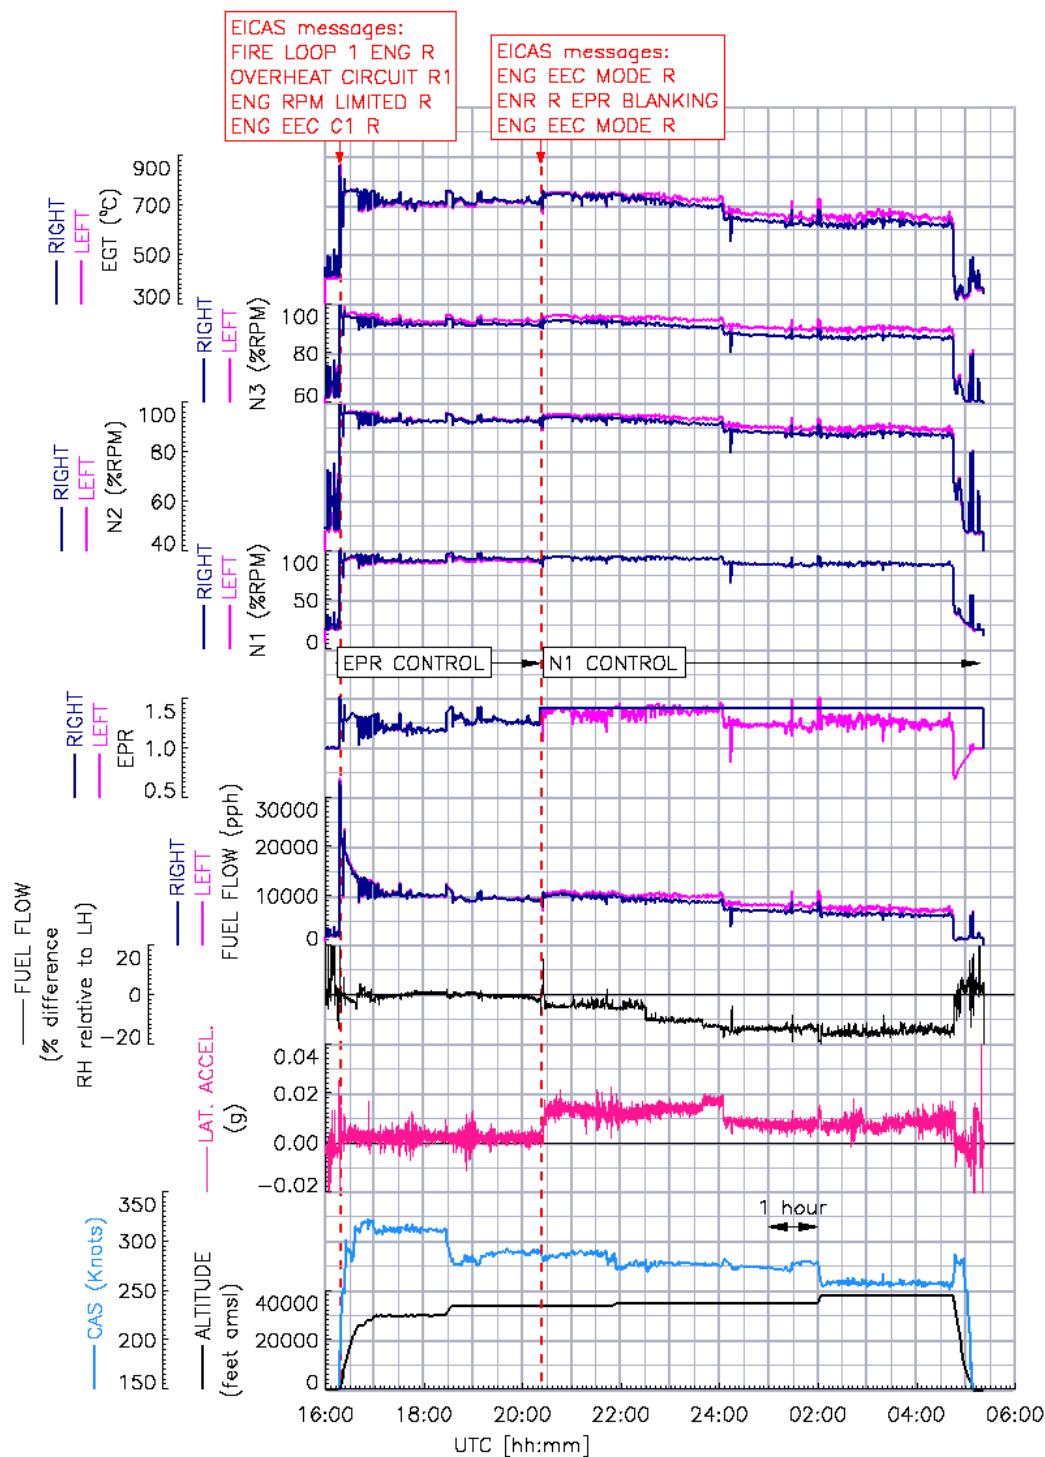
Figure 5
Salient FDR parameters of incident flight

Figure 5 shows data for the complete flight to London Heathrow Airport. Also indicated on Figure 5 are the EICAS messages displayed to the crew. These messages were recorded on the Maintenance Message Data Report, downloaded from the EICAS after the flight. The first set of messages were at 1618 hrs during the time of the right engine EGT fluctuations. However, the report only records the time for each message as hours and minutes so the exact timing is unknown. For the next four hours the EPRs and fuel flow for both engines were matched but small discrepancies between the engines were recorded for N1 (1 to 3.5%RPM), N2 (0 to 1%RPM), N3 (1 to 2%RPM), and EGT (0 °C to 8°C).

The second set of EICAS messages occurred at 2023 hrs, approximately four hours into the flight, as the right engine EPR signal was lost. It was at this point the engines switched from Normal EEC mode ('EPR') to Alternate EEC mode ('N1'). From this point onwards the engine N1s were matched but discrepancies between the engines (left greater than right) were recorded for fuel flow, N2, N3 and EGT. In particular, a 5% difference in fuel flow was measured, increasing in steps to 15% by the end of the cruise portion of the flight. Also recorded was a lateral asymmetry to the right: rudder trim (not shown) was only used between 0254 and 0320 hrs, when 0.05 inches of left rudder trim actuator movement was recorded.

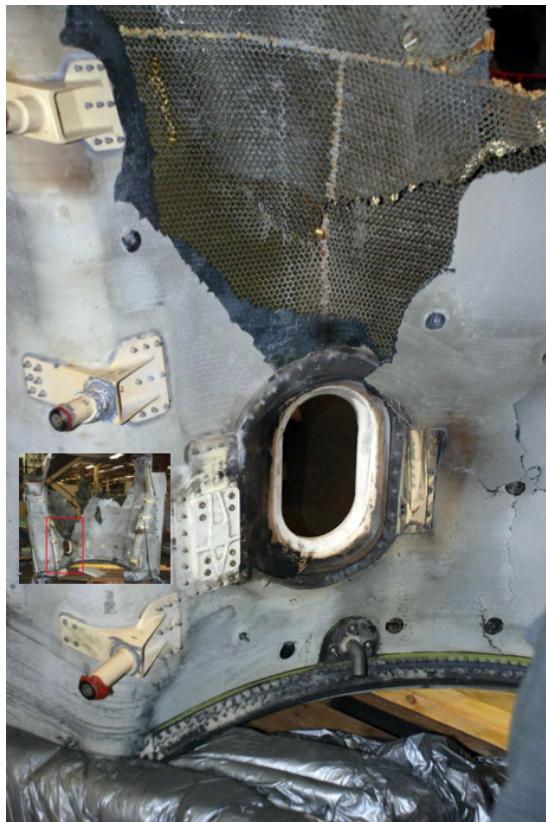
During this examination the manufacturer identified several locations with clear indications of thermal exposure and disbond. Of those, the location of greatest interest was around the drag link fitting, immediately above the HP3 cutout (Figure 6). This was among the more discoloured areas, and it was clearly included in the disbonded region of the panel. The discolouration of

other areas of the inner wall was evidence of overheating at those locations, but the manufacturer reported that discolourations outside the disbond region associated with the panel collapse were '*unlikely to be implicated in the failure*' of the panel. This was consistent with the manufacturer's initial assessment at Amsterdam.

The manufacturer further noted significant characteristics of the disbonded surface. These included areas with low bond strength, as evidenced by small fillet scars and/or adhesive failure between the honeycomb core and the facesheet, and a region of significantly overheated adhesive between the drag links next to the HP3 cutout.

Figure 6
HP3 duct disbond location

As a result of the initial incidents, in February 2005 the aircraft manufacturer issued Service Bulletins 777-78A0059 and 777-78-0060. These SBs principally involved one-time inspections of the thrust reverser inner wall, insulation blankets, compression pads, and drag link fittings (-059), and the application of sealants (-060).

Following further events at other operators, one of which was on an airframe which had SBs -059 and -060 correctly completed, an additional Service Bulletin, 777A78-0065 was issued in June 2008, requiring recurring inspections. Initial inspection of the blanket sealing on G-YMMP was carried out on 5 February 2010 and a repeat inspection was carried out on 14 May 2010, with no significant damage reported.

The airframe manufacturer issued a further, and extensive, Service Bulletin in late 2009, 777-78-0071, stating that the existing thermal protection system was insufficient to prevent damage to the inner wall of the thrust reverser and incorporating a new thermal protection system to reduce the temperatures experienced by the inner wall during flight. There was some initial delay in the approval by the EASA of the design change included within this Service Bulletin, as EASA was requesting further data and design substantiation from the airframe manufacturer, and the design change had not been fully approved at the time
