**No: 1/89**

**Ref: EW/C1072**

Cessna F150K, G-AYEY

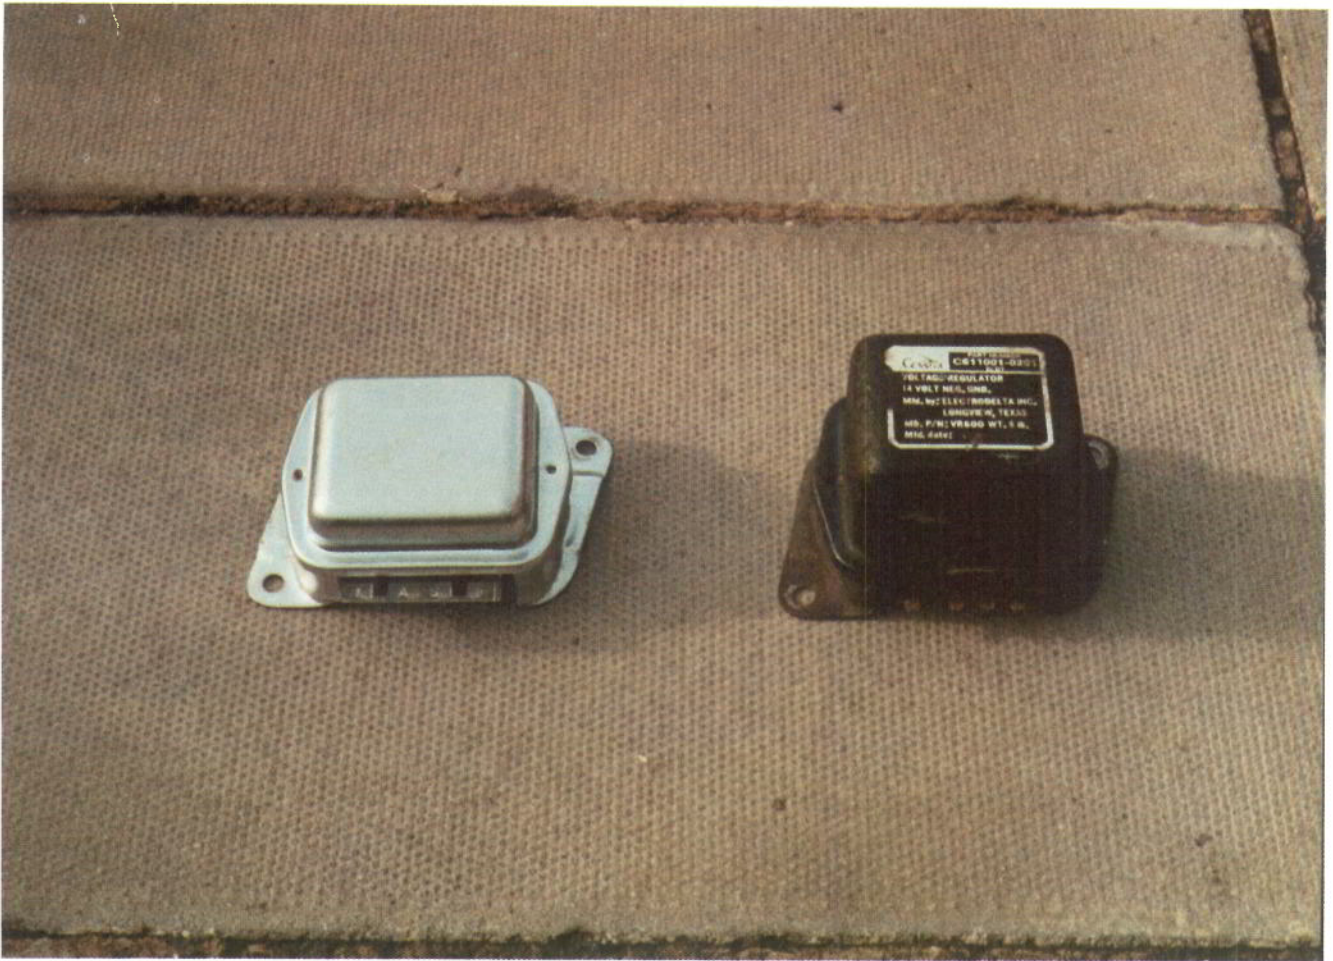
Rig testing was carried out on the alternator and voltage regulator. The alternator was found to perform correctly but when the voltage regulator was placed in circuit with it no charge was produced. Internal examination of the regulator revealed that it had suffered severe heating damage to part of a circuit board. It was also noted that the regulator, although interchangeable with that originally fitted (ie having similar mountings and connectors) was different in design. In particular, the original unit incorporated an electro-mechanical relay, whereas the unit installed in the aircraft was a wholly solid-state device. Examination of the exterior of the unit revealed no identification of any sort, although examination of the circuit boards of both units suggested that they were intended to perform similar functions. The considerable difference in their designs, however, appears to have accounted for their different behaviour under failure conditions. The maintenance company which installed the regulator was unable to establish how the component had entered their stores system and it has so far not been possible to determine its origin.

Unidentified Voltage Regulator  
Found in G-AYEY After Accident

Regulator Type Normally  
Installed In These Aircraft
