ACCIDENT

Aircraft Type and Registration:	Corben Junior Ace Model E, G-BSDI	
No & Type of Engines:	1 Continental Motors Corp A75-8F piston engine	
Year of Manufacture:	1981	
Date & Time (UTC):	25 February 2012 at 1200 hrs	
Location:	White Ox Mead Airstrip, near Bath	
Type of Flight:	Private	
Persons on Board:	Crew - 1	Passengers - None
Injuries:	Crew - None	Passengers - N/A
Nature of Damage:	Main landing gear cross-member broken	
Commander's Licence:	National Private Pilot's Licence	
Commander's Age:	64 years	
Commander's Flying Experience:	320 hours (of which 60 were on type) Last 90 days - 12 hours Last 28 days - 6 hours	
Information Source:	Aircraft Accident Report Form submitted by the pilot

Synopsis

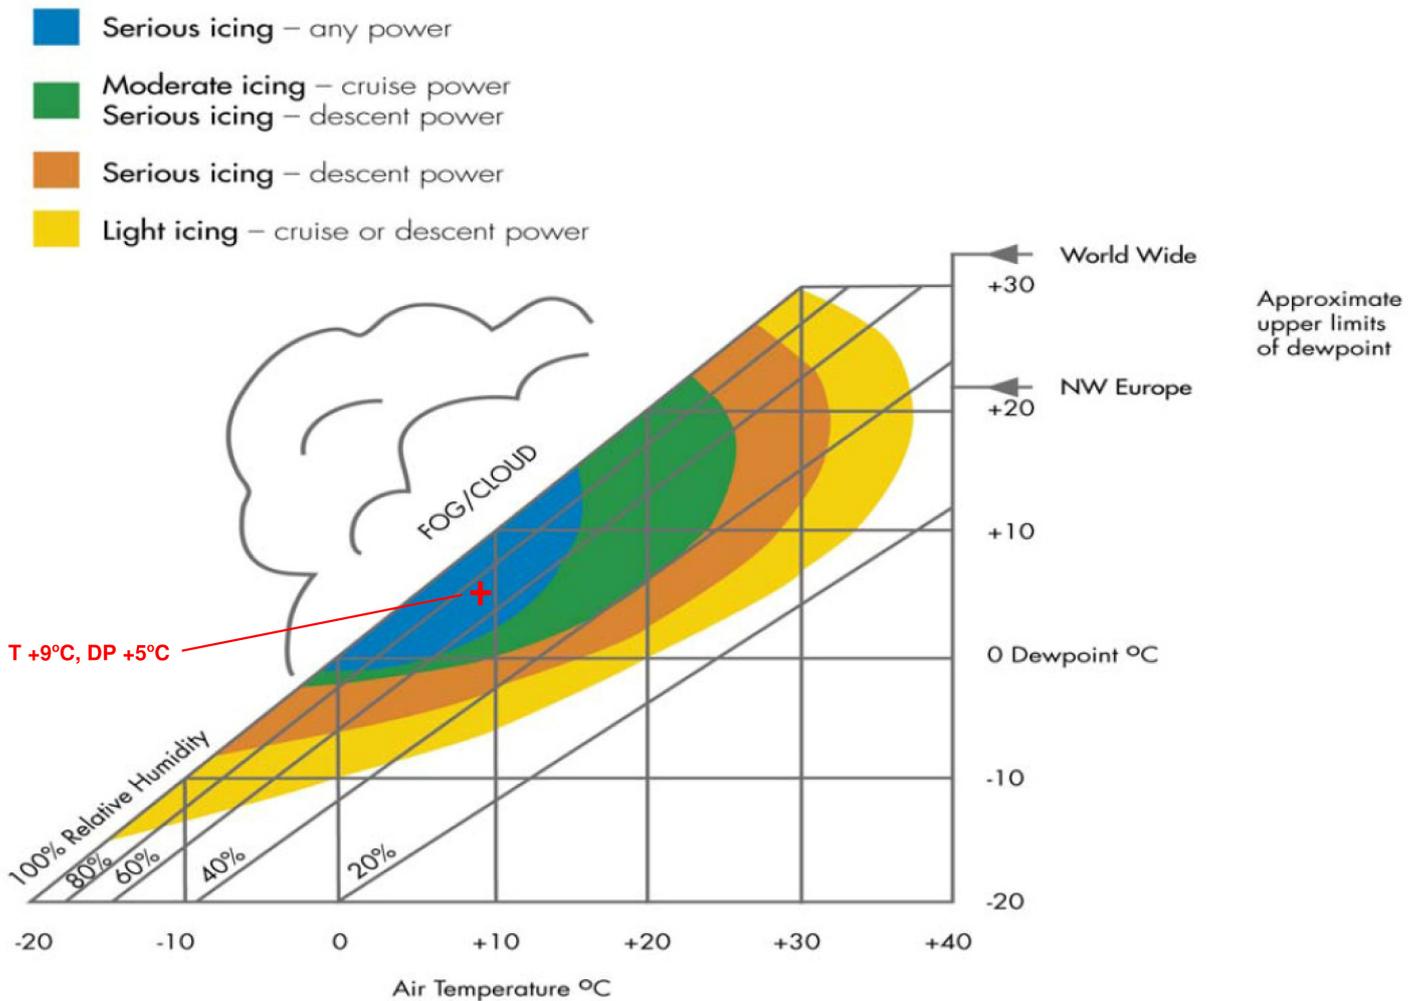
Figure 1
Carburettor icing chart

No weather observations were recorded at the airstrip. Bristol Airport, however, located 12.5 nm east-north-east of the airstrip, recorded a surface temperature of +9°C and a surface dewpoint of +5°C shortly before the accident, indicating that the risk of carburettor icing in the area was serious at any power setting (Figure 1).
