ACCIDENT

Aircraft Type and Registration:	Grob G115E Tutor, G-BYWH	
No & Type of Engines:	1 Lycoming AEIO-360-B1F piston engine	
Year of Manufacture:	2000	
Date & Time (UTC):	12 September 2009 at 1440 hrs	
Location:	RAF Leeming, North Yorkshire	
Type of Flight:	Military	
Persons on Board:	Crew - 2	Passengers - None
Injuries:	Crew - None	Passengers - N/A
Nature of Damage:	Damage to the landing gear rib and lower wing skin	
Commander's Licence:	Airline Transport Pilot's Licence	
Commander's Age:	46 years	
Commander's Flying Experience:	5,500 hours (of which 600 were on type) Last 90 days - 85 hours Last 28 days - 35 hours	
Information Source:	AAIB Field Investigation and RAF Unit Inquiry

Synopsis

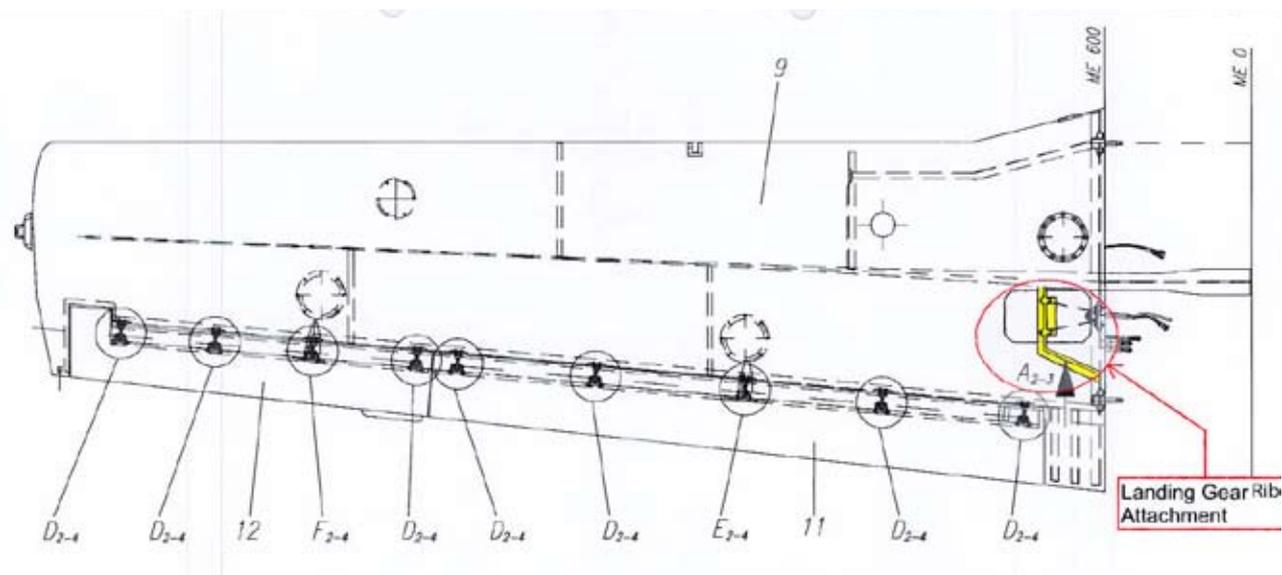
Figure 2

Diagram of Grob G115E wing structure.

the rear of the gear leg cut out of 50 mm for the left panel and 20 mm for the right panel. The orientation of the fibres and the cracking of the surface coating indicated that the panels had been pushed outwards by the gear legs. This was matched by witness marks on the paint of the gear legs. The lower wing skin was significantly cracked in the recess which formed the access port. Detailed inspection of the carbon fibres along the edges of these cracks indicated that the wing skin had been pushed upwards relative to its normal position.

Inspection of the disassembled sections of the gear rib showed that the rib/web had separated from the front spar and also along the top and bottom wing skins. It was not possible to determine exactly how far down the rib length the failure extended, as this was not confirmed prior to the deliberate removal of the rib from the wing skins during the disassembly process. However, an assessment of the additional areas of damage suggests that this separation must have extended along the rib. The bond failure on the left wing rib was predominantly

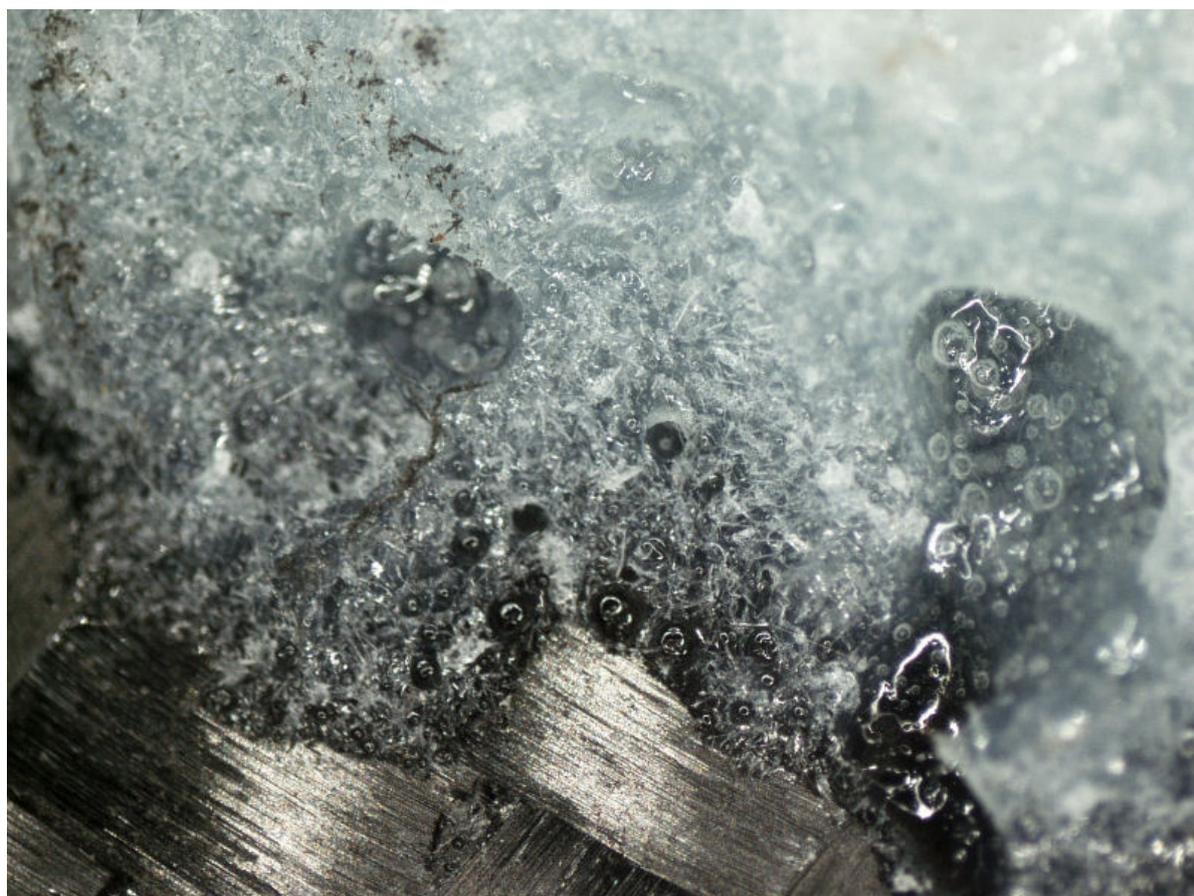
Figure 3

The adhesive which had bonded the rib/spar and rib/skin joints was an unusual white translucent colour, with only small areas of pale yellow coloured adhesive at the edges of the joints. Inspection under a microscope identified that the white colour was due to a high level of porosity within the adhesive (Figure 3). Ductile fibrils were also identified in the areas of the adhesive that had failed cohesively, suggesting a ductile rather than brittle failure. A brittle failure would normally be anticipated from the epoxy resin system specified for these joints in the manufacturer's design specification. Fourier Transform Infra Red (FTIR) spectroscopy was

Magnified image of the white adhesive showing porosity

The adhesive in the failed joints had high levels of porosity. Industry studies have shown that the presence of porosity within epoxy-based materials causes a significant reduction in the mechanical properties of the material. Studies showed that shear strength reduction by a factor of ten was observed between a non-porous and porous epoxy material². The thickness of the adhesive layer forming the bonds meant the presence of porosity was also likely to have had a greater influence on the mechanical properties of the bond, than would have been the case for thinner adhesive layers.³

It is likely that the porous nature of the adhesive created a weak bond which may have contributed to the failure of the joints between the ribs and the spar and skins. The thickness of the layers of adhesive and the presence of significant voids/pores may also have contributed to the weakness of the joints. In some areas the adhesive layer was found to be three times thicker than the manufacturers own design specification and 20 times thicker than the limit suggested by industry studies beyond which it becomes detrimental to the shear strength of the bond. Both these features can result from insufficient pressure holding the structure together during the curing process, excessive layer thickness can also result from the use of adhesive to fill gaps created by large tolerances in component dimensions.

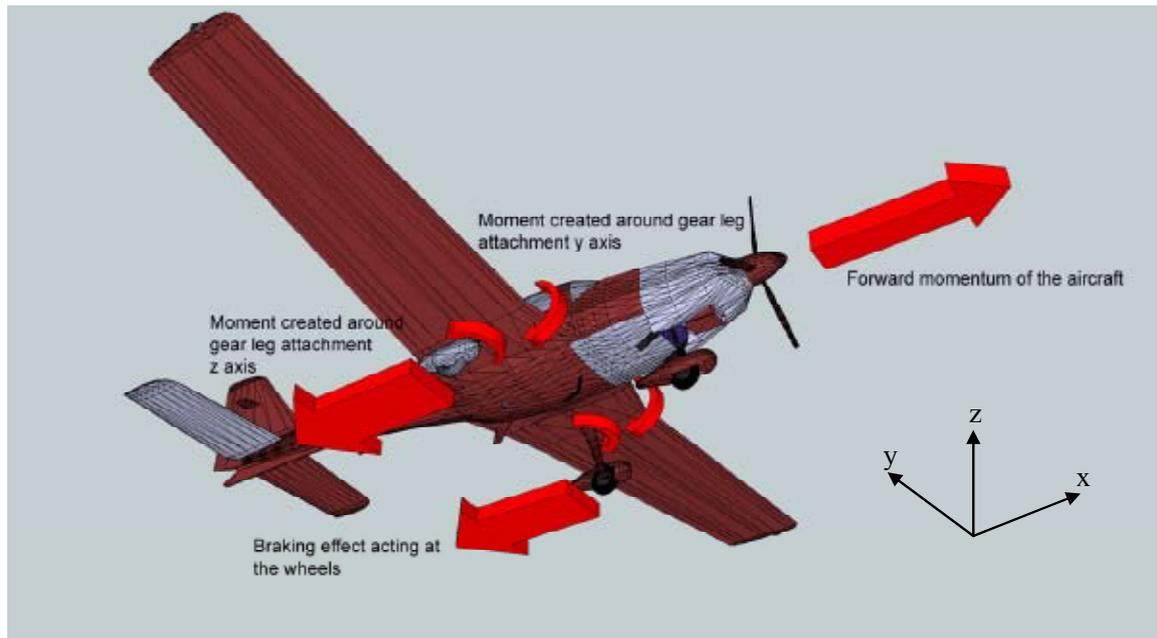
Figure 4

When the brakes were applied during the avoiding action, both the wheels locked causing the aircraft to skid. The momentum of the aircraft effectively acting through the aircraft's centre of gravity and the effect of the locked brakes at the level of the wheels/tyres, produced moments around the gear leg attachment points in both the vertical and horizontal planes (Figure 4). These were transmitted into shear loads on the adhesive bonds locating the gear ribs. The adhesive bonds failed and the ribs separated from the spar and wing skins around a section of their circumference, with the ribs flexing outwards and downwards. This caused the rib and web to crack at the point where it kinks to meet the root rib. It also caused associated flexing and cracking of the lower wing skin, as it became a secondary path for the loads. Loss of the rigid location of the landing gear meant the deceleration loads could no longer be transferred to the primary aircraft structure, compromising stopping distance and the ability of the pilot to control the aircraft.

Illustration of loads acting on the aircraft
