SERIOUS INCIDENT

Aircraft Type and Registration:	Gulfstream G150, D-CKDM
No & Type of Engines:	2 Honeywell TFE731-40AR turbofan engines
Year of Manufacture:	2007
Date & Time (UTC):	6 February 2011 at 1317 hrs
Location:	Royal Air Force Northolt Airport, London
Type of Flight:	Commercial Air Transport (Passenger)
Persons on Board:	Crew - 2 Passengers - 3
Injuries:	Crew - None Passengers - 1 (Minor)
Nature of Damage:	Fire damage to left brakes and tyres, left and right brakes seized
Commander's Licence:	Airline Transport Pilot's Licence
Commander's Age:	32 years
Commander's Flying Experience:	1,750 hours (of which 490 were on type) Last 90 days - 54 hours Last 28 days - 15 hours
Information Source:	AAIB Field Investigation

Synopsis

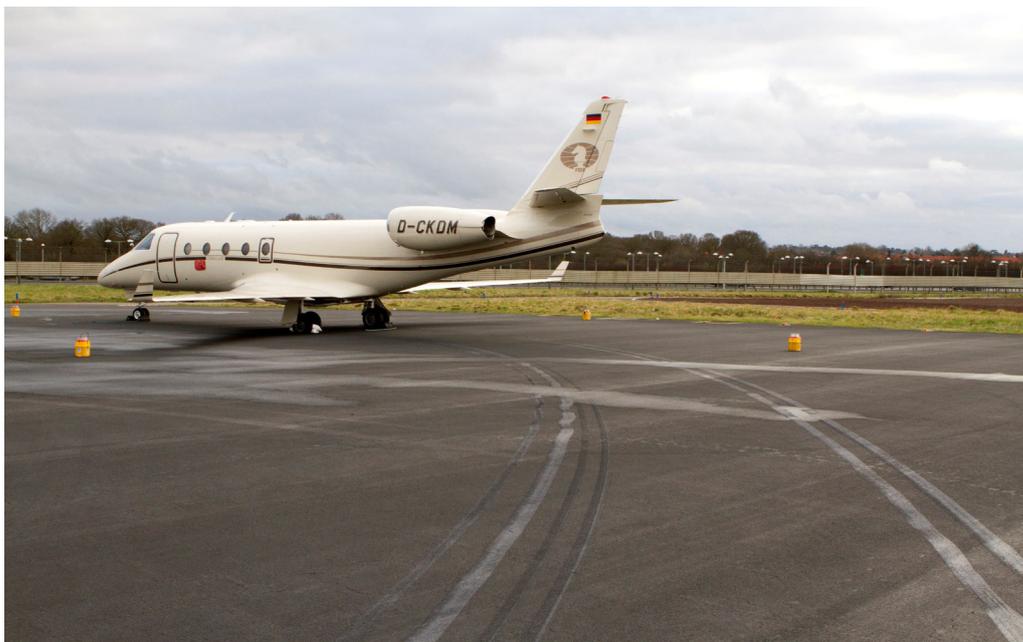
Figure 2

The aircraft had come to rest about 5 m from the end of the paved surface of Runway 25, orientated approximately 90° to the left of the runway centreline (Figure 2). The left main gear tyres and brakes had suffered fire damage (Figure 3). The left outboard tyre had two flat spots and had deflated as a result of a blown fuse plug, while the right main gear tyres were in good condition. The brake assemblies on both the left and

Final position of D-CKDM, about 5 m from the end of the paved surface of Runway 25

right main gear had seized so it was not possible to taxi or tow the aircraft. In order to tow the aircraft to a hangar the left main gear was jacked and lowered onto a trolley, while the seized brake disks and rotors from the right main gear were removed.

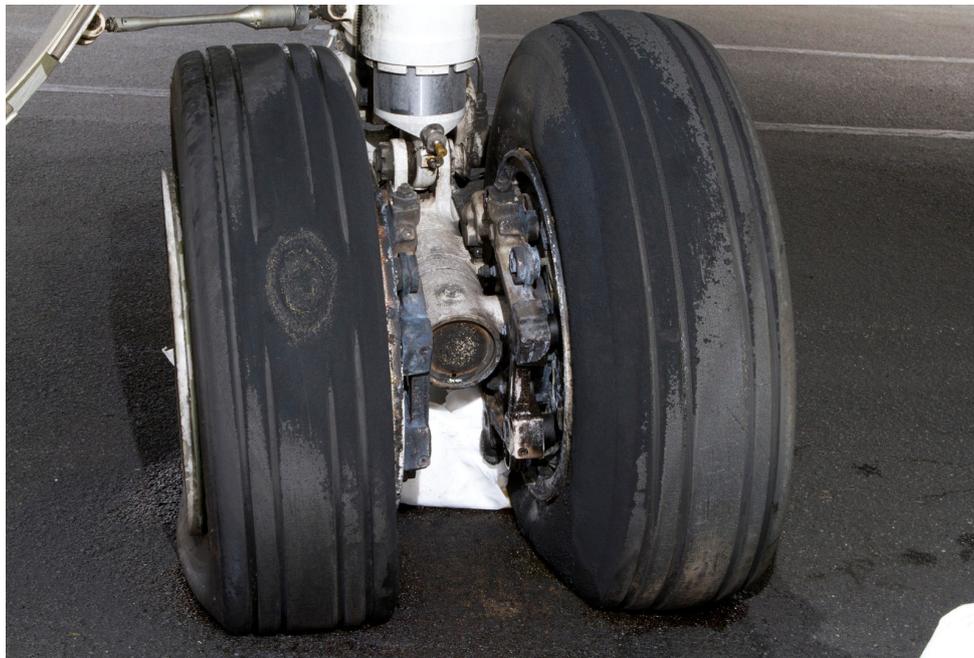
Figure 3

The fire service vehicles had received the emergency call from ATC and deployed along the runway behind the aircraft. The driver of one vehicle observed that it was after the aircraft had come to a stop that a fire started around the left mainwheels.

Fire damage to the left main gear tyres and brakes (view looking forward); flat spot on left tyre

The brake assemblies were examined by the brake manufacturer. They determined that the steel disks had welded themselves together on all four brake assemblies, and they stated that it was not uncommon for steel brakes to weld themselves together following a high-speed rejected takeoff. The brake pistons were all extended as can be seen in Figure 6 where the left inboard brake assembly is compared to a new one. The left brake assemblies had suffered more heat damage than the right brake assemblies and this was attributed to the fire. The brake assemblies were leak tested which resulted in one piston on the left outboard brake assembly leaking with a constant flow at 1,500 psi. One piston on the left inboard brake assembly also started leaking with a constant flow at 1,250 psi. None of the right brake assembly pistons exhibited any leakage at 3,000 psi. The leaks were attributed to deformed O-ring seals. The manufacturer could not determine if the brakes were leaking before the stop, but based on the condition of the brake disks, which were deformed due to normal operating pressure and excessive heat, there had been sufficient heat generated to deform the seals and cause the leak during the stop or immediately after. The fire probably started when leaking hydraulic fluid made contact with the hot brake disks.

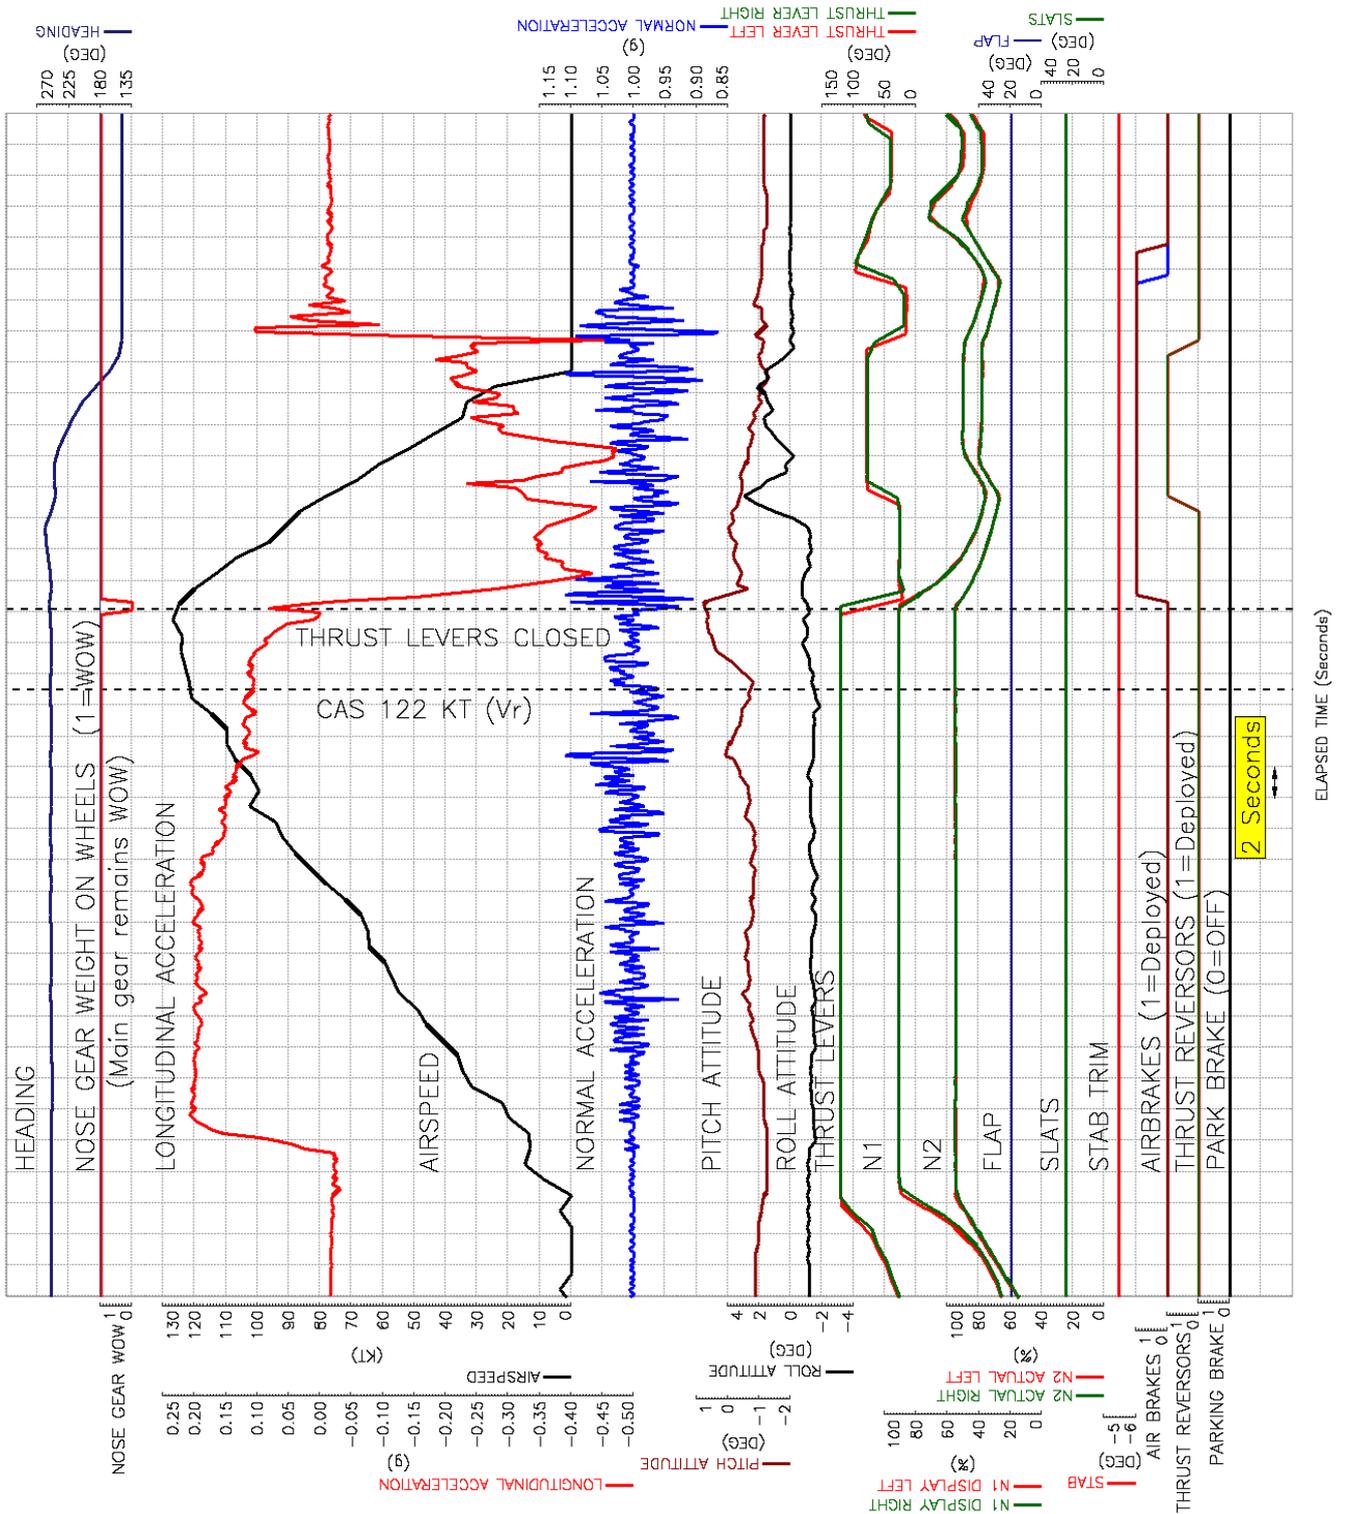
Figure 4
D-CKDM - Rejected takeoff at Northolt

The incident takeoff is shown in Figure 4. The engine start was normal and, having configured the aircraft for a flap 20° takeoff with stabilizer trim set to -5.45°, the parking brake was released and the aircraft taxied from the south side apron towards Runway 25. Shortly after releasing the parking brake and the aircraft having started to move, both the commander and co-pilot confirmed that they had checked the correct operation of the brakes. The aircraft entered Taxiway B South before being cleared to enter the runway and backtrack before being positioned for takeoff, near to the threshold of Runway 25. The flight crew did not refer to any problems whilst taxiing. Checklists were carried out, which included a full and free check of the flight controls.

Whilst waiting for departure clearance, the parking brake indicated that it was set to the ON position for a period of 7 seconds. This occurred about 80 seconds after the aircraft had come to a stop at the threshold and approximately 35 seconds prior to the commencement of the takeoff roll. The aircraft was subsequently cleared for takeoff. The commander having previously briefed that he would be carrying out a static takeoff, increased

both engines to the maximum takeoff power of 91% N1 (Figure 4). Having confirmed that the engine power was set and the co-pilot was holding the control column, the commander advised “BRAKE RELEASE” and the aircraft started to accelerate. During the initial acceleration phase, the longitudinal acceleration remained predominantly stable at about 0.2 g, and as the airspeed reached 80 kt, the commander took over the control column. At about the same time, the longitudinal acceleration started to reduce, and at 119 kt (V_1), it had stabilised at just greater than 0.1 g. The aircraft was about 860 m from the end of the runway at this time. Approximately one second later, at an airspeed of 122 kt, the co-pilot called “ROTATE”. Three seconds later, the commander confirmed that the aircraft was not responding to his control column input and two seconds later the thrust levers were closed, which was shortly followed by deployment of the airbrakes and the rapid deceleration of the aircraft. The flight crew stated that they had applied heavy manual braking at this time. During the five seconds between the rotate command and the rejection of the takeoff, the pitch attitude of the aircraft had increased by less than 2°, from about 1° nose-down to just less than 1° nose-up, and the airspeed had reached a maximum of 128 kt. About two seconds prior to closing of the thrust levers, the longitudinal acceleration had further reduced to nearly 0 g. The aircraft was about 570 m (\pm 40 m) from the end of the runway at this time.

As the aircraft decelerated, reverse thrust was applied and, approaching the end of the runway the aircraft made a left turn onto a heading of 150° before coming to a stop. The commander then attempted to taxi the aircraft from the runway, but the aircraft would not move. About two minutes later, just as the RFFS were arriving, the aircraft was evacuated when a fire was noticed around the area of the left wheel brake assembly. Both engines were also shut down at this time.

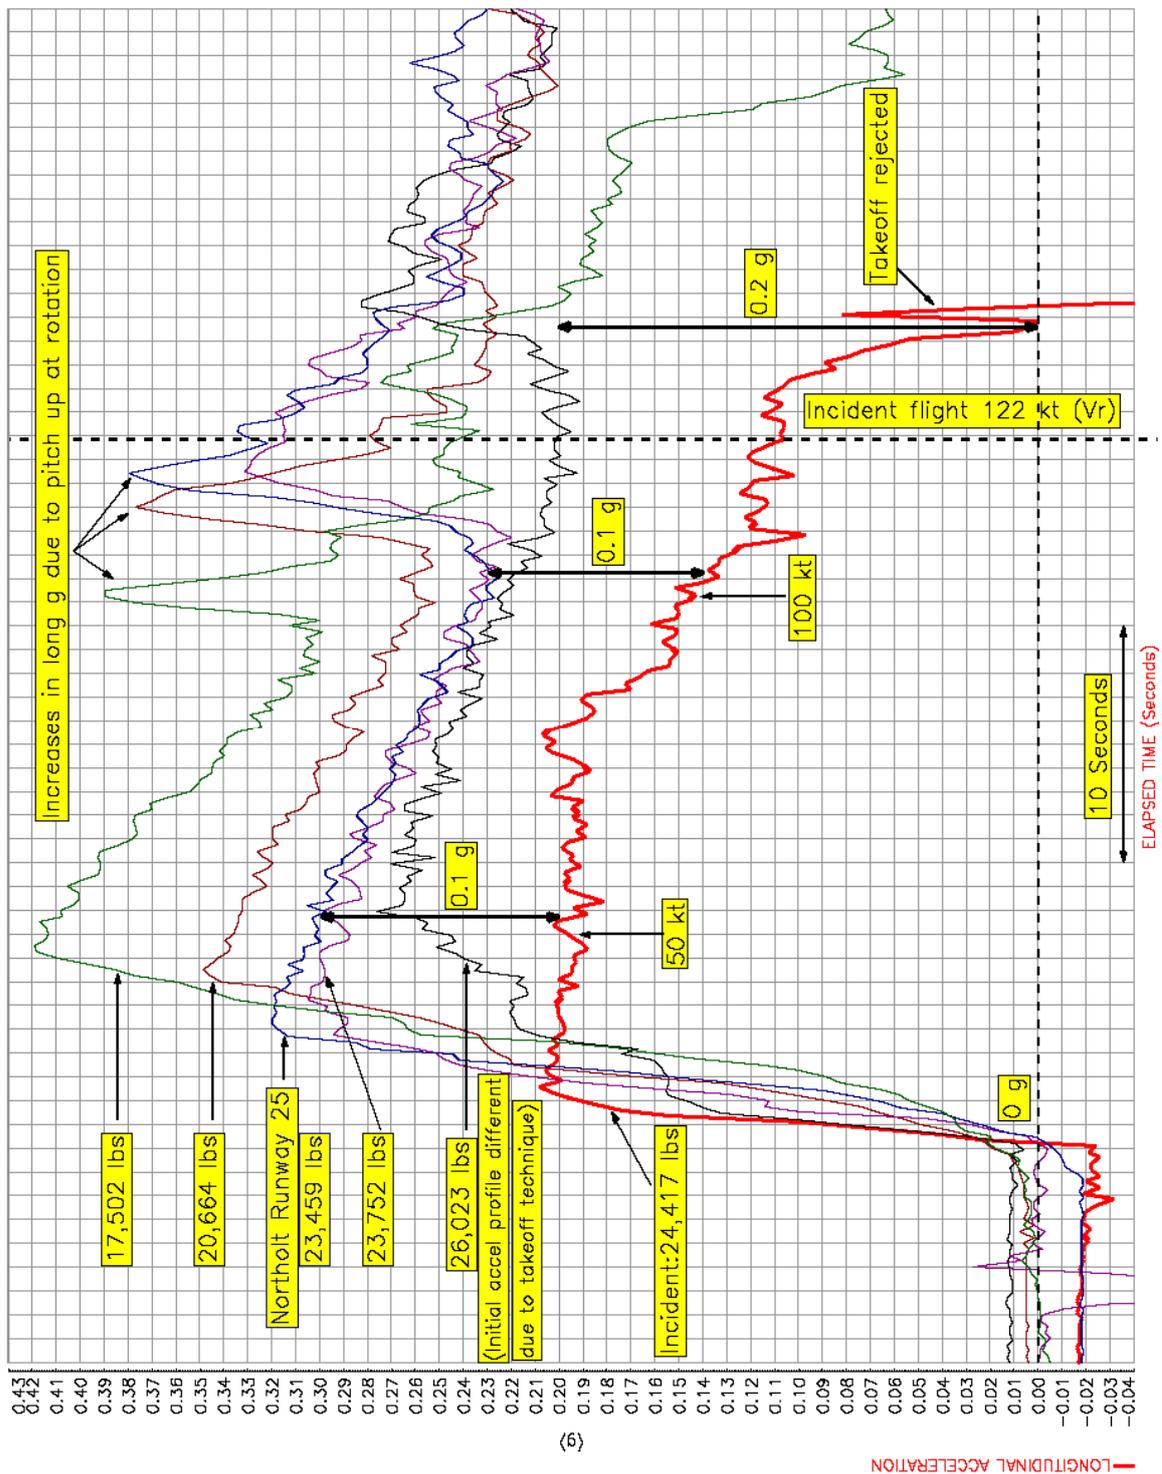
Figure 5

The aircraft's longitudinal acceleration profile during the incident takeoff run was compared with the eight previous takeoffs and the subsequent flight from Northolt (Figure 5). The takeoffs were confirmed as having used almost identical power settings as during the incident, of about 91% N1. Takeoff weights were obtained for all of the flights, with weights ranging from 26,023 lb to 17,502 lb. The takeoff weight of the incident flight was 24,417 lb. From the ten takeoffs, the incident takeoff run was found to have the lowest peak acceleration of about 0.2 g. The next lowest was 0.28 g, which was during the heaviest takeoff with the aircraft weighing 1,606 lb more than at the time of the incident. The highest longitudinal acceleration was 0.42 g which was recorded when the aircraft weight was at its lightest, weighing 6,915 lb less than at the time of the incident. Two of the takeoffs (one being from Northolt Runway 25) were within 958 lb of the incident takeoff weight (Figure 5). Both of these takeoffs had very similar acceleration profiles to each other, with similar peak longitudinal accelerations of about 0.3 g. Being of a similar weight and having used the same takeoff technique, aircraft configuration, runway and almost identical power settings to that of the incident takeoff, it may have been expected that the magnitude and acceleration profile of the subsequent takeoff from Northolt Runway 25 would have been very similar to that during the incident takeoff run. However, the aircraft accelerated about 0.1 g less during the incident takeoff run.

The manufacturer was provided with a copy of the FDR data. Their analysis concluded that the reduction in acceleration had been a result of the brakes being applied during the takeoff run.

Comparison of incident takeoff with four previous takeoffs and subsequent takeoff from Northolt Runway 25

The aircraft then departed for a flight to Luton. The aircraft's weight was 23,459 lb, 958 lb below the incident takeoff weight and the aircraft accelerated and rotated normally (Figure 5).

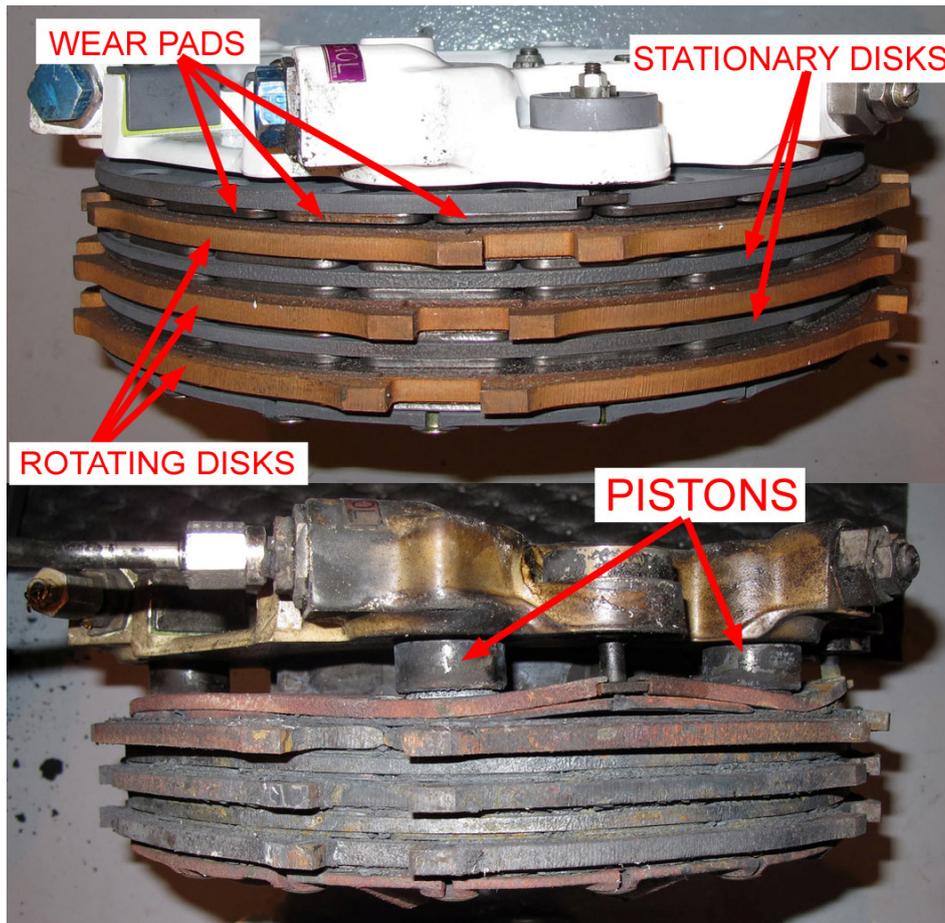
Figure 6

The manufacturer concluded that the damage, discolouration and deformation of the brake assemblies were typical and acceptable following a high-speed rejected takeoff.

Comparison of new brake assembly (upper image) to the left inboard brake assembly from D-CKDM (lower image)
