<b>Aircraft Type and Registration:</b>	Hiller 12 OH-23B, N33514	
<b>No &amp; Type of Engines:</b>	1 Franklin 6V335B piston engine	
<b>Year of Manufacture:</b>	1954	
<b>Date &amp; Time (UTC):</b>	18 November 2004 at 1258 hrs	
<b>Location:</b>	Northampton (Sywell) Aerodrome, Northamptonshire	
<b>Type of Flight:</b>	Private	
<b>Persons on Board:</b>	Crew - 1	Passengers - 1
<b>Injuries:</b>	Crew - None	Passengers - None
<b>Nature of Damage:</b>	Tail boom severed, damage to main rotor blades, one skid bent and engine crankcase fractured	
<b>Commander's Licence:</b>	FAA Private Pilot's Licence	
<b>Commander's Age:</b>	58 years	
<b>Commander's Flying Experience:</b>	7,152 hours (of which 16 were on type) Last 90 days - 28 hours Last 28 days - 19 hours	
<b>Information Source:</b>	AAIB Field Investigation

## Synopsis

The aircraft ran out of fuel transitioning to the hover during an approach to land. The fuel gauge was reading approximately 25% full at the time. Investigations revealed that the fuel gauge fitted was not approved for use on aircraft.

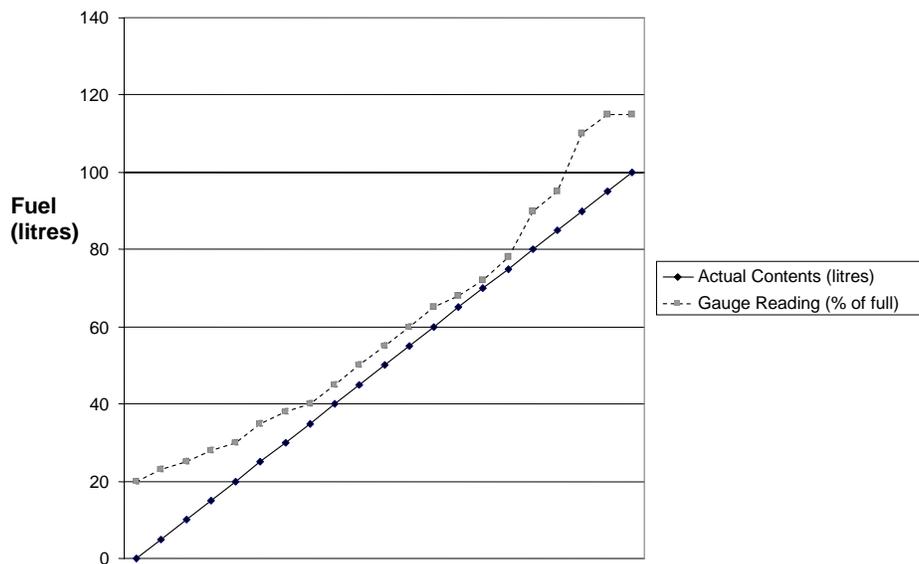
Fuel flowed readily from the tank and no cavitation of the electric fuel pump was apparent. The helicopter's tail was then weighted down, to simulate a nose-high attitude, as might be encountered when transitioning into the hover. In this attitude, the pump was again selected on, and fuel began to flow. Very soon, the flow became less steady and the pump was heard cavitating. Some 700 mls of fuel were collected before flow ceased. The helicopter was again returned to the level attitude and the test re-commenced, with a further one litre being collected before flow stopped. The tank was then drained into a measured container. The total fuel taken from the tank was determined to be 4.8 litres, or 1.3 USG.

The fuel tank was gradually re-filled with measured quantities of Avgas, the gauge readings being taken at various fuel states. The chart above compares fuel in the tank with fuel contents indicated on the gauge.

The pilot relied upon the quantity indications displayed on the fuel gauge and had no specific cause to doubt the readings. The fuel gauge fitted to the helicopter was inaccurate, indicating significantly more fuel on board than was present in the tank. The fuel gauge was not approved for use on the helicopter. The pilot or owner however, could have established a better knowledge of the helicopter's fuel consumption, had records of flying times and fuel consumed been kept.
