ACCIDENT

Aircraft Type and Registration:	1) Boeing 777-236, G-VIIK 2) Airbus A321-231, G-EUXH
No & Type of Engines:	1) 2 General Electric GE90-85B turbofan engines 2) 2 International Aero Engine V2533-A5 turbofan engines
Year of Manufacture:	1) 1998 2) 2004
Date & Time (UTC):	27 July 2007 at 1900 hrs
Location:	London Heathrow Airport
Type of Flight:	1) Commercial Air Transport (Passenger) 2) Commercial Air Transport (Passenger)
Persons on Board:	1) Crew - 14 Passengers - 213 2) Crew - 9 Passengers - 102
Injuries:	1) Crew - None Passengers - None 2) Crew - None Passengers - None
Nature of Damage:	1) Left aileron and wing panel damaged 2) Vertical fin and fairing damaged
Commander's Licence:	1) Airline Transport Pilot's Licence 2) Airline Transport Pilot's Licence
Commander's Age:	1) 49 years 2) 46 years
Commander's Flying Experience:	1) 13,429 hours (of which 2,073 were on type) Last 90 days - 211 hours Last 28 days - 71 hours 2) 11,800 hours (of which 2,700 were on type) Last 90 days - 169 hours Last 28 days - 45 hours

Synopsis

Boeing 777, G-VIIK, collided with a stationary Airbus A321, G-EUXH, whilst being pushed back from its stand at London Heathrow Terminal 4. Moments earlie

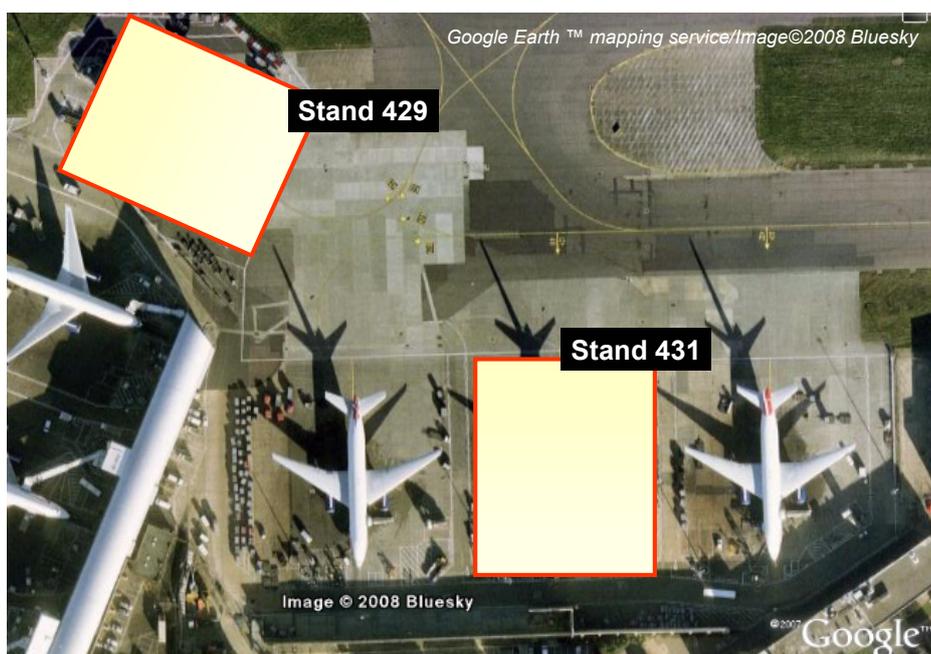
Figure 1

Layout of stands and taxiway in accident area

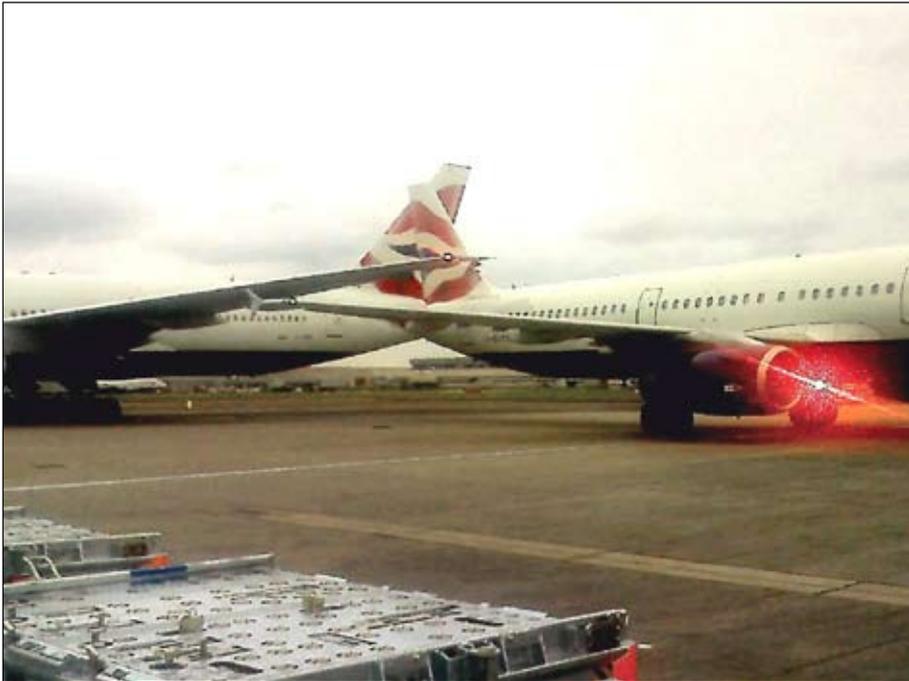
Figure 2

Aircraft in proximity at about the time of the accident

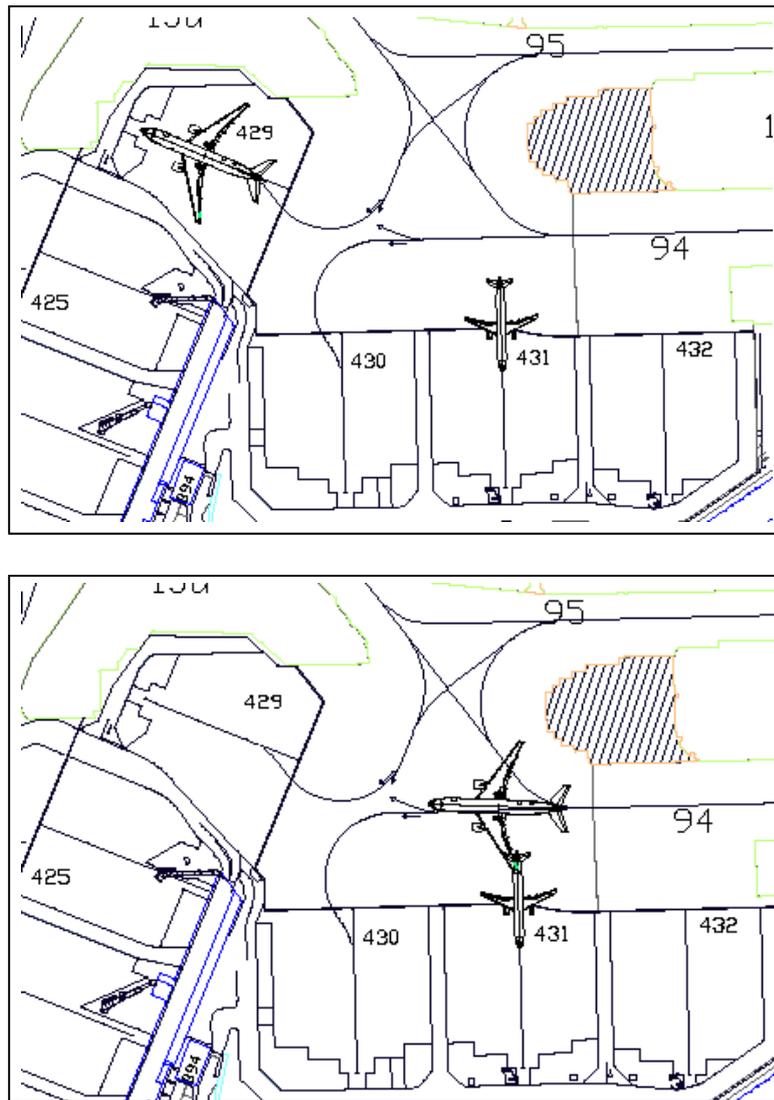
Figure 3

When the AAIB arrived on scene later that evening, Airbus A321 G-EUXH was still positioned on the centreline of Stand 431, about 50 metres short of the intended parking position. Boeing 777 G-VIIK had been towed back onto Stand 429 and was still attached to its tug. The rear half of the Airbus was encroaching into the taxiway (Figure 3). The main wheels were on the taxiway, two metres from the taxiway/stand demarcation line, and its tail extended 17 metres into the taxiway. The force of the collision had caused the Airbus' nose to move approximately two metres to the right. Tyre marks on the taxiway indicated that the aircraft had rotated around its left main landing gear.

Positions of the two aircraft before and after pushback of G-VIIK
(other aircraft not shown)

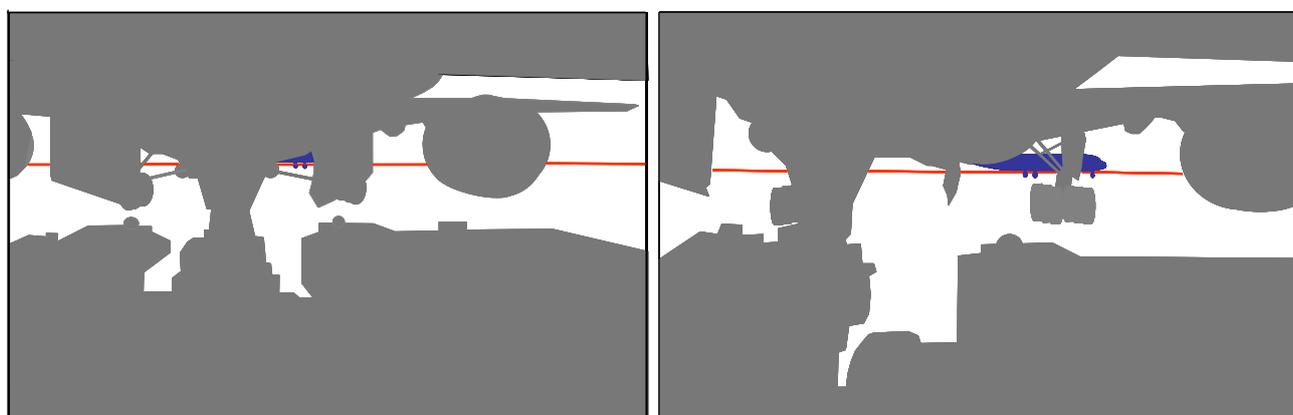
View from tug driver's seat (left) and view rearwards from the forward facing tug passenger seat (right) at start of pushback. Approximate position of Airbus G-EUXH shown in blue.

As the tug driver stated (and Figure 4 illustrates), the view behind the aircraft from his position was very restricted, so he was dependent to a large extent upon the headset operator warning of obstacles or hazards that may not be visible to the driver. The driver would have been aware that the headset operator's continued presence in the cab was contrary to procedures and would affect his ability to identify possible hazards. The driver had overall responsibility for the safety of the aircraft and ground crew during the pushback; he could have delayed or halted it at any time, but he did not.

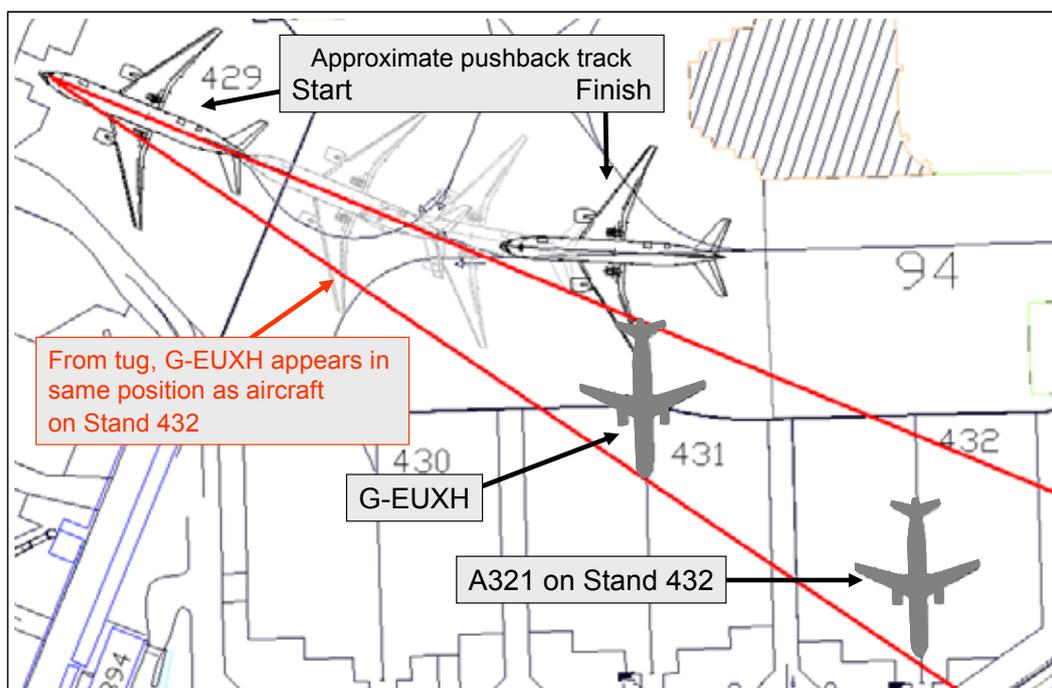
**Figure 5**

At the time of the accident there was an Airbus A321 aircraft, in the operator's livery, parked on Stand 432. This was on the far side of Stand 431 when viewed from the tug position. The ground crew would almost certainly have seen this aircraft earlier, though it would not have been a factor for the pushback. With G-EUXH stopped short of Stand 431, it would have appeared to an observer in the tug cab to be in about the same relative position (albeit closer) as the aircraft on Stand 432, and probably partially obscured the aircraft actually parked there (Figure 5). It is conceivable that one or both of the ground crew had seen G-EUXH from the tug's cab

Relative position of the two Airbus aircraft as viewed from the tug cab
