## ACCIDENT

<b>Aircraft Type and Registration:</b>	Cirrus SR22, N588CD	
<b>No &amp; Type of Engines:</b>	1 Continental IO-550-N piston engine	
<b>Year of Manufacture:</b>	2006	
<b>Date &amp; Time (UTC):</b>	6 November 2006 at 1025 hrs	
<b>Location:</b>	Chichester (Goodwood) Airfield, West Sussex	
<b>Type of Flight:</b>	Training	
<b>Persons on Board:</b>	Crew - 2	Passengers - None
<b>Injuries:</b>	Crew - None	Passengers - N/A
<b>Nature of Damage:</b>	Damage to nose gear leg, main landing gear legs, left wing leading edge, fuselage underside and propeller	
<b>Commander's Licence:</b>	Commercial Pilot's Licence (with Instructor rating)	
<b>Commander's Age:</b>	38 years	
<b>Commander's Flying Experience:</b>	8,055 hours (of which 150 were on type) Last 90 days - 195 hours Last 28 days - 55 hours	
<b>Information Source:</b>	Aircraft Accident Report Form submitted by the pilot and further enquiries by the AAIB

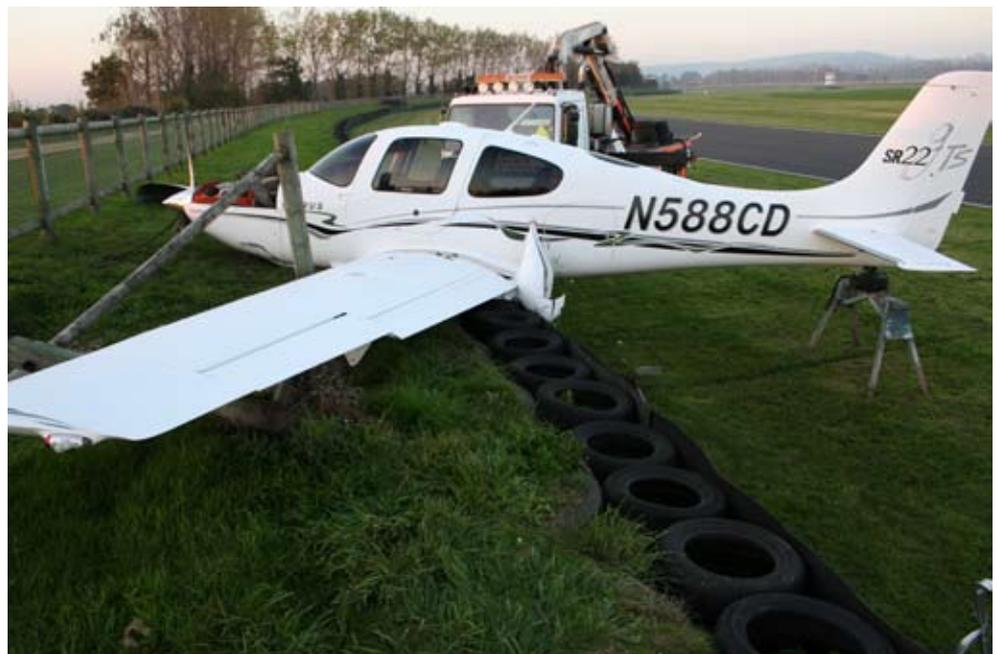
**Figure 1**

The student taxied the aircraft and lined up on Runway 24. After a final briefing from the instructor, the student applied power. The aircraft veered to the left and the student stated that she was both distracted and alarmed by the extent to which this happened. She found that she could only concentrate on trying to control the aircraft's direction. At approximately 60 kt the instructor told her to pull back on the stick to initiate rotation. However, the student was so consumed with trying to maintain control with her feet that she confused the throttle lever in her left hand with the control stick in her right hand and inadvertently pulled back with her left hand, closing the throttle. At this point the instructor took control and he reported that, with the throttle closed and the speed already decaying, he decided to abort the takeoff. He applied the brakes but found no braking action on the wet grass. He released the brakes and reapplied them but still found no effect. He continued to pump the brakes, pulled the mixture lever to idle cut-off and switched off the electrics. The aircraft crossed over the motor circuit track at the end of the runway and hit the tyre wall on the other side. The instructor estimated the impact speed at between 10 and 20 kt. The aircraft came to an abrupt stop and both he and the student were able to evacuate safely. The airfield's fire service arrived within a minute but there was no fire (see Figure 1).

Aircraft in its final resting position against the tyre barrier

The contributory factors in this accident were: the delayed application of full power during the takeoff run, the student pilot's apprehension and inadvertent closing of the throttle, and the slippery wet grass.
