**ACCIDENT**

<b>Aircraft Type and Registration:</b>	Grob G115E, G-BYVZ	
<b>No &amp; Type of Engines:</b>	1 Lycoming AEIO-360-B1F piston engine	
<b>Year of Manufacture:</b>	2000	
<b>Date &amp; Time (UTC):</b>	3 November 2005 at 1400 hrs	
<b>Location:</b>	RAF Church Fenton, North Yorkshire	
<b>Type of Flight:</b>	Training	
<b>Persons on Board:</b>	Crew - 1	Passengers - 1
<b>Injuries:</b>	Crew - None	Passengers - None
<b>Nature of Damage:</b>	Propeller and nose wheel assembly damaged	
<b>Commander's Licence:</b>	RAF pilot's licence	
<b>Commander's Age:</b>	24 years	
<b>Commander's Flying Experience:</b>	289 hours (of which 116 were on type) Last 90 days - 41 hours Last 28 days - 21 hours	
<b>Information Source:</b>	Aircraft Accident Report Form submitted by the pilot and company engineering investigation report

**Synopsis**

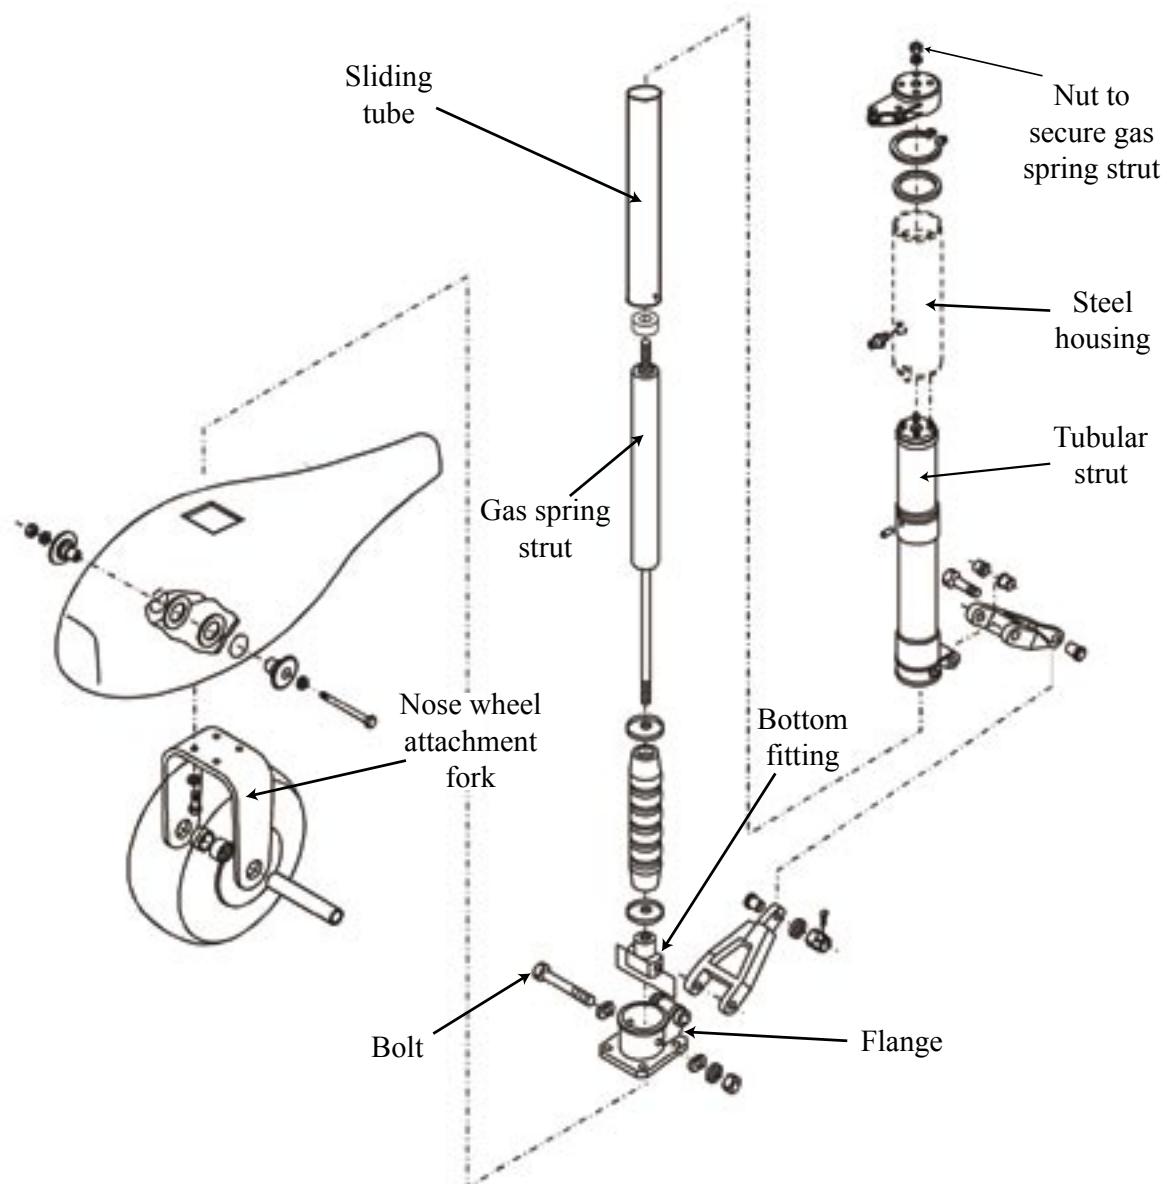
The nose landing leg is secured to the aircraft by a steel housing and consists of a tubular strut, sliding tube, gas spring strut and a flange which is mounted on to the nose wheel fork assembly. The top of the sliding tube is retained within the tubular strut and the bottom of the sliding tube is secured by a bolt to the flange. The top of the gas spring strut is secured to the steering actuator lever by a nut and washer arrangement and the bottom

of the gas spring strut is screwed into the bottom fitting, which is secured to the flange by a bolt. The same bolt is used to secure the sliding tube and gas spring strut to the flange. See Figure 1.

**Figure 1**  
Nose landing leg assembly

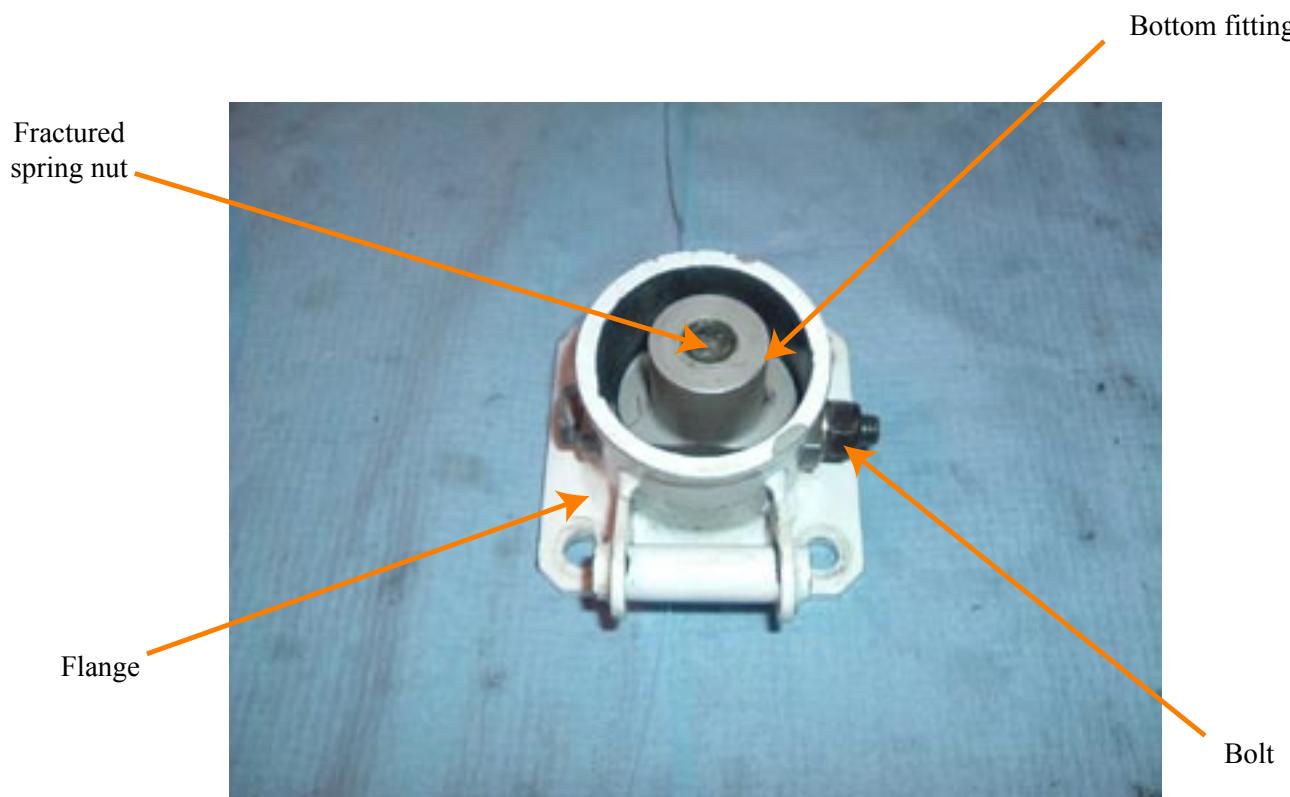
nose landing gear sliding tube and gas spring strut bottom fitting to the flange had been incorrectly fitted such that the bolt only secured the bottom fitting to the flange. Consequently, when the aircraft landed, the weight on the nose wheel was sufficient to cause the failure of the bottom of the gas spring strut which resulted in the collapse of the nose wheel. See Figure 2.

**Figure 2**  
Failure of gas spring strut

The nose landing gear was last refitted to the aircraft during the 150 hour maintenance activity and failure of the gas spring strut occurred 3.5 flying hours and 9 landings later.

A similar incident occurred in June 2002 which resulted in the maintenance organisation instigating a fleet check to determine if the bolts on any other aircraft had been incorrectly fitted. Believing this to be an isolated occurrence, the maintenance organisation introduced a cautionary note into the maintenance manual emphasising the need to ensure that the bolt passes through both the sliding tube and gas spring bottom fitting.

The maintenance organisation estimates that there are approximately 60 occurrences a year when the subject bolt in the nose landing leg is disturbed. Nevertheless, despite the relatively low frequency of the bolt being incorrectly fitted, the maintenance organisation has reclassified the assembly of the nose leg as a critical task and has introduced a Vital/Duplicate inspection to confirm that the nose wheel undercarriage flange assembly is correctly assembled prior to fitment of the nose wheel fork.
