SERIOUS INCIDENT

| Aircraft Type and Registration: | ATR42-300, EI-FXA | |
| Date & Time (UTC): | 22 February 2012 at 0700 hrs | |
| Location: | On approach to Glasgow Airport | |

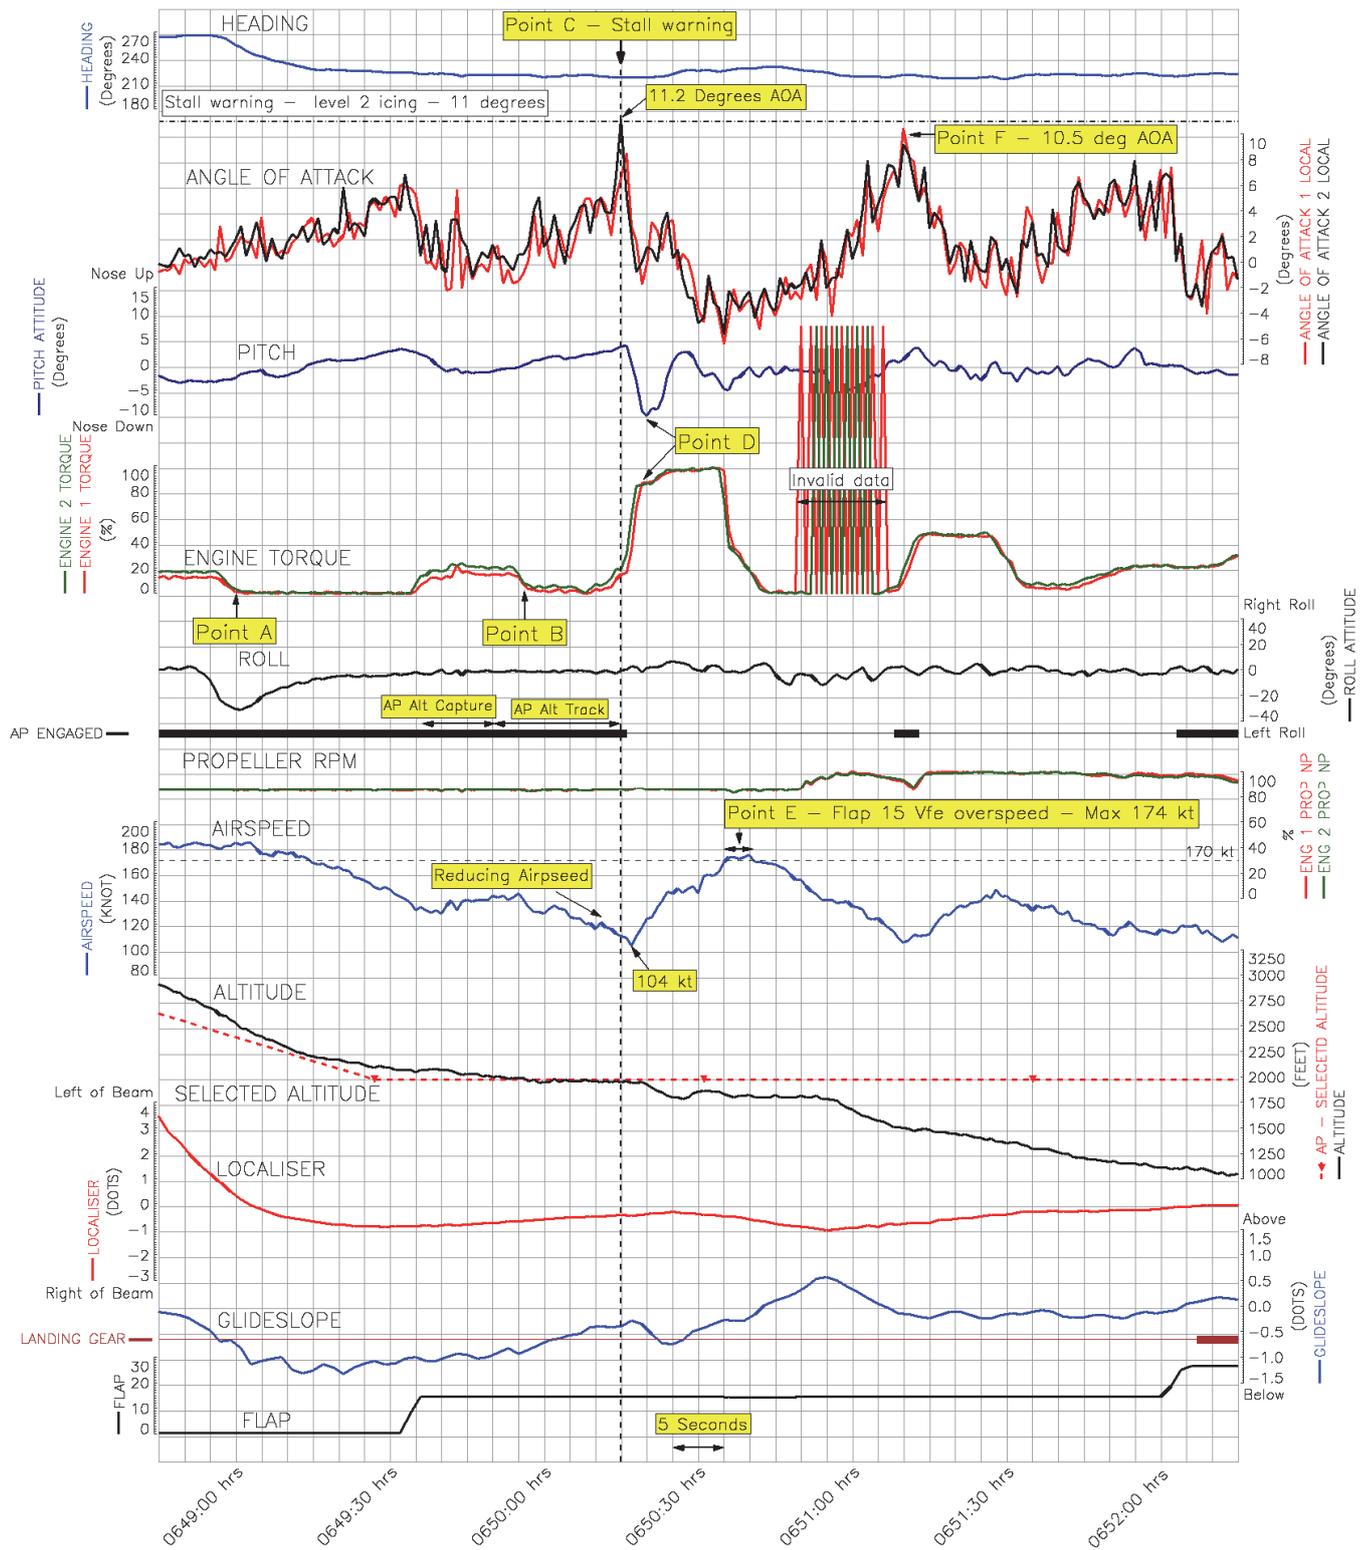
Figure 1
Approach to Glasgow Airport Runway 23

As the flight director captured the localiser the commander instructed the co-pilot to arm the approach mode. Engine torques were reduced to approximately 0% and the rate of descent was reduced. The aircraft was now 8.2 nm from the runway at 2,500 ft and 185 KIAS (see Figure 1, Point A).

At 140 KIAS and 2,100 ft amsl, flap 15 was deployed and the engine torque was increased to about 20%. Approximately 15 seconds later, the autopilot levelled the aircraft at the selected altitude of 2,000 ft amsl. Engine torques were reduced to about 3% (see Figure 1, Point B), airspeed reduced, and the autopilot progressively pitched the aircraft nose-up as it maintained 2,000 ft amsl. Neither of the flight crew mentioned the gradually reducing airspeed.

The co-pilot commented that they were 6.5 nm from the runway, but that the autopilot had not yet captured the glideslope. With the aircraft below the glideslope, the approach controller inquired whether it was established on the ILS. As the first officer keyed the radio to respond, the stall alert sounded and the stick shaker activated. Simultaneously, the autopilot disconnected (see Figure 1, Point C). The aircraft was approximately 1,700 ft agl at 111 KIAS and the angle of attack was +11.2°. The co-pilot called "FLY THE AIRCRAFT [EXPLETIVE]". The commander almost immediately pitched the aircraft nose down to -10° and advanced the power levers almost to full power (see Figure 1, Point D), saying as he did so "I'VE GOT IT I'VE GOT IT DON'T WORRY".

Airspeed reduced to 104 KIAS before increasing. The pitch attitude remained approximately -10° and the co-pilot called “NOSE UP NOSE UP” to which the commander replied “NO”. At 125 KIAS the commander started to pitch the aircraft nose-up, having descended to approximately 1,600 ft agl.

As the aircraft descended, its airspeed reduced to a minimum of 111 KIAS and the angle of attack reached 10.5° (0.5° below the stall alert/stick shaker threshold) (see Figure 1, Point F). Passing approximately 1,500 ft amsl, the flight crew attempted to re-engage the autopilot but it disconnected immediately. Simultaneously, engine torque was increased to 45%, airspeed increased and the angle of attack reduced. The controller asked if the aircraft was still on frequency and the co-pilot replied “AFFIRM, STANDBY WE’VE JUST GOT...
