**INCIDENT**

<b>Aircraft Type and Registration:</b>	Boeing 767-2Q8, N330LF	
<b>No &amp; Type of Engines:</b>	2 General Electric CF6-80C2 turbofan engines	
<b>Year of Manufacture:</b>	1989	
<b>Date &amp; Time (UTC):</b>	8 November 2006 at 1329 hrs	
<b>Location:</b>	Bristol (Filton) Aerodrome	
<b>Type of Flight:</b>	Commercial Air Transport (Non-Revenue)	
<b>Persons on Board:</b>	Crew - 2	Passengers - None
<b>Injuries:</b>	Crew - None	Passengers - N/A
<b>Nature of Damage:</b>	Left main landing gear door missing, hydraulic system failure	
<b>Commander's Licence:</b>	Air Transport Pilot's Licence	
<b>Commander's Age:</b>	56 years	
<b>Commander's Flying Experience:</b>	7,536 hours (of which were on type) Last 90 days - 115 hours Last 28 days - 45 hours	
<b>Information Source:</b>	AAIB Field Investigation

**Synopsis**

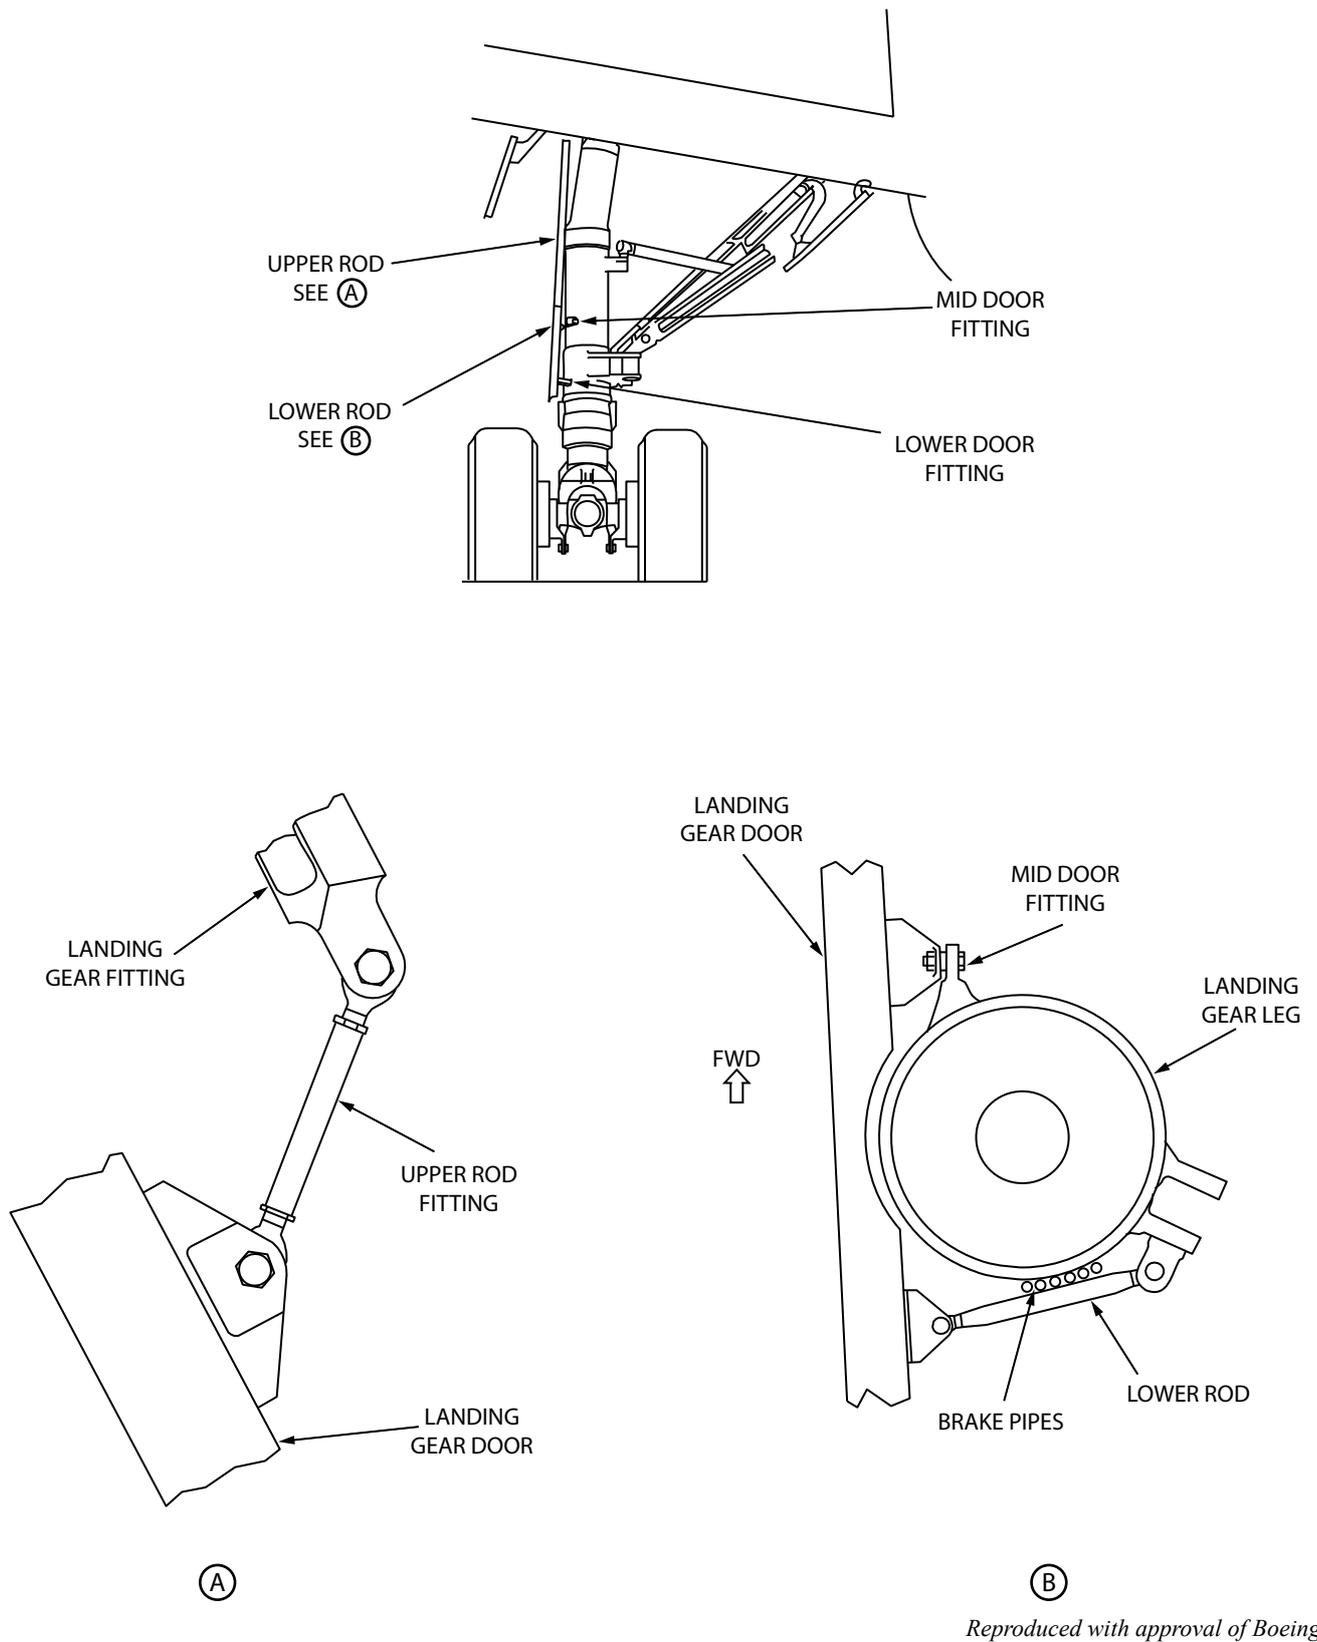
**Figure 1**

The landing gear door is fitted with four attachment brackets which secure it to the landing gear leg; 'upper rod' and 'mid door' attachments, forward of the leg, and 'lower rod' and 'lower door' fittings, aft of the leg, Figure 1. As the names imply, both the upper and lower rod fittings make use of adjustable eye-ended rods to secure the door to lugs on the landing gear leg. The mid door attachment makes use of a nut and bolt to secure the door to a lug on the leg, and the lower attachment uses a short threaded eye-end rod and nut to secure the door to the lower rear mounting lug. When installed, the lower rod passes between the rear face of the landing gear leg and the wheel brake hydraulic pipes. The brake system is fitted with four hydraulic fuses, one in each pressure supply pipe, which are designed to shut off the hydraulic supply to individual brake units should a significant leak occur.

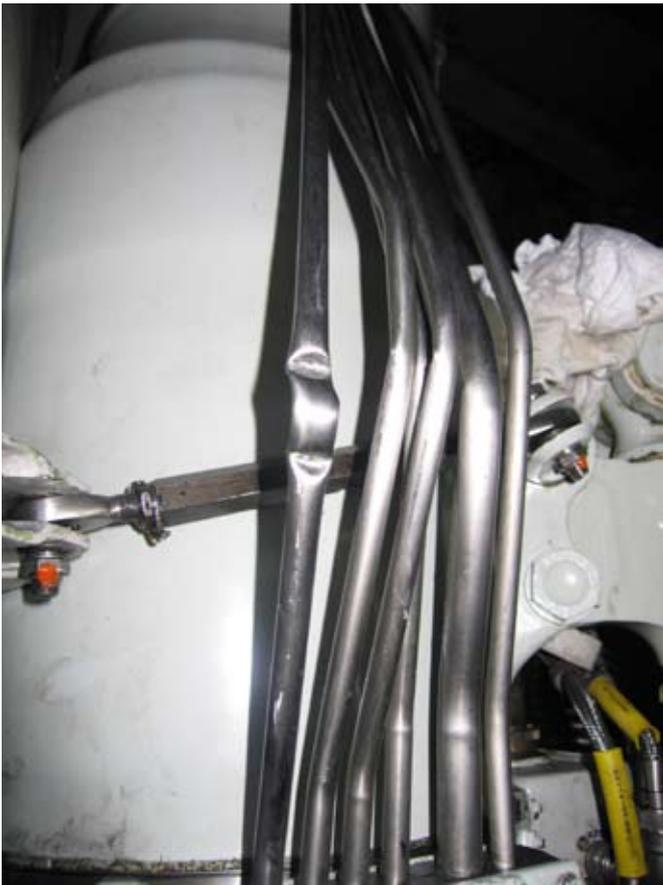
**Figure 2**

Examination of the aircraft revealed minor damage to the lower wings skins, the landing gear bay and the landing gear trunnion door; no other damage caused by the release of the door was observed on the aircraft structure. Visible damage to the landing gear leg was confined to the steel inserts pressed into the door attachment lugs. Approximately 10% of the landing gear door remained attached to the leg by the lower rod, the remainder having departed the aircraft prior to landing. Six hydraulic pipes, secured to the rear of the landing gear leg, had been bent and crushed by the rod, Figure 2, and two of the hydraulic fuses, those for the two rear brake units, were found to have operated.

After the brake pipes had been repaired, the aircraft was flown to Nimes for replacement of the landing gear door. No further defects were reported during the retraction of the landing gear on this or subsequent flights.

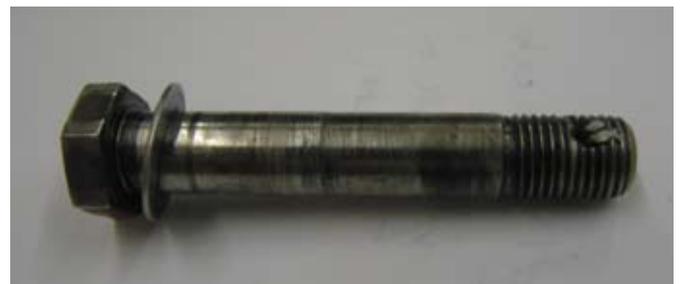
**Figure 3**

A bolt from the mid door attachment was recovered from the stand, which exhibited a degree of damage to the threads and which contained the remains of a cotter pin, Figure 3. With the exception of some minor bending and scoring of the shank, the bolt had not

suffered from any deformation and remained within manufactured dimensional tolerances. The threads of the bolt were free from contamination, evenly spaced and of uniform depth.

The remains of the cotter pin and the lack of distortion to the mid-fitting bolt indicated that the nut fitted to this bolt had failed due to a tensile overload. The loss of the nut would have precluded the mount from carrying

The loss of the landing gear door was initiated by the failure of the castellated nut on the door mid-mount fitting. Whilst the speed at which the landing gear was deployed was higher than that expected in routine operation, it was within the aircraft's landing gear limit speed, and was considered unlikely to have initiated the nut failure.
