**ACCIDENT**

<b>Aircraft Type and Registration:</b>	Pegasus Quik, G-CWIK	
<b>No &amp; Type of Engines:</b>	1 Rotax 912 ULS piston engine	
<b>Year of Manufacture:</b>	2004 (Serial no: 8018)	
<b>Date &amp; Time (UTC):</b>	12 May 2012 at 1013 hrs	
<b>Location:</b>	100 ft below summit of Ben More, Stirlingshire, Scotland	
<b>Type of Flight:</b>	Private	
<b>Persons on Board:</b>	Crew - 1	Passengers - 1
<b>Injuries:</b>	Crew - 1 (Fatal)	Passengers - 1 (Fatal)
<b>Nature of Damage:</b>	Aircraft destroyed	
<b>Commander's Licence:</b>	Private Pilot's Licence (Microlights)	
<b>Commander's Age:</b>	63 years	
<b>Commander's Flying Experience:</b>	826 hours (of which 1 was on type) Last 90 days - 12 hours Last 28 days - 6 hours	
<b>Information Source:</b>	AAIB Field Investigation

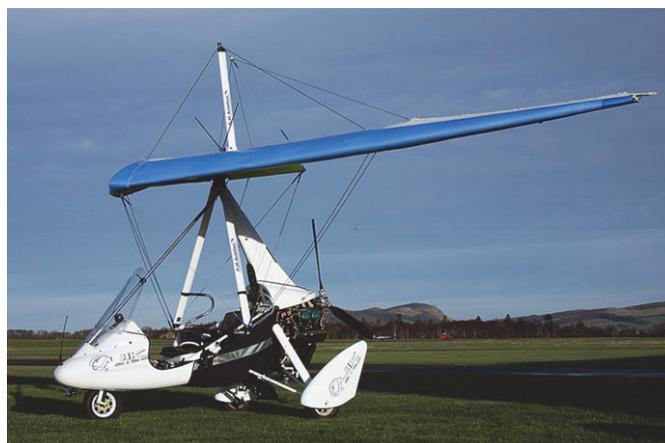
**Figure 1**

Accident aircraft G-CWIK

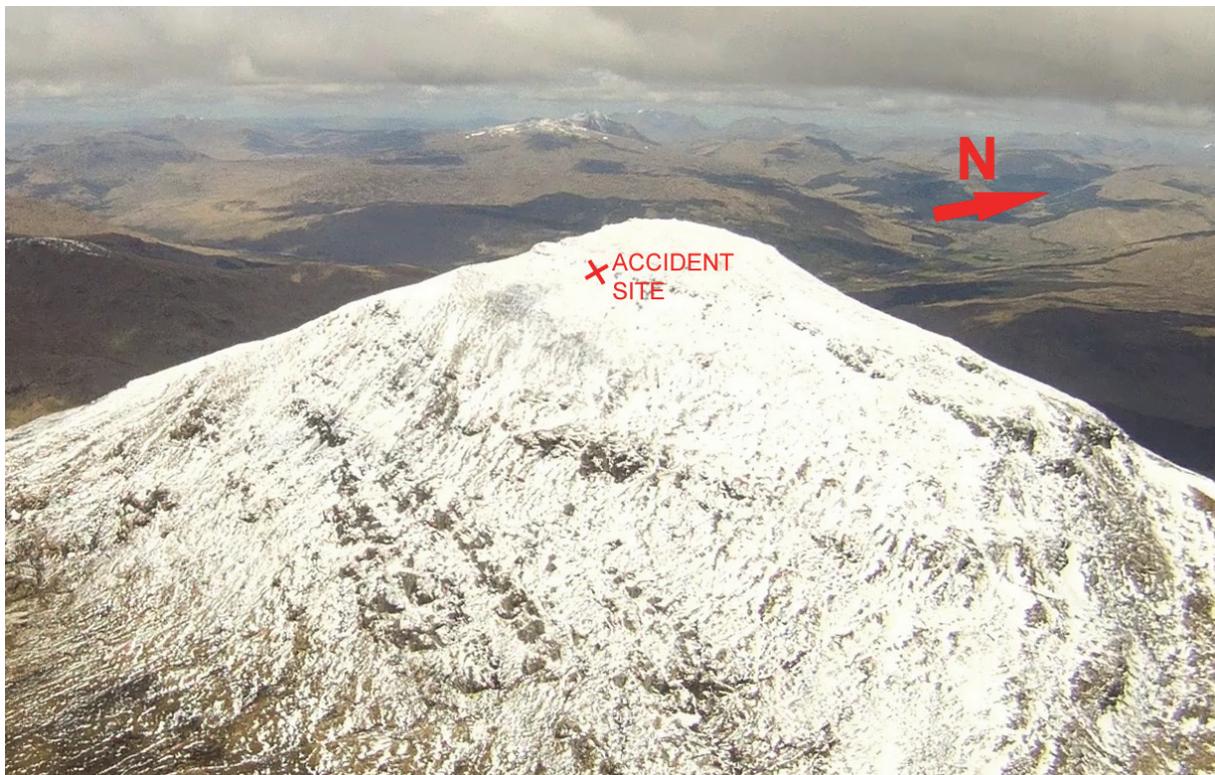
**Figure 2**

The aircraft had struck Ben More mountain on its south-eastern side 100 ft below the summit (Figure 2). The accident site was consistent with the aircraft having hit a small rock in a steep nose-down attitude with some left bank. The nosewheel and parts of the nose structure were embedded in the ground by the rock and the main aircraft wreckage was lying inverted 8 m away from the rock in the direction of 225°(M). The fuel tank had split and was empty but there was a distinct smell of fuel at

Accident site location, 100 ft below summit of Ben More (image extracted from video camera fitted to G-CWIK)

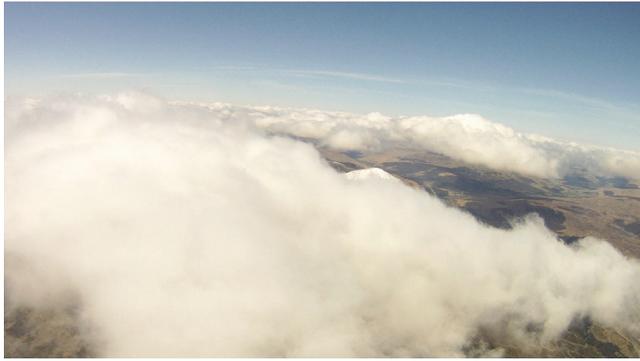
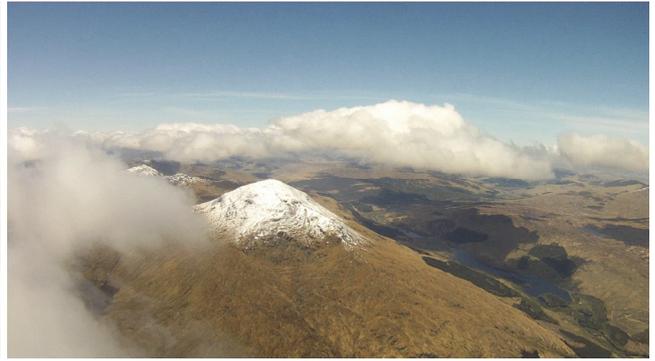
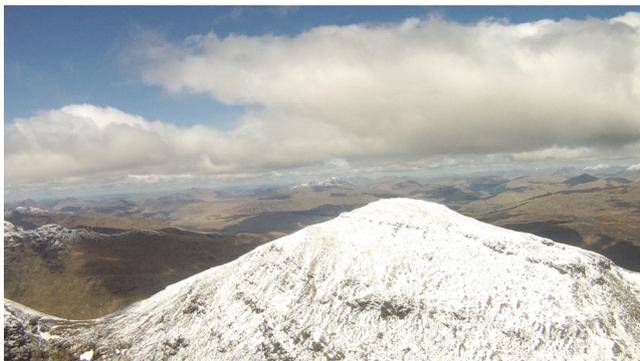
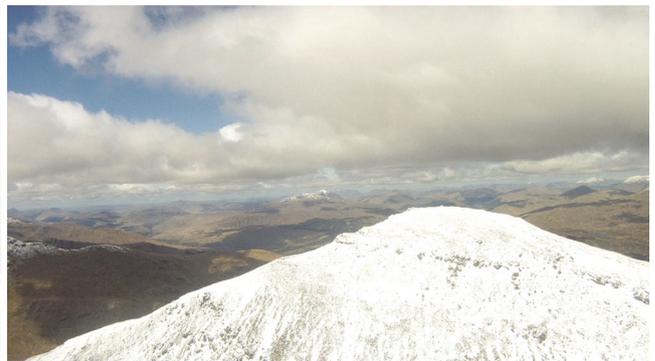
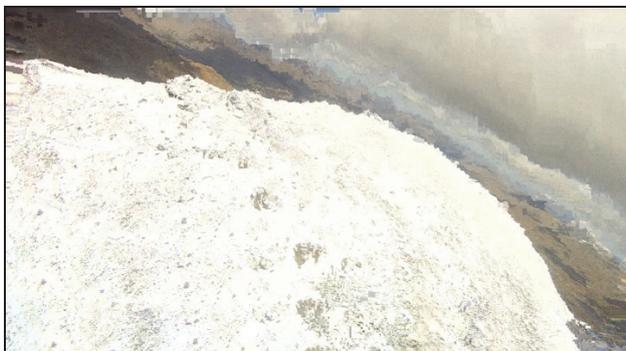
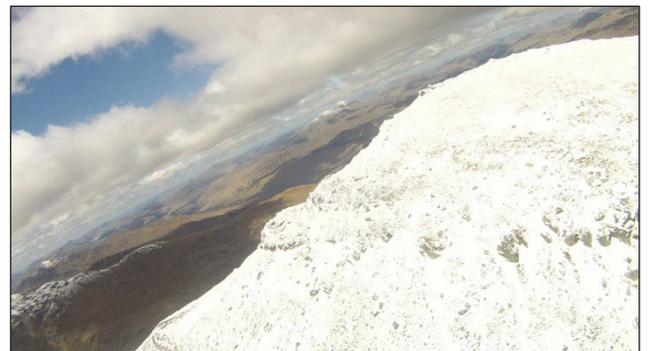
**5 seconds to final frame****Figure 3**

The video images provided good evidence of the weather conditions and flight path, shown in Figures 3 and 4 and described in the 'History of the flight' section of this report. The Figure 3 images at '6 seconds' and '5 seconds' indicate a roll rate of about 55°/sec and subsequent images showed a nose-down pitch.

Snapshots extracted from the recovered video, showing the approach to Ben More

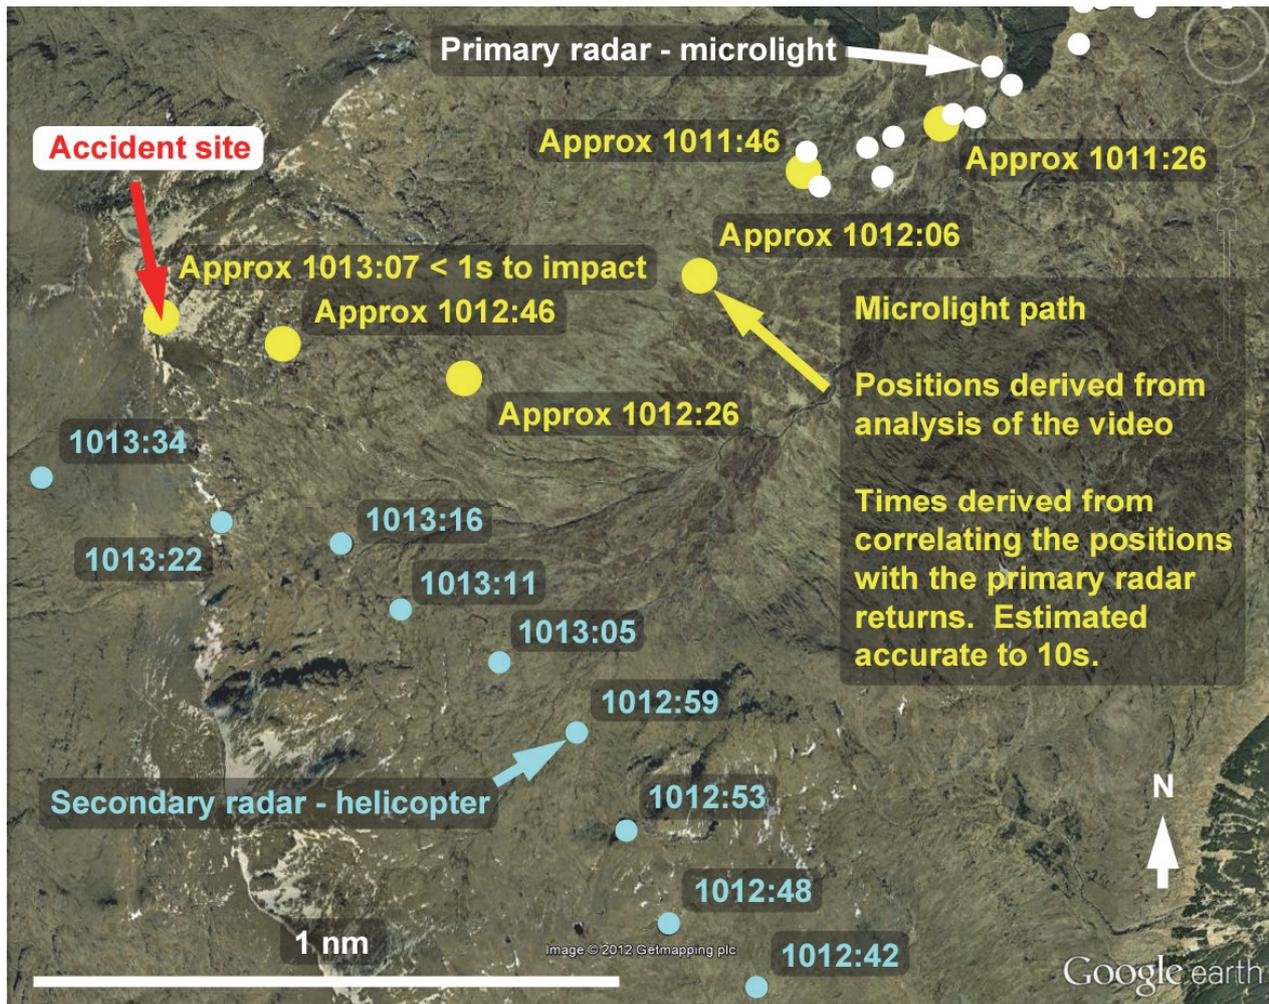
Figure 4

Flight paths and timings of the microlight and helicopter

between 0.4 nm and 1.1 nm ahead of the helicopter. This established that the helicopter was not a factor in the accident.

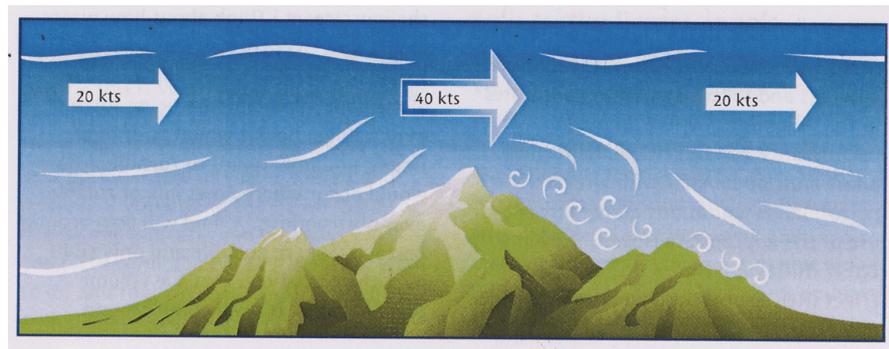
**Figure 5**

Wind strength increases as it passes over a mountain feature, due to the Venturi effect of the mountain. As a result, wind strength on the summit of a mountain will be significantly greater than the ambient wind speed away from the summit at the same height.

The Venturi effect of the mountain increasing the wind speed at the summit

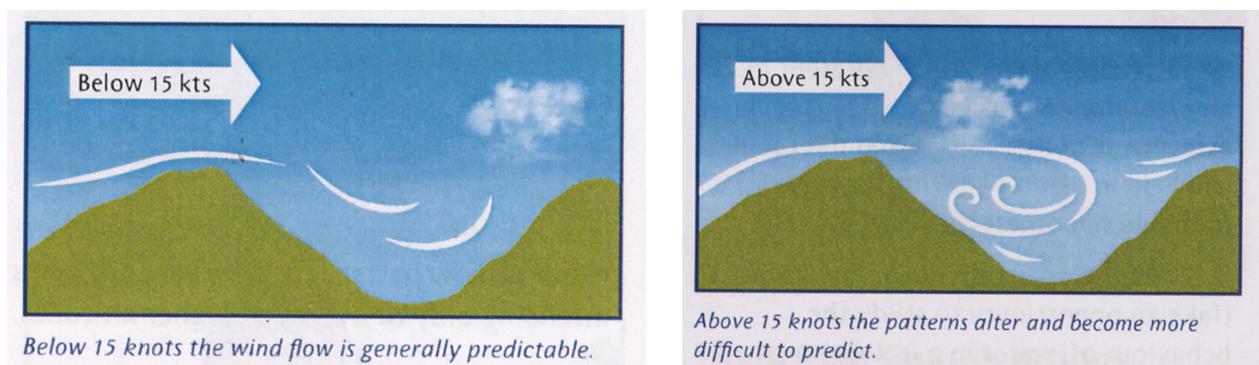
**Figure 6**

The strength of the ambient wind will govern the degree of turbulence created. A gentle wind will simply flow over the terrain following the contours but as the strength increases the wind will curl over and around features, forming up and down drafts as well as vortices, the severity of which will increase with the strength of the wind. This effect is shown in Figure 6.

The creation of hazardous turbulence in the lee of high ground related to wind strength

It is recommended that the Civil Aviation Authority produce a Safety Sense Leaflet, or other guidance material, covering the activity of mountain flying for the UK general aviation community.
