**Contact with quay and the subsequent foundering
of FV *Shalimar*
Scrabster, Scotland
30 April 2014**

SUMMARY

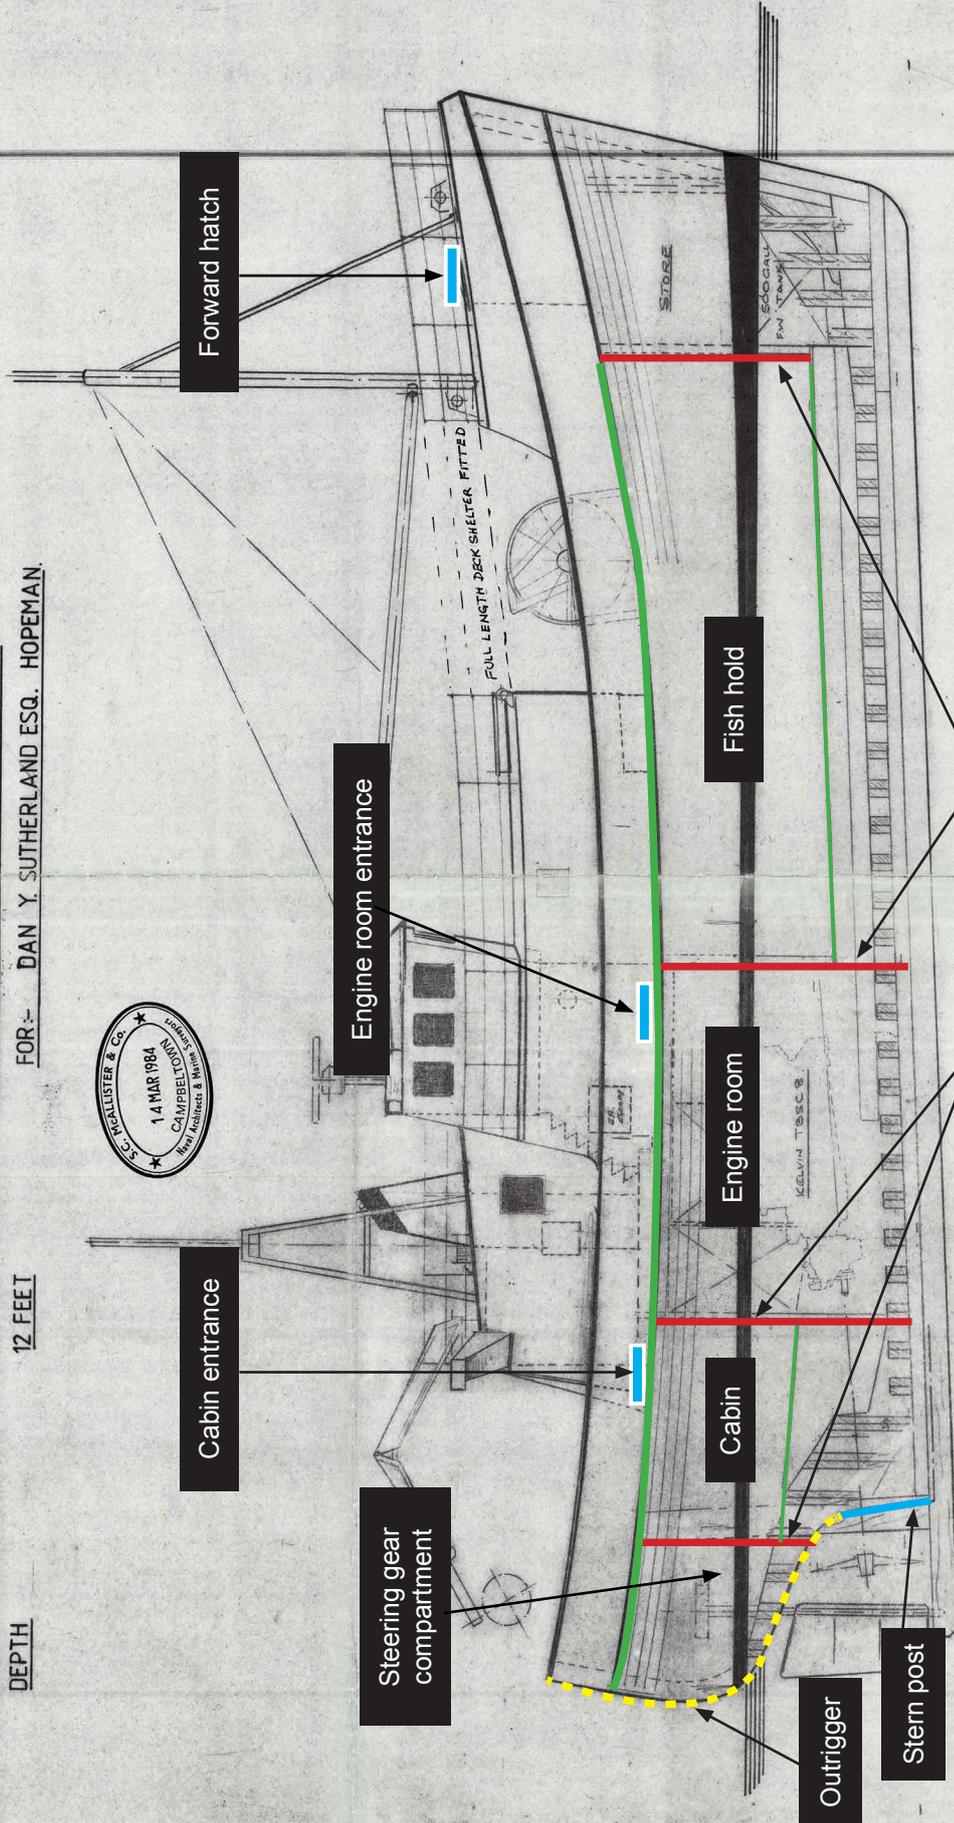
Figure 2: Shalimar general arrangement

The engineer left the engine room and made his way to the cabin where, through the open door, he saw water in the steering gear compartment (**Figure 2**). The bilge alarm also sounded. The engineer quickly returned to the engine room and restarted the auxiliary engine. Once the engine was running, he started the general service pump.

The vessel's layout (**Figure 2**) was typical of a Scottish seine netter with the cabin, engine room and fish hold located in the hull and the galley, mess room and wheelhouse within the superstructure at main deck level. Access to the engine room was through a hatch located on the port side forward in the galley, while access to the cabin was by a hatch located on the starboard side aft of the superstructure.

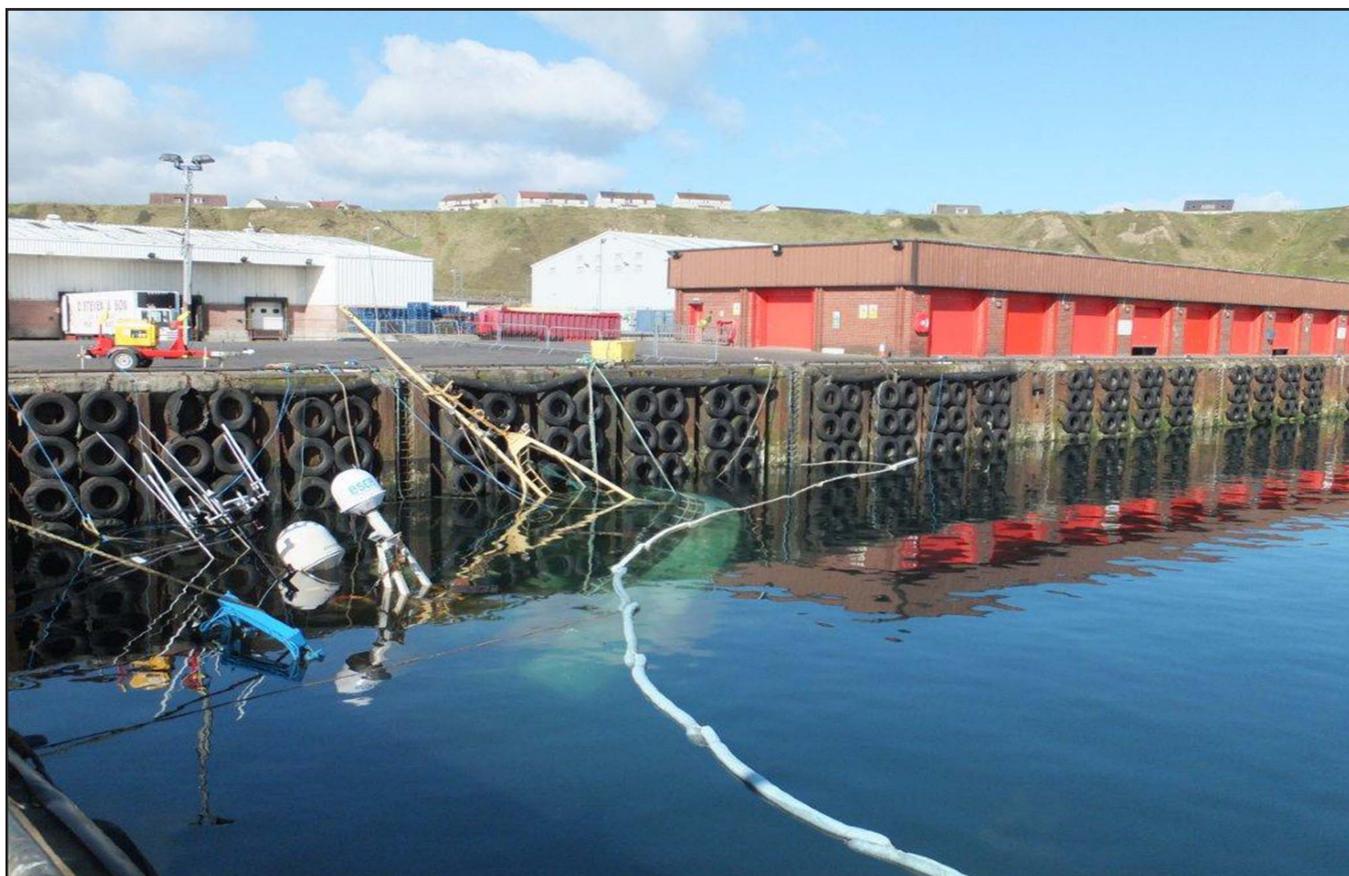
Figure 3: *Shalimar* submerged alongside

The skipper and the engineer remained on board the vessel until the fire and rescue service arrived at 2141. Following a discussion with the fire service's on-scene commander, the skipper and engineer returned to *Shalimar* with a hose from the fire tender to pump the water out of the hull. The skipper tried to put the hose into the forward deck hatch opening but, as *Shalimar* was now listing heavily to port, he was unable to do so. The skipper and engineer realised that the vessel could not be saved and they scrambled ashore just before *Shalimar* sank alongside the quay at 2150 (**Figure 3**).

Shalimar's cruiser-style stern (**Figure 2**) struck the quay on the protruding framing in between the tyre fenders (**Figure 3**). The force of the impact forced the bottom of the outrigger away from the stern post and sprung adjacent planks from the stern frame (**Figure 5**). Although the resulting water ingress was quickly detected and a general service pump was started, the rate of ingress exceeded the pump's capacity. As *Shalimar's* fish room bulkheads were not watertight, the incoming seawater quickly spread through the vessel. This caused the vessel to list heavily to port and then sink only 23 minutes after the impact with the quay.

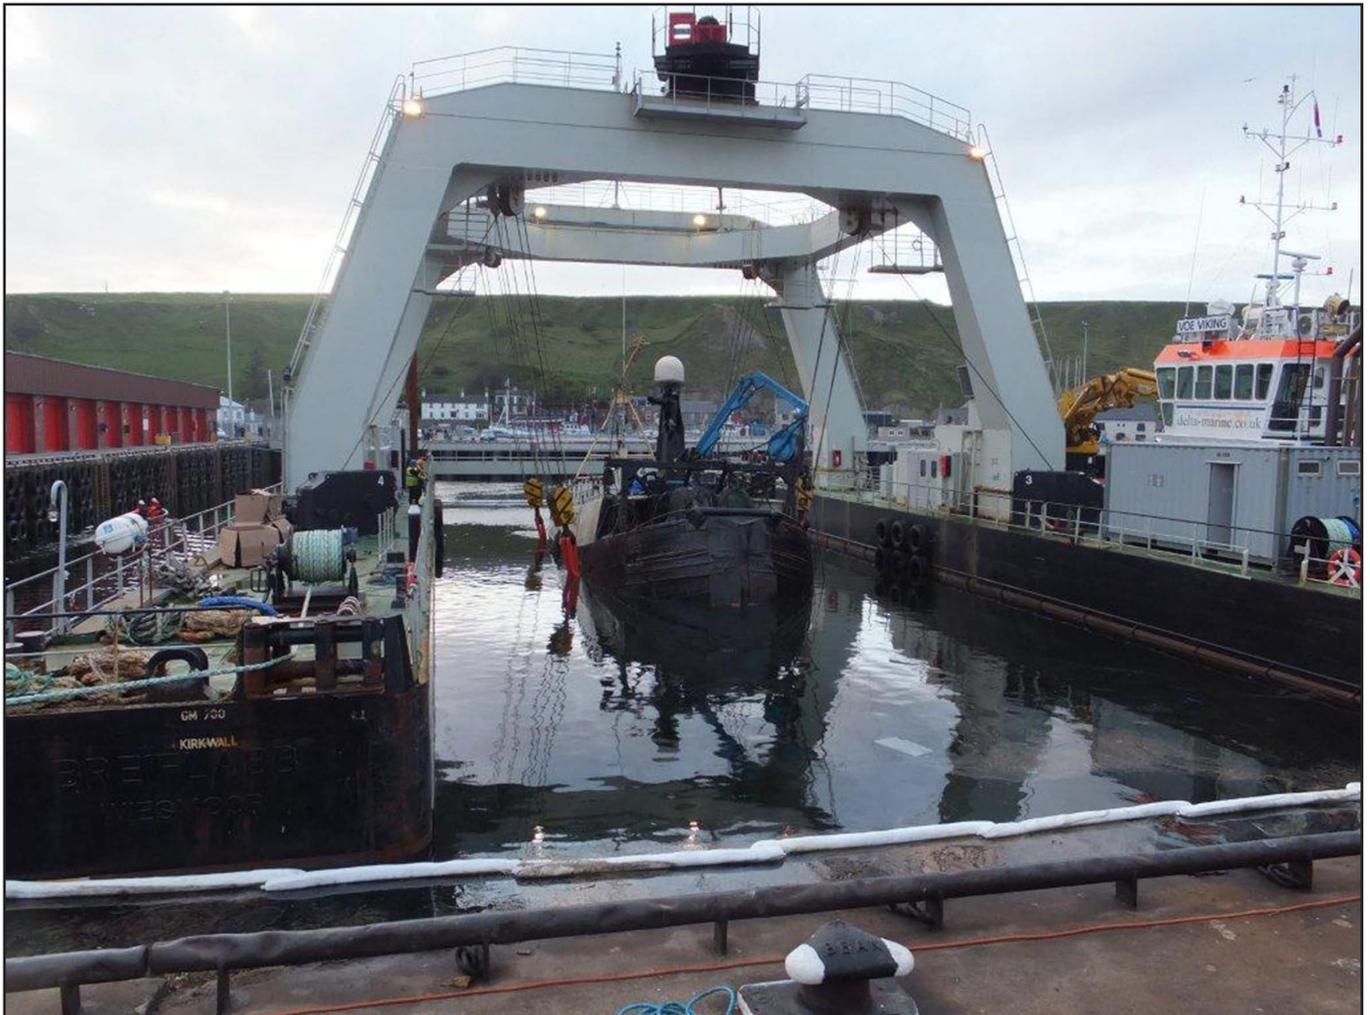
Figure 4: Salvage

On 12 May 2014, *Shalimar* was lifted clear of the water by a floating straddle crane (**Figure 4**). Examination of the vessel's hull identified that the damage to the cruiser-style stern was just below the bulwark on the centreline, an area which was not protected by the fishing vessel's fenders. The lower part of the outrigger⁴ had been levered outboard, and adjacent larch planking had sprung away from the oak stern framing, which created a substantial area for water to ingress (**Figures 2 and 5**).

Other than the damaged area, the wooden hull was in sound condition with no obvious weaknesses or underlying defects that would have been detrimental to the vessel's structural integrity or strength. Once temporary repairs had been completed, *Shalimar* was towed to MacDuff, Scotland, where the vessel was declared a constructive total loss.

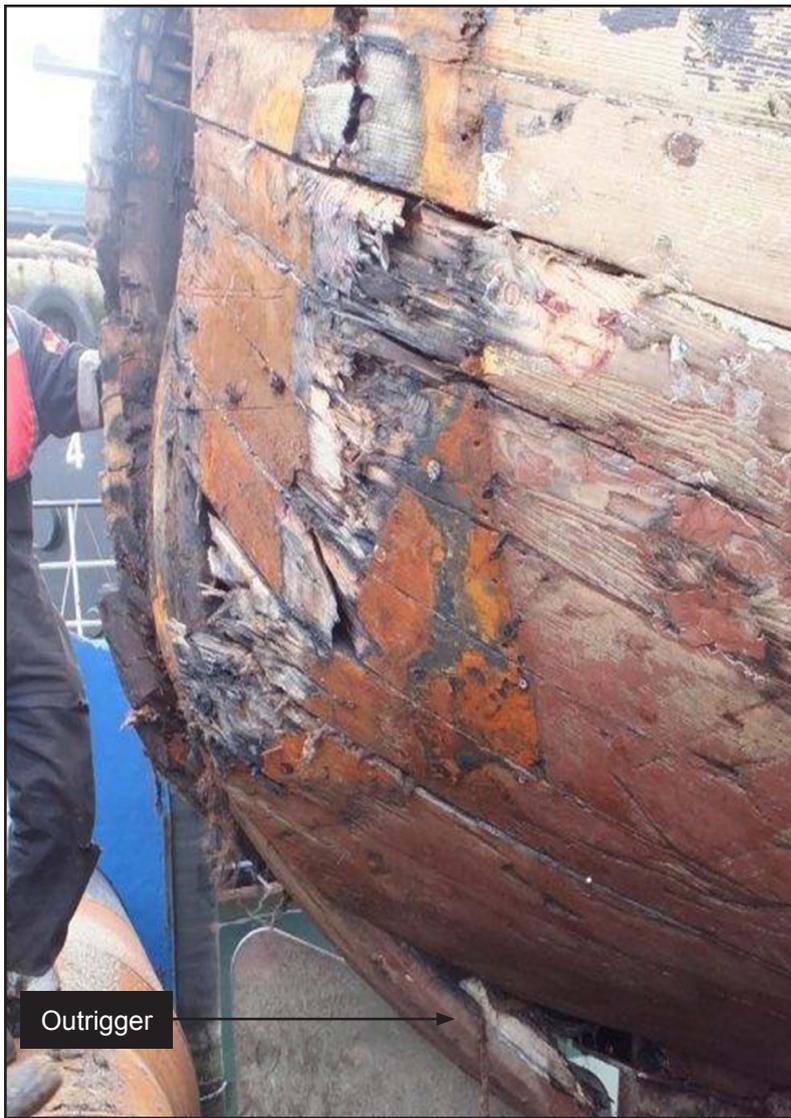
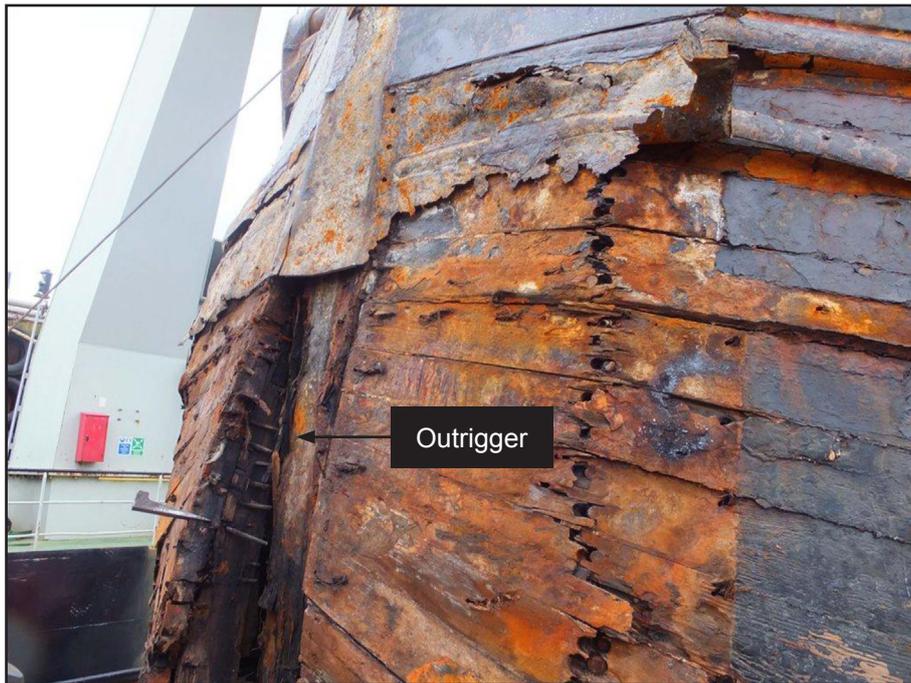
Figure 5: Stern damage

In view of the extent of the damage (**Figure 5**) it would have been almost impossible for the crew to stem the water ingress in the time available. It is sometimes feasible to stop or minimise flooding caused by a breached hull by fothering⁸ but this would have been difficult to achieve on this occasion due to the location of the damage, the equipment required and the crew's lack of training and practice in this area.

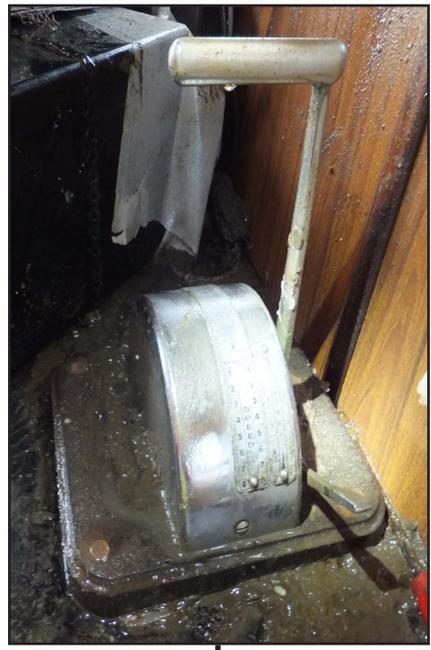
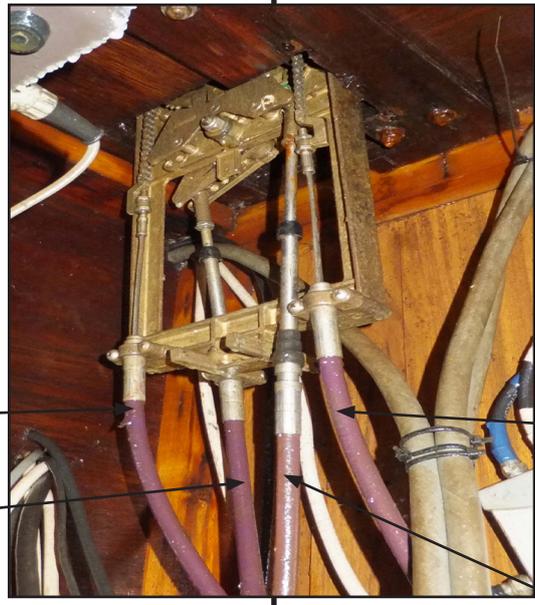
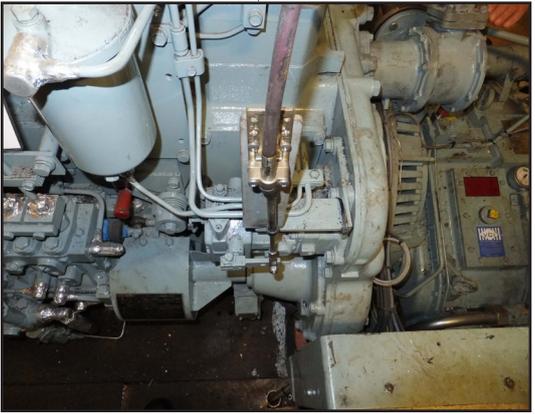
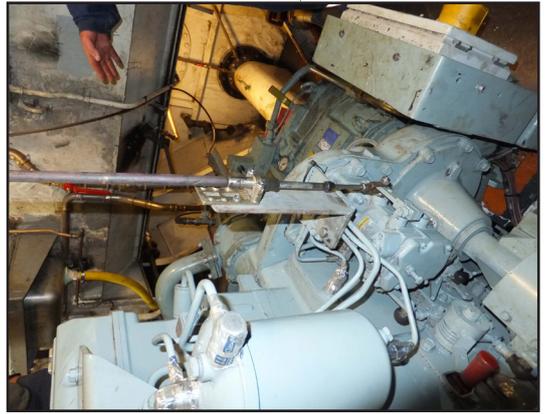
Figure 6: Engine and gearbox control arrangement

Two control levers were fitted in the wheelhouse: a master and a slave. The master lever was located on the starboard side of the wheelhouse and the slave lever was on the port side. The movement of the levers was synchronised by morse cables so that when either control lever was moved, the other would move in the same direction by the same amount (**Figure 6 – cables a and b**). The master control lever was also connected to the engine governor and gearbox in the engine room by morse cables (**Figure 6 – cables c and d**).

Apart from a minor adjustment to the morse cables when the vessel was re-engined in 2012, there is no evidence of the morse control system being inspected, greased or maintained.

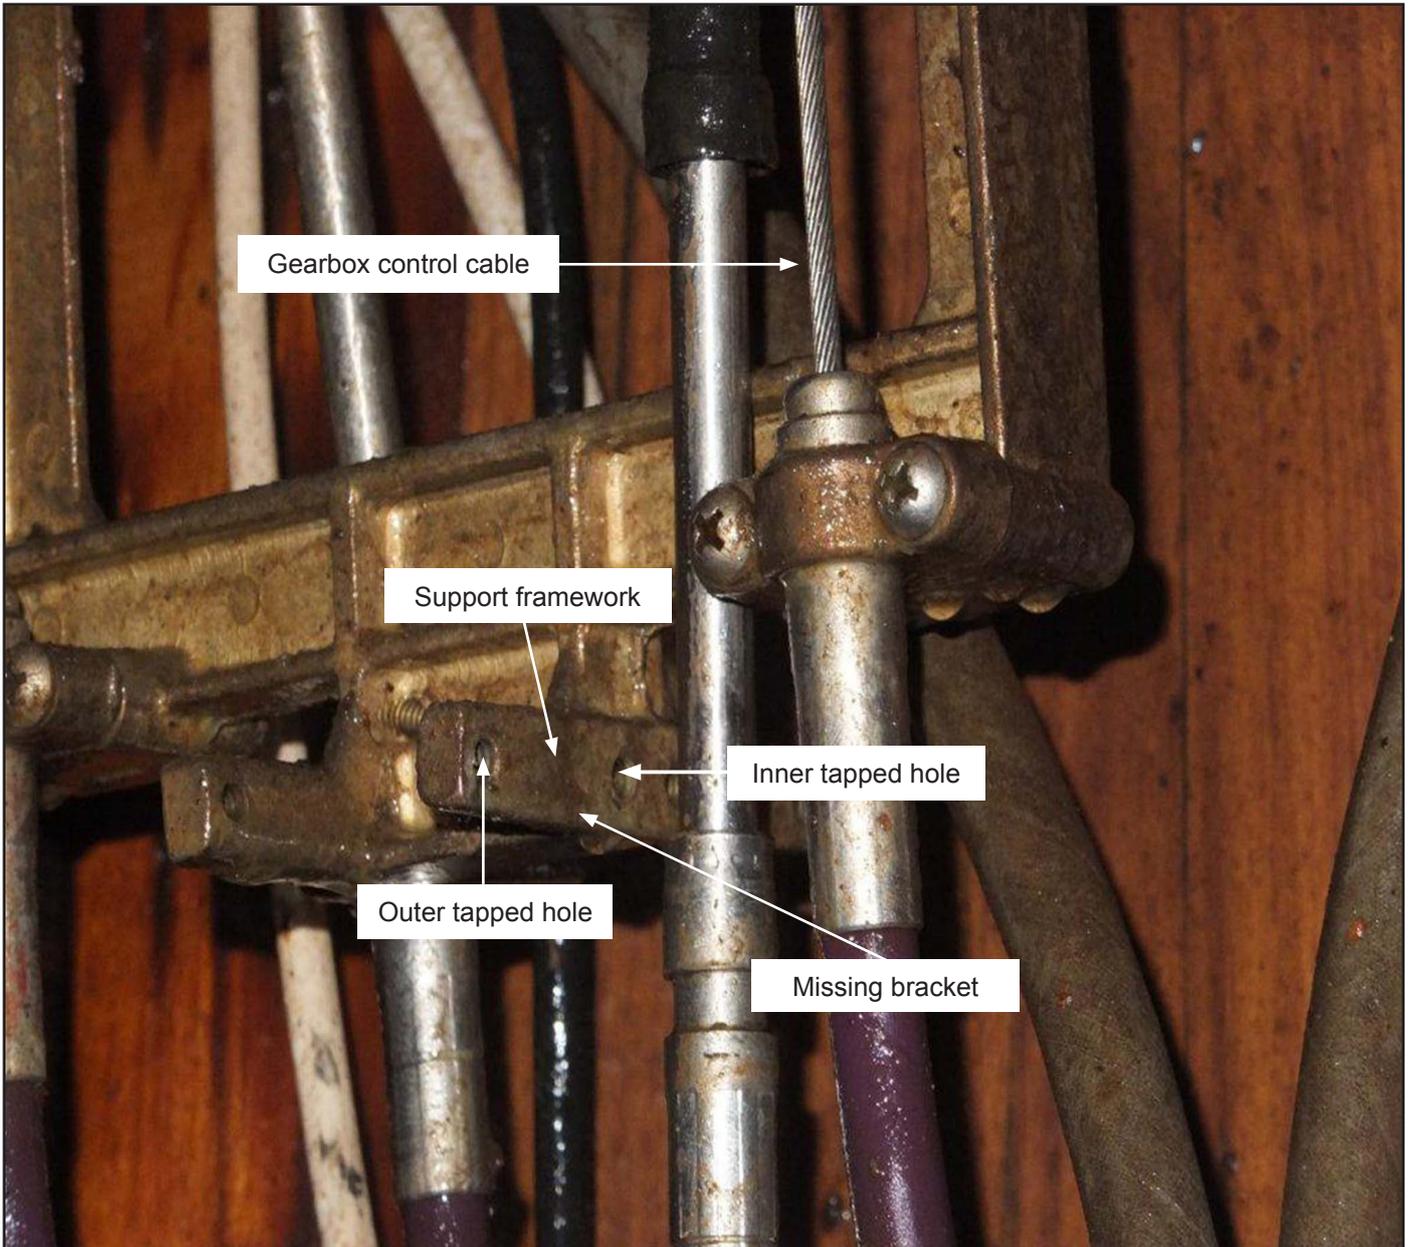
Figure 7: Support framework

Following *Shalimar's* salvage, examination of the engine and gearbox control system behind a console in the wheelhouse identified that a retaining bracket used to secure the cable between the master control lever and the gearbox had detached from the supporting framework (**Figure 7**).

Shalimar struck the quay wall because the vessel's movement astern could not be stopped. The skipper had moved the engine and gearbox control lever in the wheelhouse to 'ahead' but the vessel continued to drive astern. Examination and testing of the engine and gearbox control system identified that the morse cable link between the control levers in the wheelhouse and the gearbox had not worked as intended because a retaining bracket used to secure the cable had detached from the supporting framework (**Figures 7 and 8**).

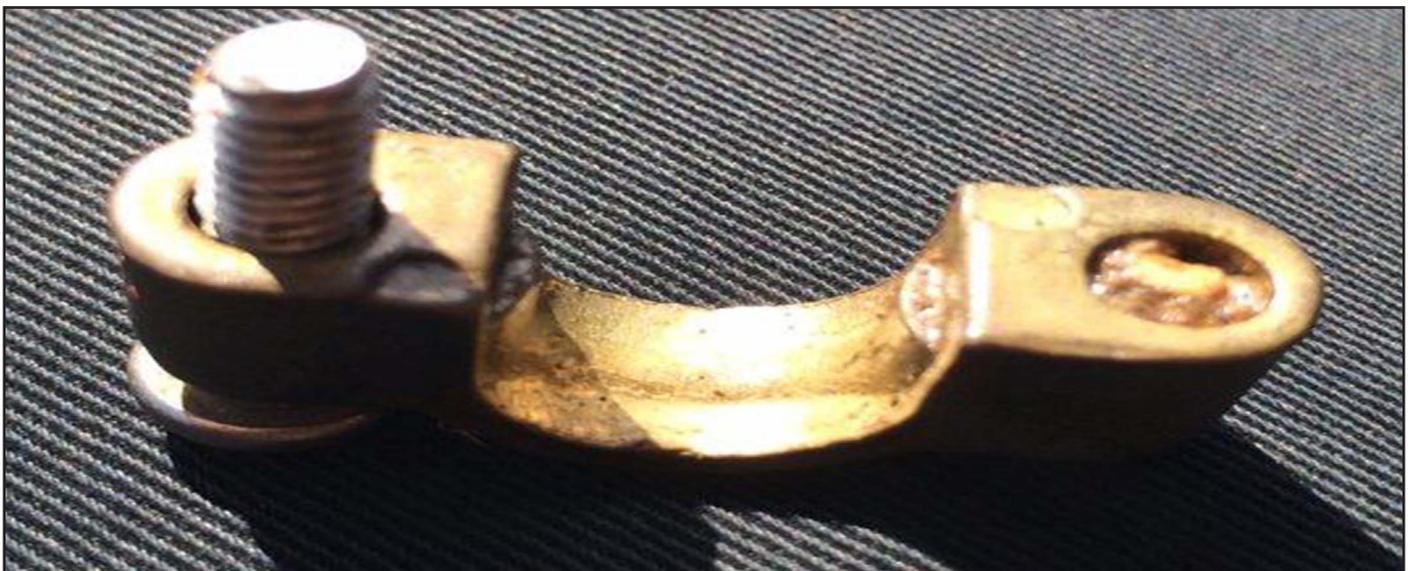
Figure 8: Detached securing bracket

The retaining bracket was found at the bottom of the console and contained only one screw. It was undamaged and the empty screw-hole was filled with debris and grease (**Figure 8**).

The retaining bracket was designed to be secured to the support framework by two screws. As only one screw was found in the bracket, the remaining screw hole in the bracket was filled with debris, and the outer of the two tapped holes in the framework was considerably cleaner than the inner, it is highly likely that the bracket had been secured with one rather than two screws for some considerable time before it detached. In view of the difficulty in accessing the inner tapped hole due to the surrounding framework and cables, it is possible that only the outer screw had been fitted when the system was first installed.

The gearbox control cable had functioned correctly for many years, but it is evident that over time the single screw in the retaining bracket worked free from the supporting framework. As the screw was fitted without a locking washer, it had probably loosened due to vibration.
